## AIRCRAFT CRASHES SHORTLY AFTER TAKE-OFF

Incident number	2009083
Classification	Accident
Date and time <sup>1</sup> of incident	16 October 2009, 08.24 hours
Place of the accident	Weert, the Netherlands
Registration	PH-RUL
Aircraft type	Pilatus PC-12/47E
Aircraft category	Single-engine propeller aircraft
Flight type	Business flight
Flight phase	Climb
Aircraft damage	Destroyed
Number of crew members	One
Number of passengers	One
Personal injury	Both occupants died
Other damage	Environmental damage to soil (kerosene pollution)
Light conditions	Daylight

After taking off from Runway 21<sup>2</sup> at Budel Airport (Kempen Airport, EHBD), the Netherlands, PH-RUL turned left and started to climb. Shortly afterwards the aircraft turned right followed by a steep descent. Approximately two minutes after take-off the aircraft crashed near a farm. The two occupants did not survive the crash and the aircraft was completely destroyed.

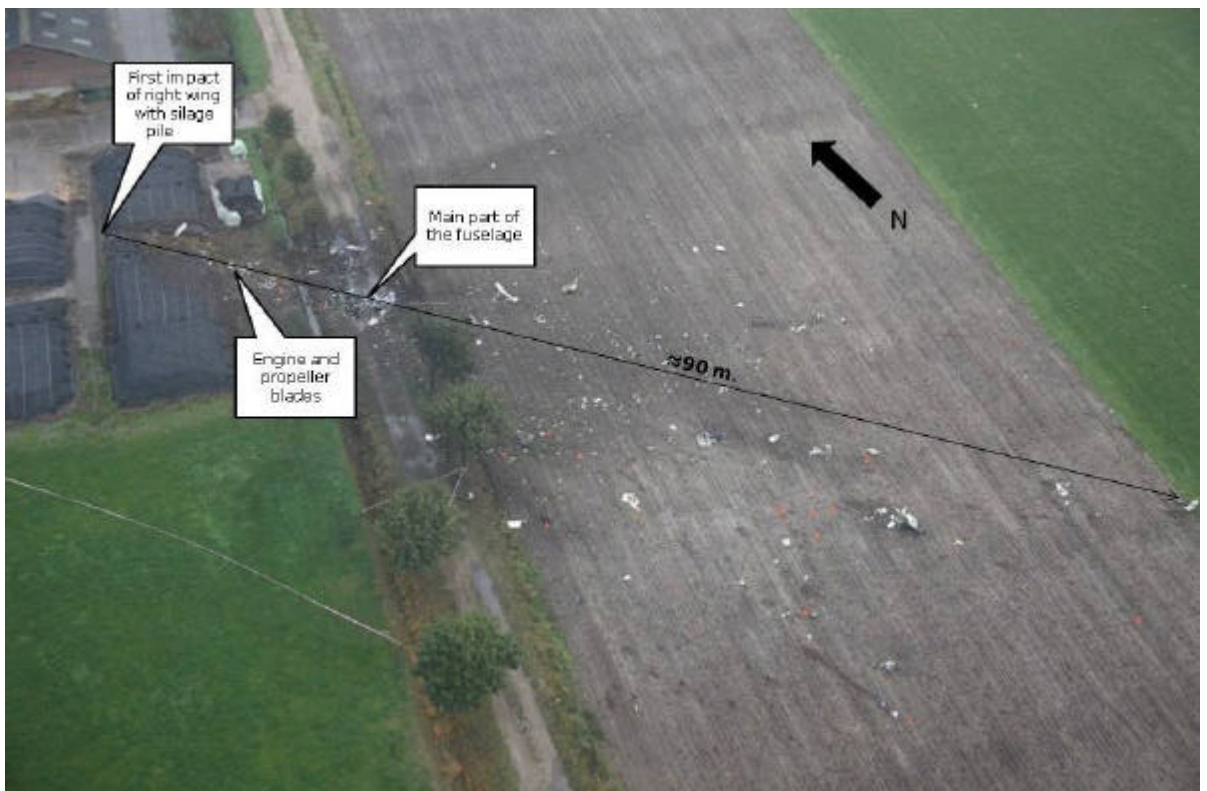
The aircraft came down next to a farm. The aircraft first hit the ground in a silage pile, which was located south of the farm. The plastic cover on the silage pile had been torn width-wise and part of the winglet on the right wing was lying where the tear started. The aircraft engine, the propeller hub and two of the four propeller blades were lying right behind the silage pile. The largest section of the aircraft was lying on the road beyond the silage pile. This section was completely destroyed and had burned out. A large number of aircraft parts were lying in the field beyond the road, strewn across a large distance. Viewed from the location in the silage pile where the aircraft had first hit the ground, the wrecked parts were roughly strewn in a 155-degree direction across a length of approximately 90 metres.

Figure 1: Aerial photograph of the site of the accident (source: Aviation Police, KLPD)

It may be concluded from the marks found in the silage pile that the aircraft first struck the ground with its right wing. The engine and propeller hit the ground behind the silage pile and the aircraft overturned. On the basis of the tracks, it emerged that PH-RUL was flying a 155° heading just before the accident. In the light of the tracks on the ground, the aircraft was flying at a high horizontal speed and banked to the right.

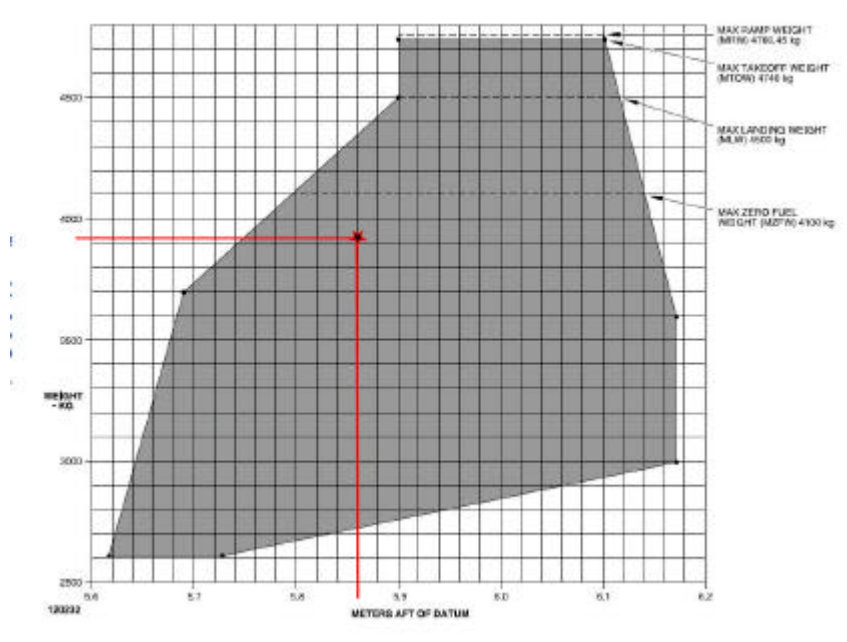
Figure 4: graph of weight and balance

The calculation made of the estimated weight of the occupants and the amount of fuel shows that the take-off weight of the aircraft was around 3,926kg. The centre of gravity was approximately 5.86 metres from the datum.

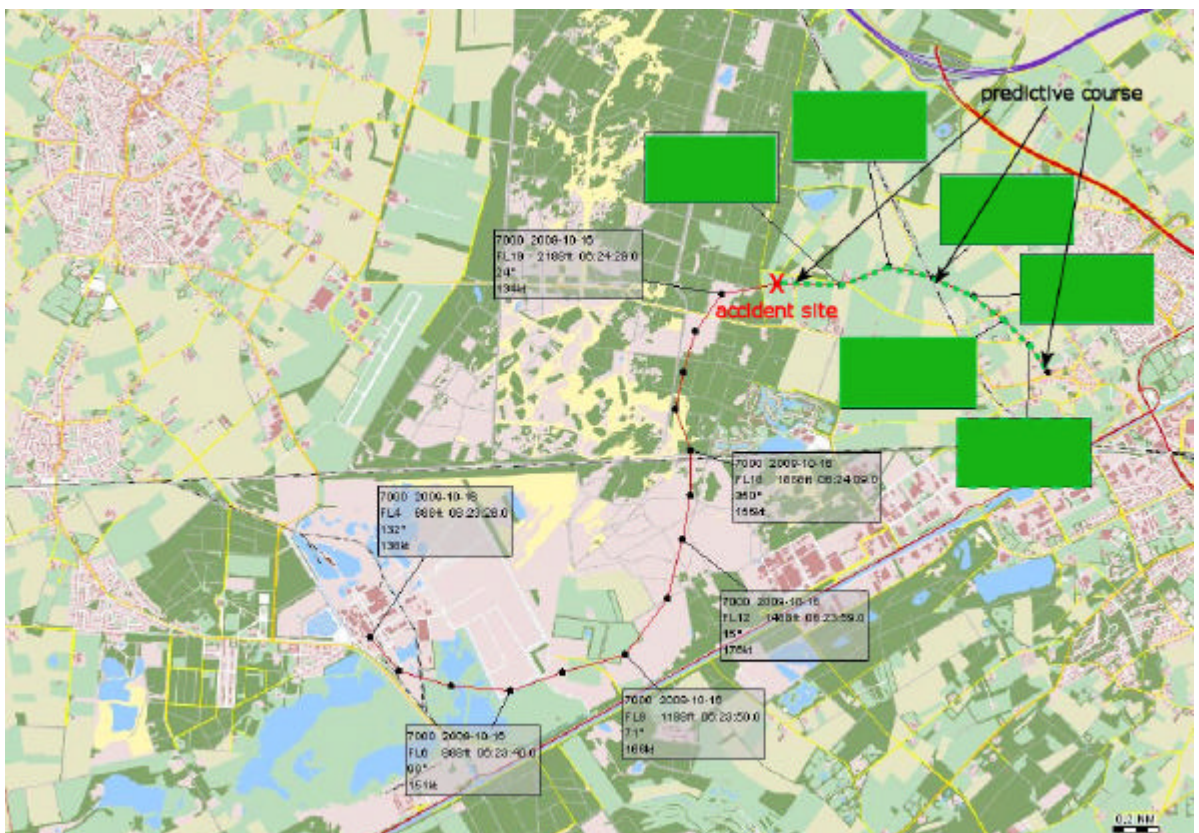
- After take-off, PH-RUL first appeared on the radar screen at 06.23.:26 UTC radar time.
- At that time the aircraft was flying at an altitude of 688 feet at a ground speed of 136 (103)<sup>13</sup> knots, south of Budel Airport with a heading of 132°.
- The aircraft made a left turn of approximately 180° in relation to the direction in which it had taken off.
- At 06.24:09 hours PH-RUL was flying west of Budel Airport at an altitude of 1,888 feet at a speed of 156 (189) knots with a heading of 350°.
- PH-RUL then turned slightly further left and then made a sharp right turn.
- The last radar image was taken at 06.24:29 hours. PH-RUL was then flying with a heading of 024° at an altitude of 2,188 feet at a speed of 134 (157) knots.

Figure 5: Radar plot of the heading flown by PH-RUL<sup>14</sup> (source: Air Traffic Control Netherlands, (LVNL))

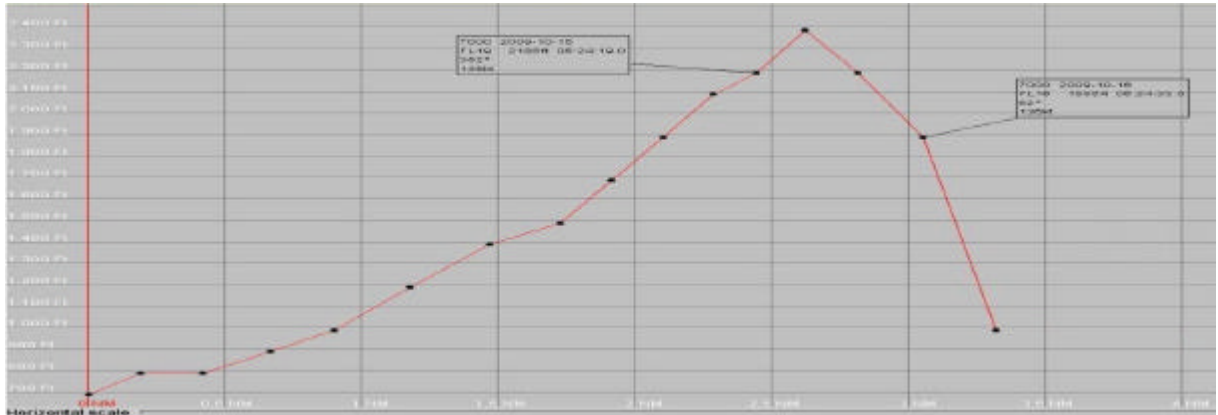
A vertical profile was also obtained. According to this profile PH-RUL was climbing at 06.24:19 hours. The next radar image showed PH-RUL flying at an altitude of 1,888 ft at 06.24:33 hours and the aircraft was descending.

Figure 6: Radar plot of the vertical profile of PH-RUL

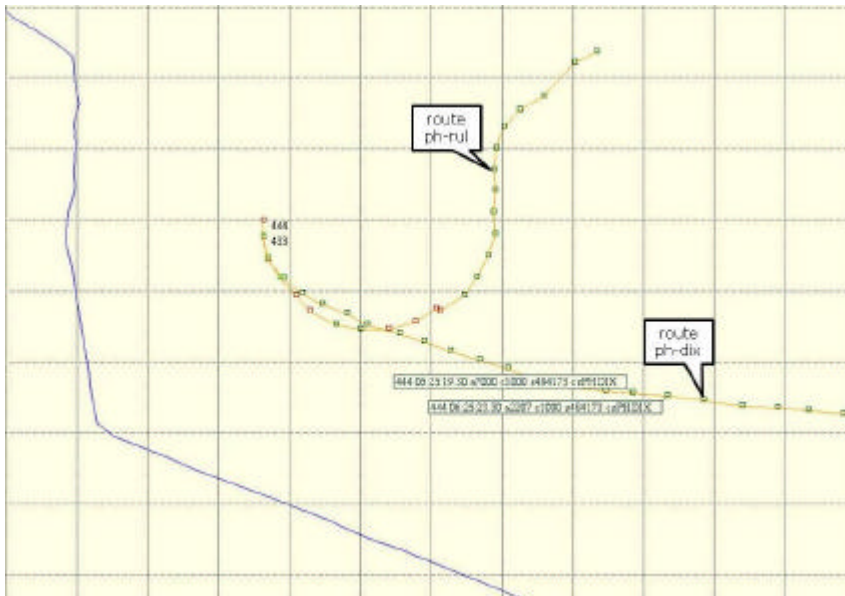
A comparison of the radar images of PH-RUL and PH-DIX shows that the two aircraft followed a different route although they had both received clearance to fly to navigation point OSGOS.

Figure 7: Radar plot of the headings flown by PH-RUL and PH-DIX (source: Dutch Mil)
