AIRCRAFT ACCIDENT REPORT AND EXECUTIVE SUMMARY

Reference:	CA18/2/3/8704	
Aircraft Registration	ZU-COX	Date of Accident	08/11/2009		Time of Accident	0920Z
Type of Aircraft	Jabiru SP		Type of Operation	Training		
Pilot-in-command Licence Type	Instructor		Age	39	Licence Valid	yes
Pilot-in-command Flying Experience	Total Flying Hours		189.3		Hours on Type	137.7
Last point of departure	Kitty Hawk Aero Estate (FAKT) in the Gauteng Province					
Next point of intended landing	Rhino Park Airfield in the Gauteng Province					
Location of the accident site with reference to easily defined geographical points (GPS readings if possible)						
Runway 27 at Rhino Park Airfield S25° 49.594' E028° 32.264'						
Meteorological Information	Wind 330° 20kts. Visibility CAVOK.					
Number of people on board	1+1	No. of people injured	0	No. of people killed	0	
Synopsis						
<p>The instructor and student pilot took off from Kitty Hawk Aero Estate (FAKT) on a training flight to Rhino Park Aero Estate (FAKT).</p> <p>During the final approach to do a touch and go on runway 27, the aircraft encountered two severe gusts of wind.</p> <p>The second gust of wind caused the aircraft to roll to the left and crash

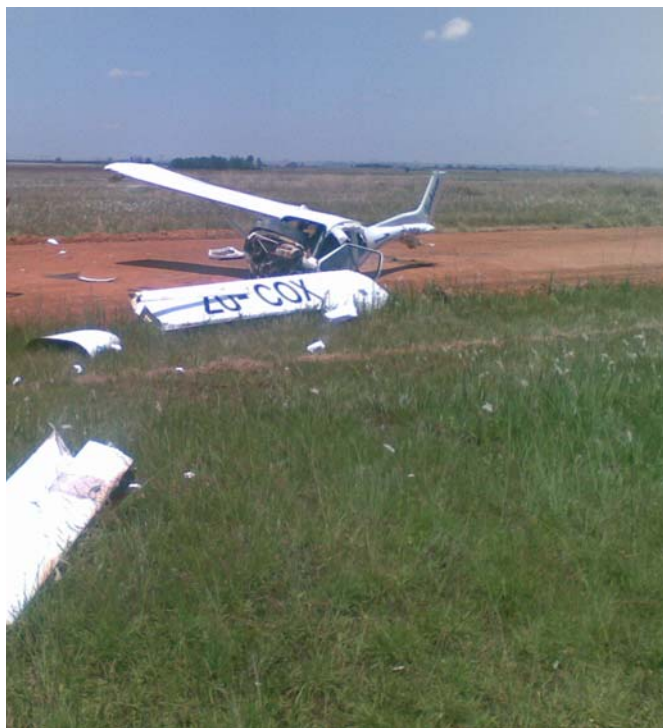
1.3.1 The aircraft was destroyed in the accident sequence.

Figure 1 showing aircraft wreckage at accident site

1.12.3 A second gust of wind from the right lifted the right wing and caused the aircraft to roll to the left. The aircraft lost altitude and the left main gear collided with a pile of rocks, causing the aircraft to cartwheel over the rocks between runway 27 and the runway under construction.

1.12.4 The left wing separated from the aircraft during the accident sequence and was found lying approximately 5 m from the aircraft.

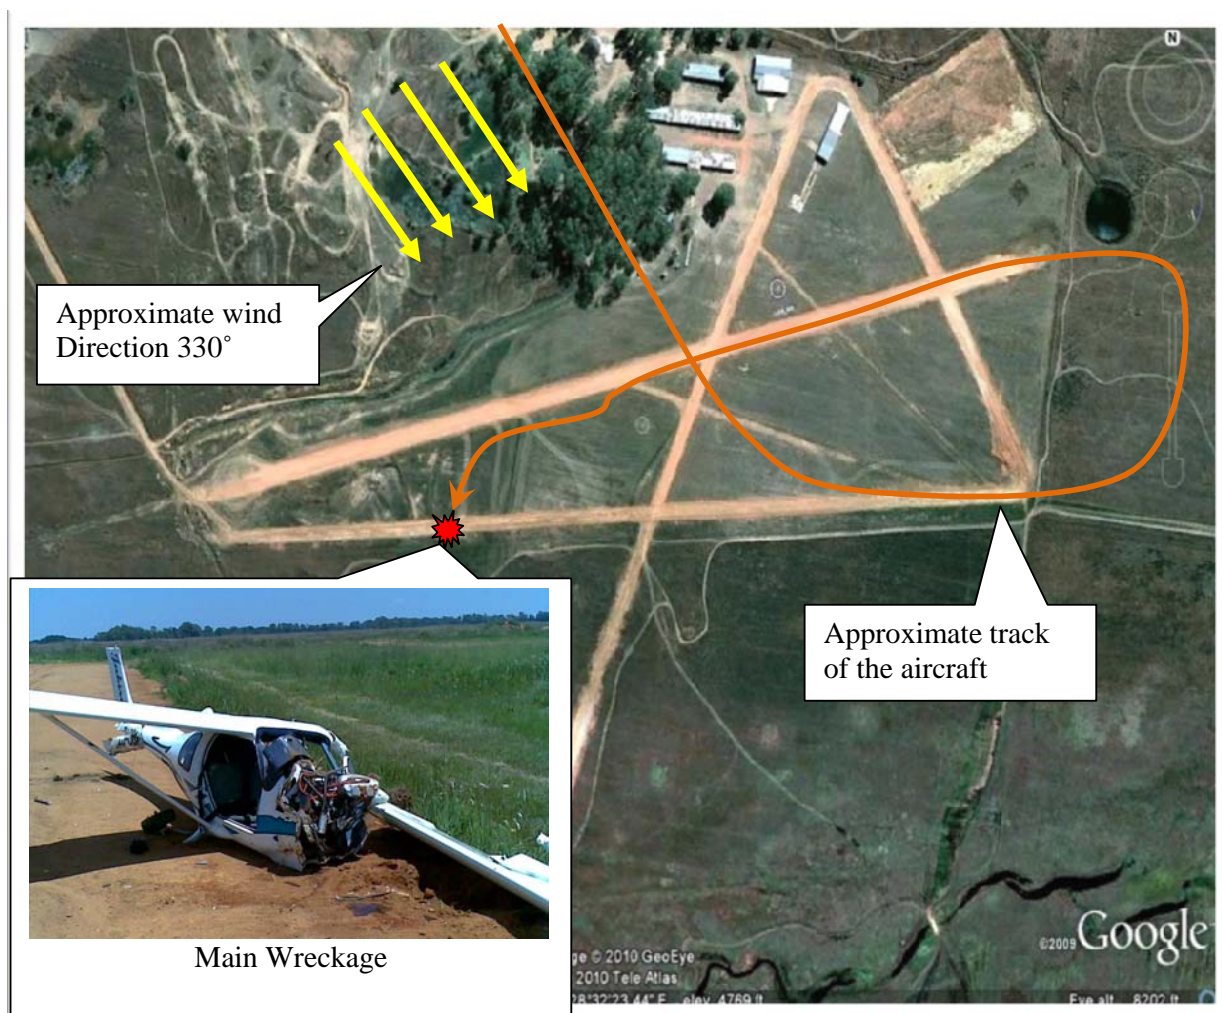
Figure 2 showing aircraft track until impact.

with the intention of performing a touch and go. The first gust of wind pushed the aircraft to the left of the runway just as the aircraft passed a clump of tall trees to the left of the runway. These trees acted as a barrier for the wind, which was blowing almost perpendicular to the flight path of the aircraft.

- 2.4 The second gust of wind, accompanied by a downdraft at the intersection of runway 03/21 and the runway under construction, pushed the aircraft further off the runway in the direction of the runway under construction. The downdraft prevented the aircraft from climbing despite full power being applied and takeoff flaps being selected.
- 2.5 The aircraft lost altitude and the left main gear collided with a pile of rocks, causing the aircraft to cartwheel over the rocks between runway 27 and the runway under construction.
- 2.6 The aircraft came to a stop in an upright position adjacent to the runway under construction.
