AIRCRAFT ACCIDENT REPORT AND EXECUTIVE SUMMARY

Reference:	CA18/2/3/8706	
Aircraft Registration	ZU-BEX	Date of Accident	14 November 2009		Time of Accident	1022Z
Type of Aircraft	English Electric Lightning MK T5		Type of Operation		Commercial – Air Show	
Pilot-in-command Licence Type		Airline Transport	Age	46	Licence Valid	Yes
Pilot-in-command Flying Experience		Total Flying Hours	10993.0		Hours on Type	unknown
Last point of departure		Overberg – Test Flying and Development Aerodrome (FAOB)				
Next point of intended landing		Overberg – Test Flying and Development Aerodrome (FAOB)				
Location of the accident site with reference to easily defined geographical points (GPS readings if possible)						
Overberg – Test Flying and Development Aerodrome (FAOB) at GPS co-ordinates: S 34°31.232 E020°22.618						
Meteorological Information		Wind direction: 250° , Wind speed: 10 kts , Temperature: 20°C, Visibility: Good, Cloud cover: 5/8, Cloud base: 2500 ft.

Probable Cause						
Uncontrolled flight due to double hydraulic failure.						
Contributory Factors						
<p>There was evidence found indicating that the aircraft was exposed to a pre impact fire in flight and the heat from the fire pro

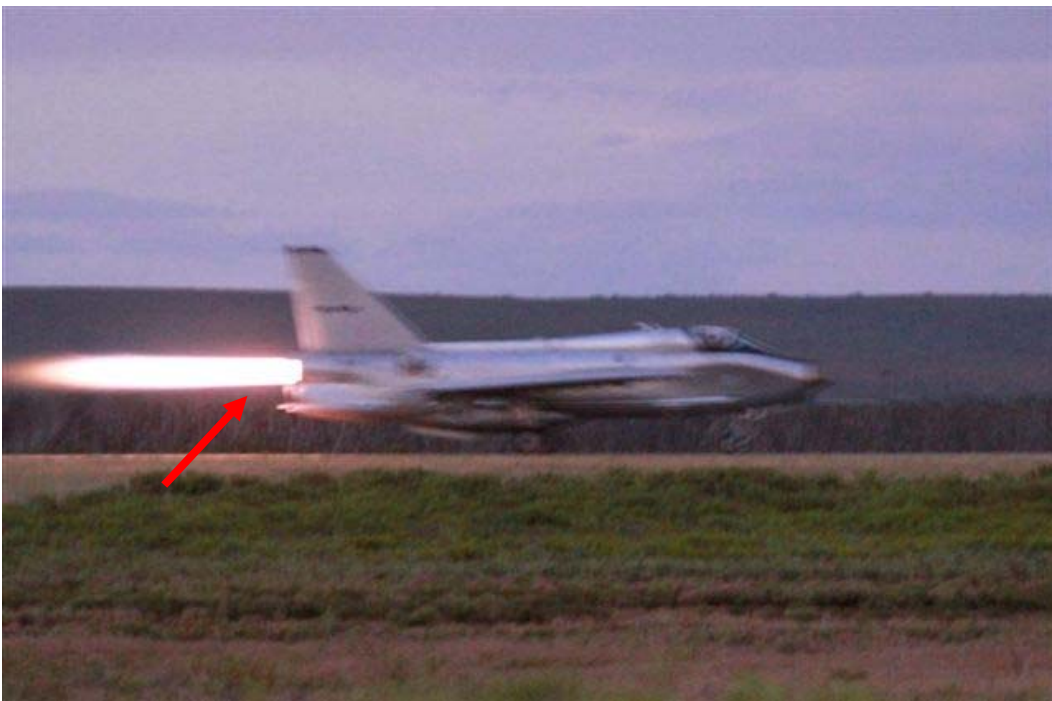
Figure 2, shows engine #2 afterburner being lit after the evening air show flight.

1.6.12 *Engine flameout*: On 13 November 2009, the engine #2 flamed out after the afterburner was lit. The pilot attempted to relight the engine, but he was unsuccessful. The ATC observed a large flame exiting the engine exhaust immediately followed by white smoke during the attempted relight. The pilot reported to ATC that he was shutting the aircraft down completely. The aircraft was standing on the runway for approximately 5 minutes, before the pilot attempted to restart. The pilot reported to ATC that external power was needed. The engine/s could not start and the aircraft had to be towed back to Apron B.

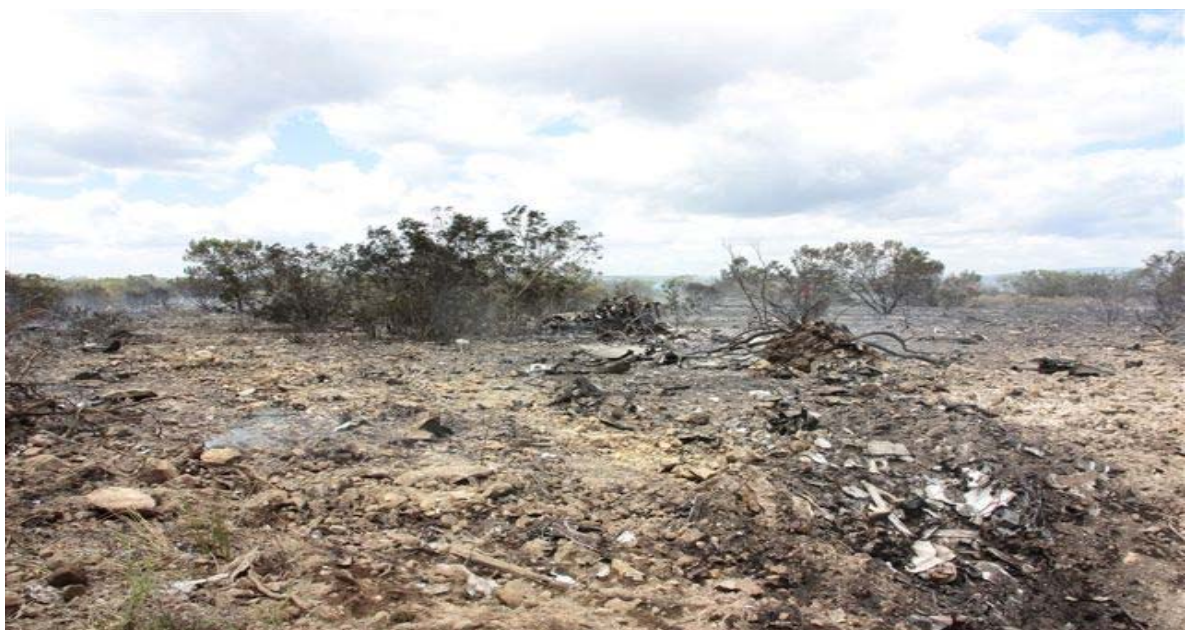
1.3.1 The aircraft was destroyed during ground impact sequence and by post impact fire.

Figure 3, shows the impact area.

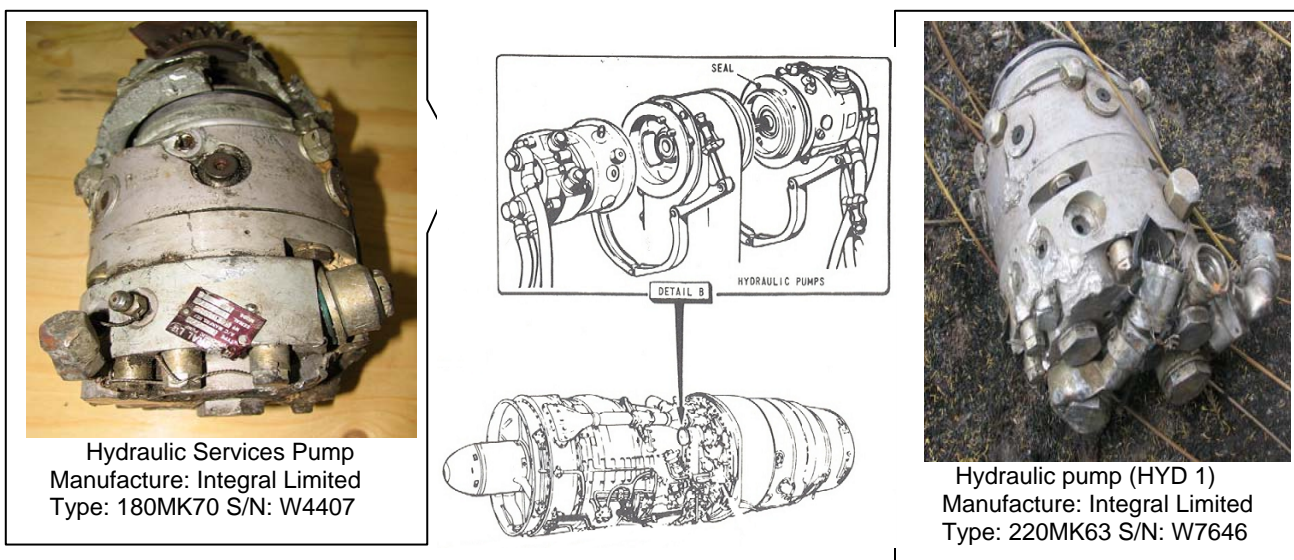
- (ii) During the onsite investigation, the hydraulic pumps (Type: 220MK63, Serial Number: W7646) on engine #1 and (Type: 180MK70, Serial Number: W4407) on engine #2 was located. The identified hydraulic pumps separated from the engines during the ground impact sequence. The pumps were recovered from the accident site for testing.

Figure 4, shows Hydraulic Services Pump and Hydraulic (HYD1) Pump.

- (iii) The hydraulic pumps identified above had no records of service life, overhaul status and repairs carried out prior to installation. The hydraulic pump (HYD 1 - S/N: W7646) was fitted to the aircraft on 16 May 2003. It was determined that the pump was operating for approximately 110.65 hours (1679.35 to 1790.00) until the accident. The other hydraulic pump (HYD 2 – S/N W4407) had the same anomaly of maintenance history not available.

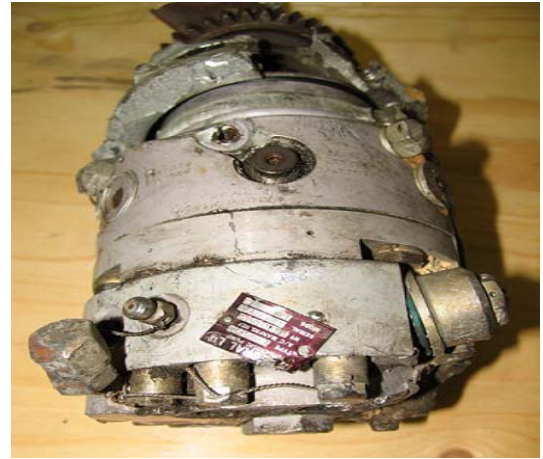
(iv) The hydraulic pump (S/n W4407) identification does not appear in the Aircraft Maintenance Manual (AMM) as a listed hydraulic pump. The pump was identified in a component life extension document as being either engine #1 or #2 services pump which was introduced by modification 4774. The pump still had attached to it a part of the drive gearing from the engine. All flexible hoses had broken off. The presumption was that the flexible hoses were destroyed in the ground impact sequence. Both pumps appeared to be in compliance with the latest modifications.

Figure 5, shows Hydraulic Pump.

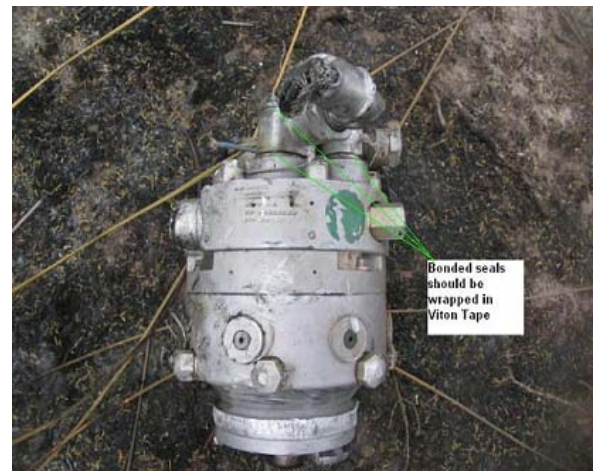
(v) The hydraulic pump (S/N W7646) still had small pieces of flexible hoses attached to it. The bonded seals on the pump were supposed to have viton tape wrapped around to prevent a hydraulic oil spray in the event of a seal failure. The anomaly identified was that the pump seals did not have viton tape wrapped around. It is unlikely that the viton tape and wire locking was removed by the accident impact, particularly as the unions are relatively undamaged. This would suggest the viton tape had never been fitted.

Figure 6, shows hydraulic pump.

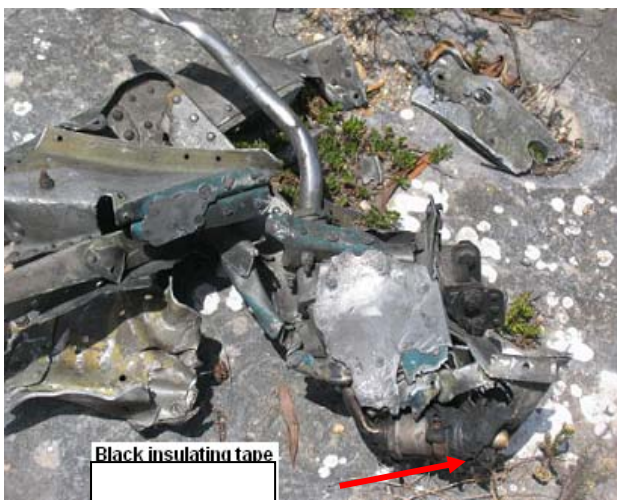
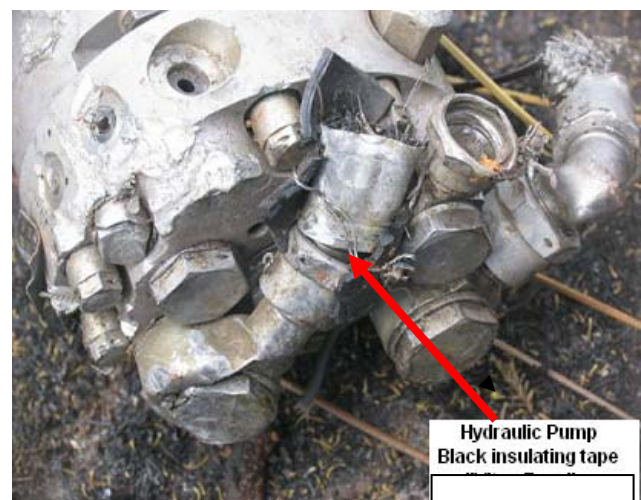
Figure 7 & 8, shows black rubber material wrapped around connecting couplings.

(i) *“The black tape is fluorocarbon tape called Viton. The purpose of viton tape used on the aircraft was to prevent spraying mist of fluid in the event of bonded seal failure. It was standard practice to wrap all hydraulic joints containing bonded seals in the engine, inter and reheat bays with viton tape. The viton tape would ensure that the hydraulic spray mist would be contained, resulting in hydraulic oil leak dripping and find its way overboard through the fuselage drains. Thunder City AMO was required to comply with requirements of AMM, AP 101B-1005-1A, Section 3, Chapter 6, Para 43A, amended in November 1979 for guidance about use of viton tape”.*

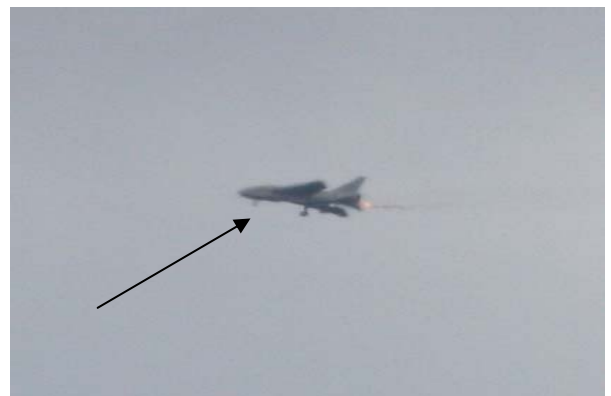
1.6.18 Undercarriage Failure: On 14 November 2009 shortly after the double hydraulic failure was reported, the pilot selected undercarriage down to perform an emergency landing. The pilot realised that the undercarriage had also failed. The nose gear, right side main gear was extended and the left side main gear was retracted. The left side main gear was still retracted at the time of ground impacted.

Figure 10, shows the undercarriage failure.

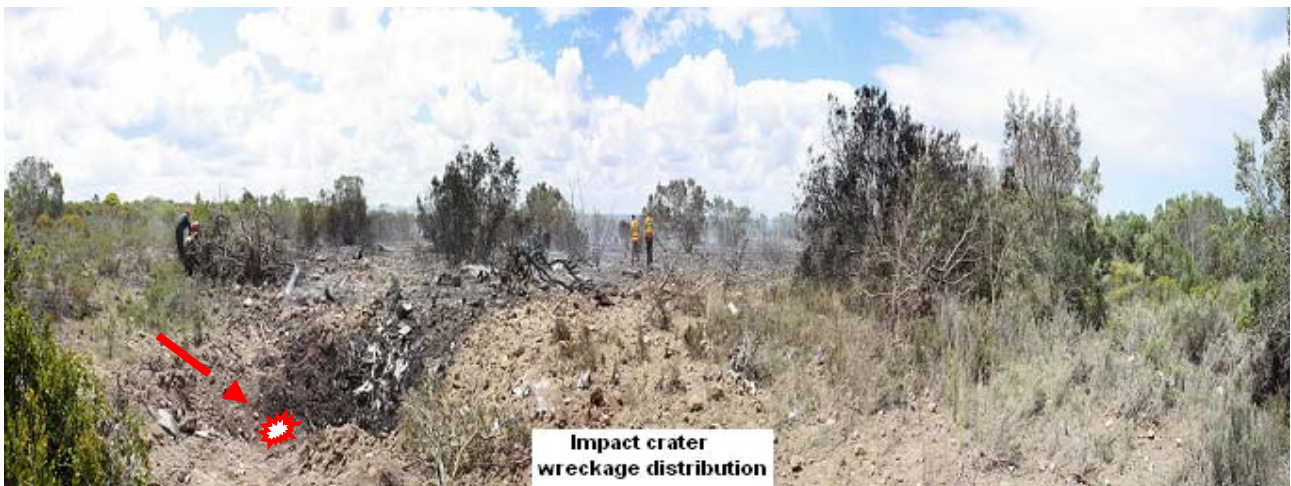
1.12.3 Because the aircraft impacted the ground at an angle, it caused the soil to pile up in the direction it was moving. On impact, the aircraft broke up and bulk of the debris was distributed in a random fashion away from the impact crater. The degree of break-up and destruction of the wreckage gave a clear indication of the impact heading and sequence. The impact information indicated that the aircraft was flying in north-westerly direction, almost parallel to Runway 35/17, losing altitude and rolling inverted to the right when it impacted with the ground.

Figure 15, shows accident site and wreckage distribution.

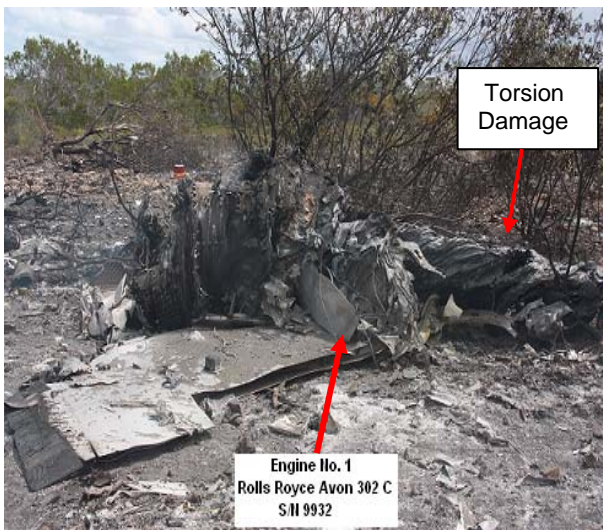
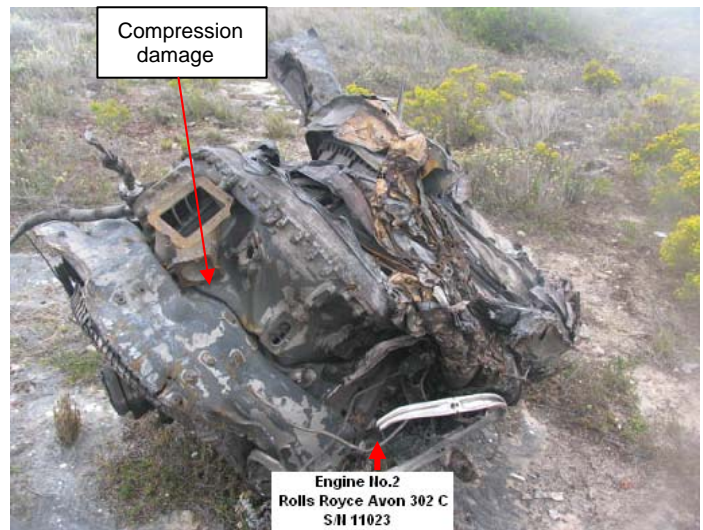
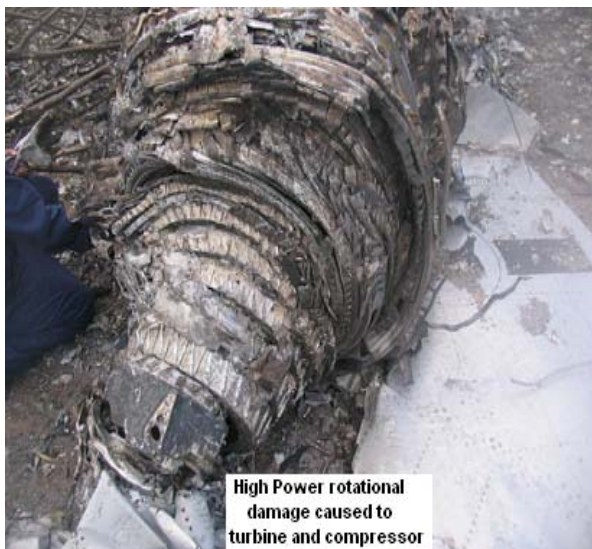
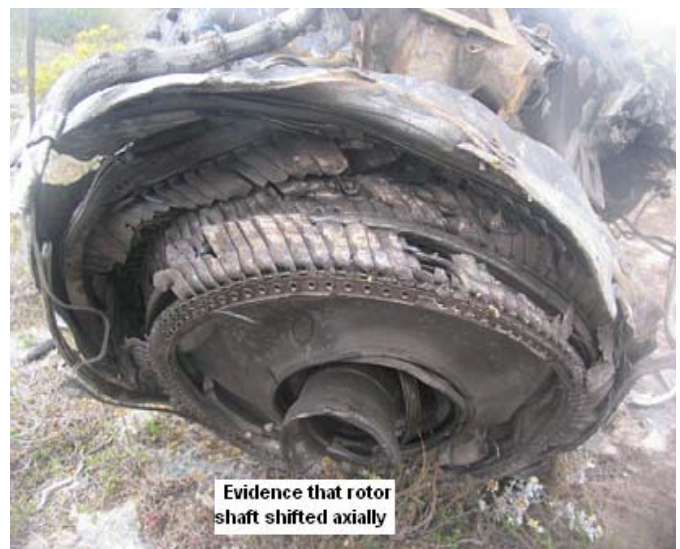
impact. The pilot did not report any information that suggested he was experiencing any engine problems at any time during the flight. Both engines separated from the airframe during the impact sequence.

Figures 19 to 22, shows engine damage.

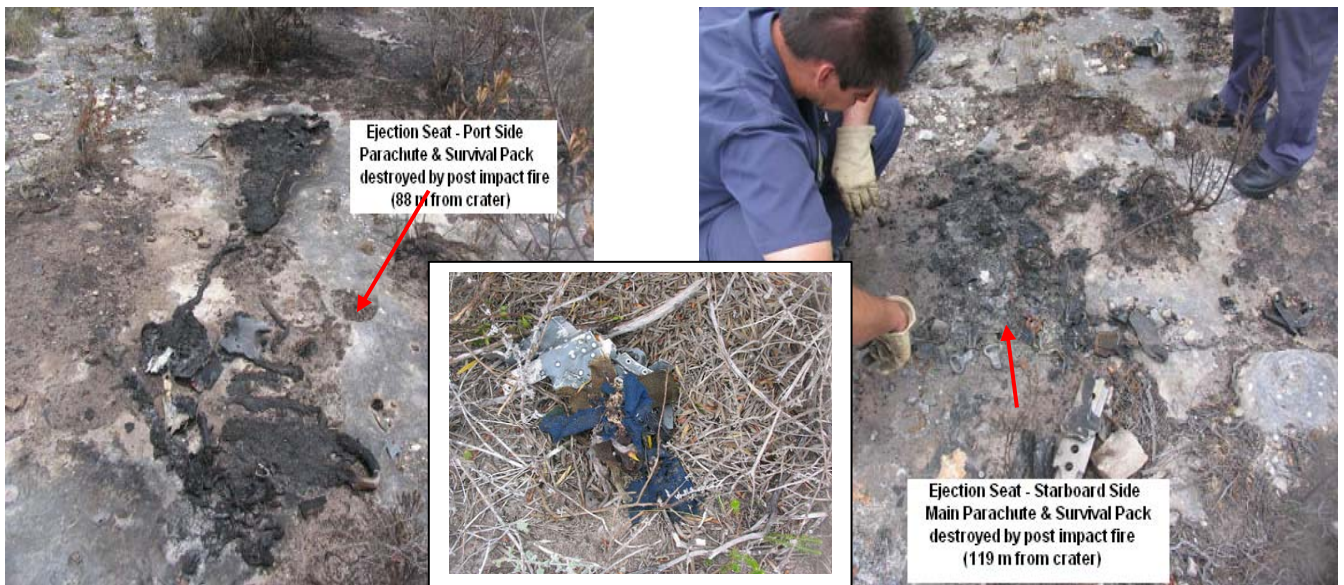
1.12.14 Fragments of the pilots flying suite (dark blue in colour) were found amongst the some of the ejection seat debris which was approximately 88 meters from the impact crater. The ejection seat debris was determined to be that of the port side ejection seat parachute and survival pack. Once the port side ejection seat debris was identified, it was easy to conclude that the other debris was that of the starboard side ejection seat. This fact was supported by the various straps which were fastened to the harness quick release fitting.

Figure 25 & 26, shows debris of ejection seat survival pack.

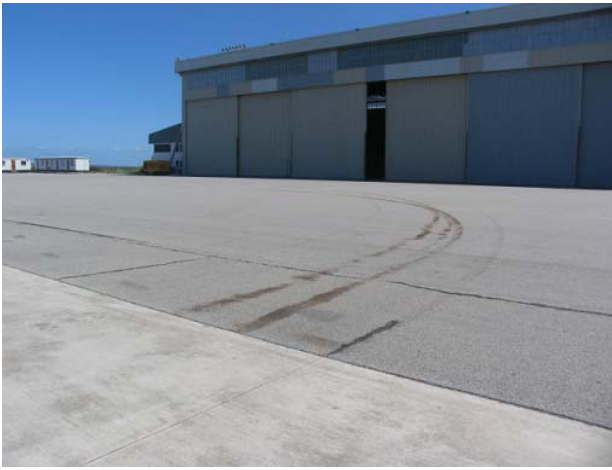
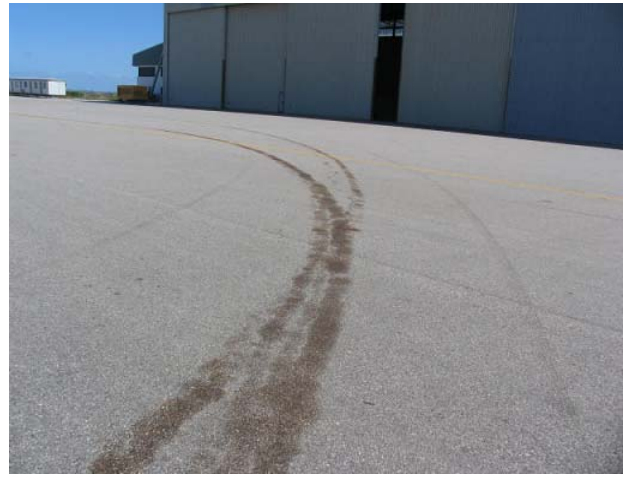
- (i) The parking bay of the EE Lightning was inspected during the investigation. There was proof found of liquid stains of an unknown substance which was leaking from the EE Lightning. The EE Lightning left trails of liquid stains on the apron following the direction the aircraft was taxiing to the runway. Below is proof of trails of liquid stains.

Figure 31 & 32 was taken on 15 November 2009. The figures show trails of liquid stains on apron and taxiway.

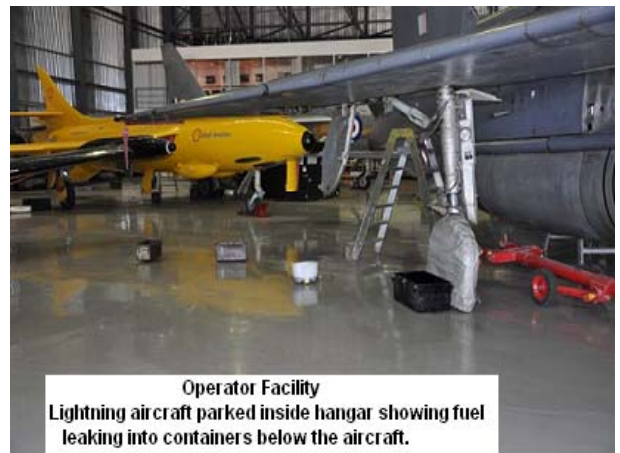
1.16.7 Thunder City AMO was visited during the investigation. There were other EE Lightning aircraft found parked inside the hangar. Specific attention was given to one of the aircraft parked in the centre of the hangar. The aircraft had containers placed underneath the wings to capture fuel leaking from different zones of the airframe. The fuel leaking was considered to be quite substantial. Reference is made to the fuel leak situation at FAOB which the ARFF personnel could not contain.

Operator Facility
Lightning aircraft parked inside hangar showing fuel leaking into containers below the aircraft.

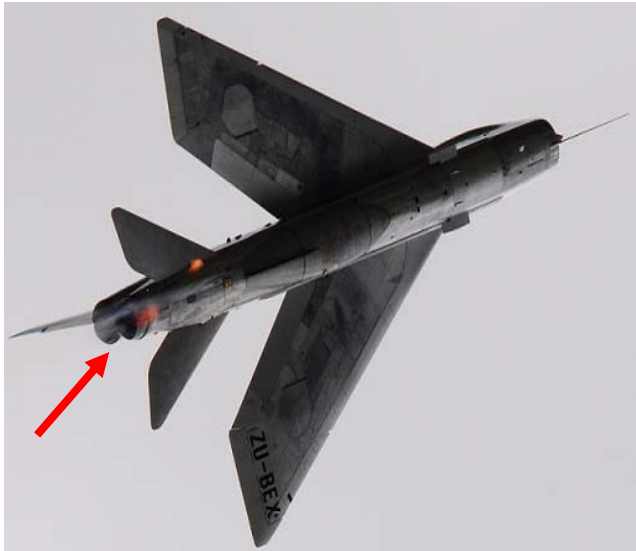
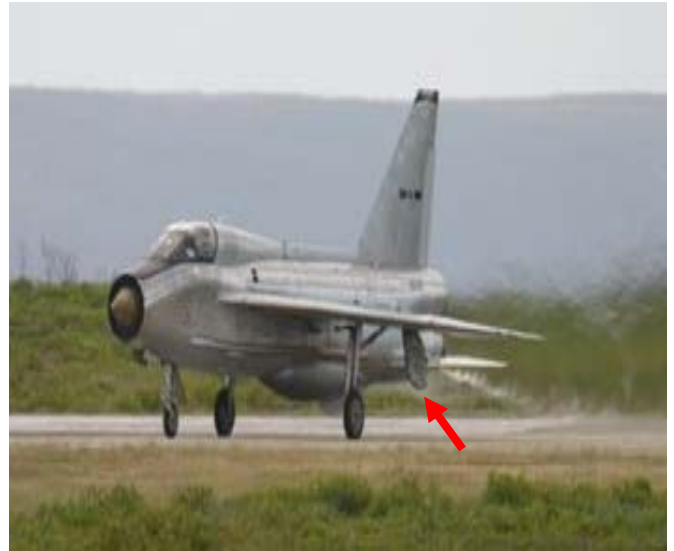
Figure 34 & 35, show proof of atomised fluid from the tail section of EE Lightning.

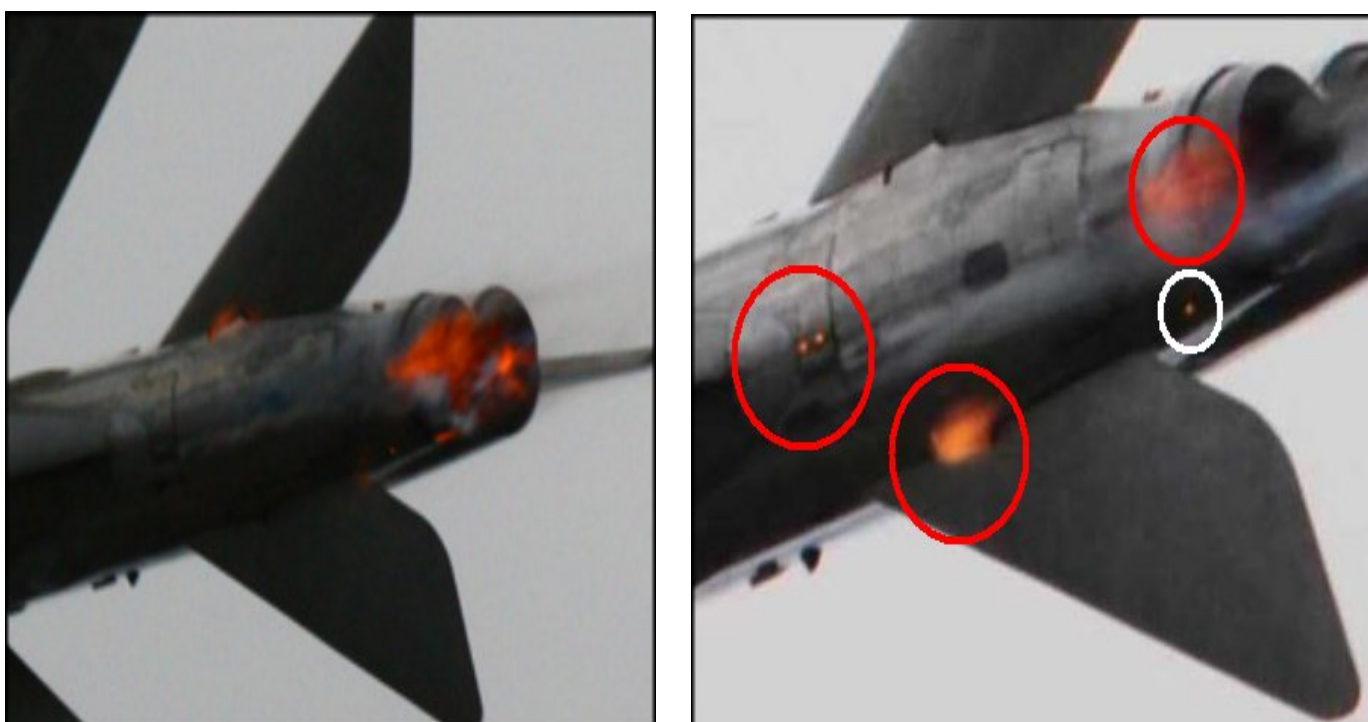
- 1.16.14 A fire in the interpipe or reheat bays would affect several major hydraulic components including the reservoirs, which were of the rubber bladder type, accumulators, selectors (invariably with bonded seals on their connecting faces) and the tailplane and rudder powered flying control units (PFCU). Also the brake parachute selector and door operating jack are situated in the rear fuselage and are powered by the No.1 controls system. A fire in this region could quickly compromise the seals in the jack and selector valve.

Figure 38 & 39 shows in-flight fire.

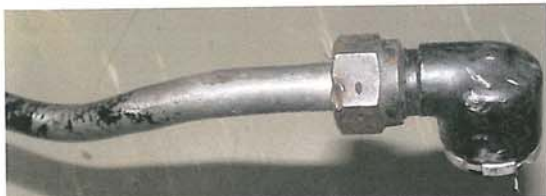
Photo 5: Primary cartridge end of pipeline showing fractured breech (digital)

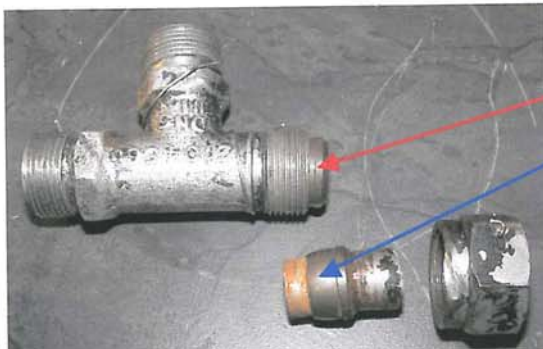
Photo 6: T-piece, removed, with (sectioned) starboard pipeline end showing fitted Ferrell - blue arrow while port side ferrell still in position - red arrow (digital)

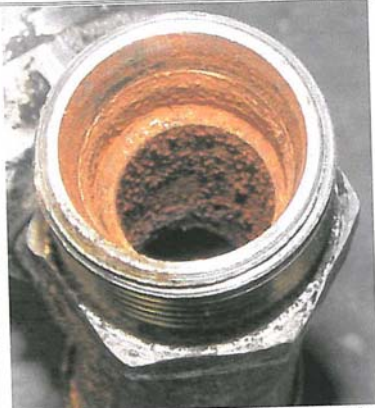
Photo 7: Inner area of t-piece showing corrosion products (digital)

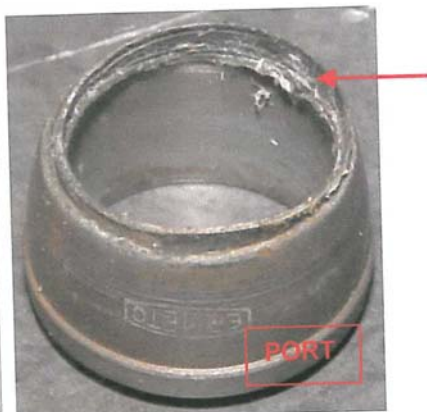
Photo 9: Port side ferrell showing metal deposits - red arrow (digital)

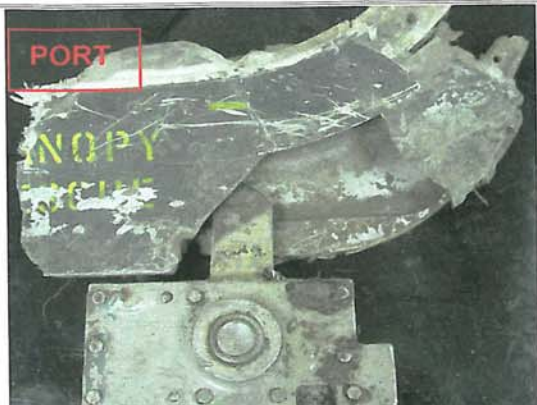
Photo 17: Port side, main canopy hook in canopy frame position, showing extensive damages (digital)

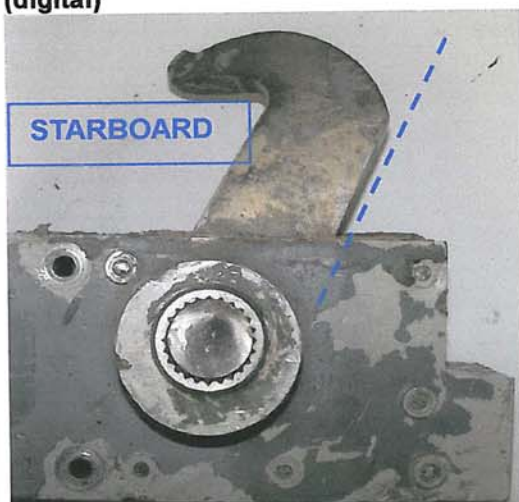
Photo 18: Starboard side, main canopy hook, as found in the unlocked position (digital)

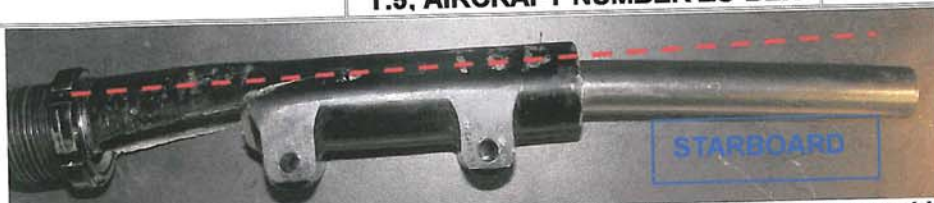
Photo 20: Starboard high velocity canopy jack showing bending damages (digital)

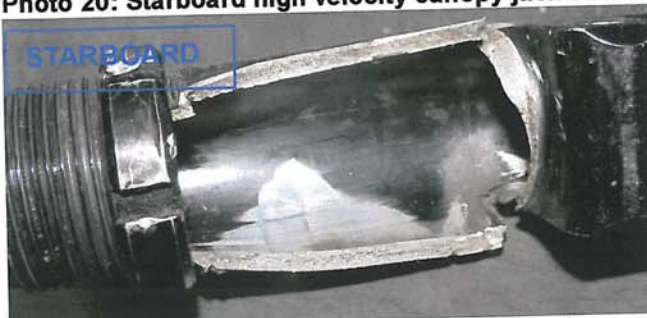
Photo 21: Starboard canopy jack sleeve showing explosion damages (digital)

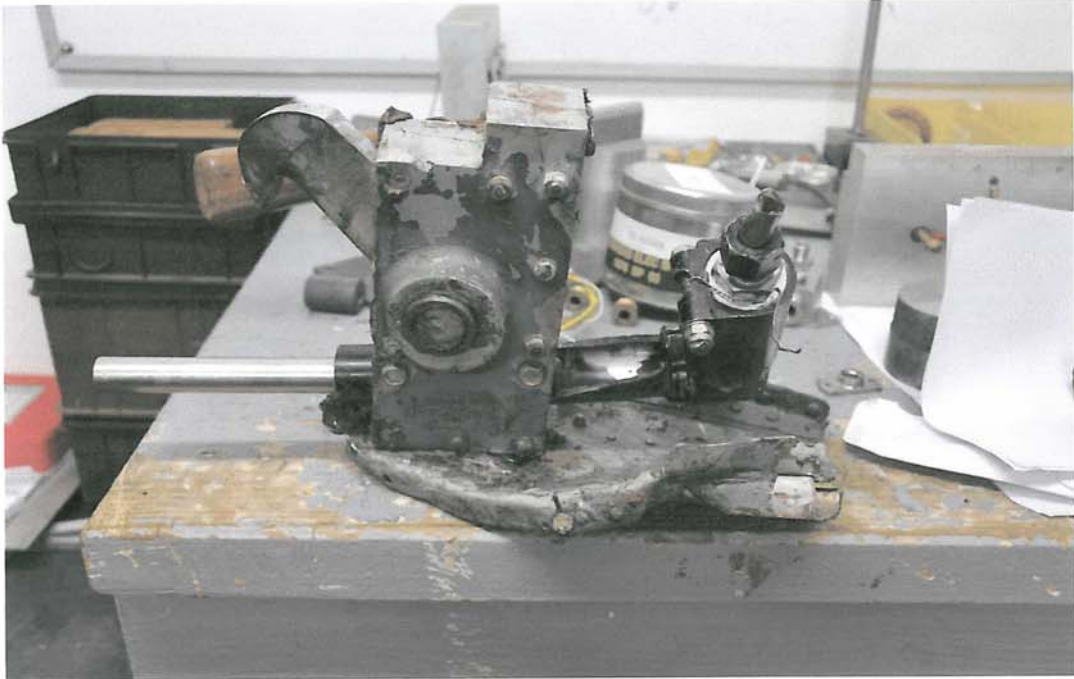
These units were dismantled and evidence was found that the two cartridges did function when the pilot selected ejection mode.
