SERIOUS INCIDENT INVESTIGATION FINAL REPORT

REF: CA18/3/2/0755

**Jetstream Aircraft 4100 ZS-OMZ
Runway Excursion during Take-off from
Port Elizabeth Airport,
SOUTH AFRICA.
18 November 2009**

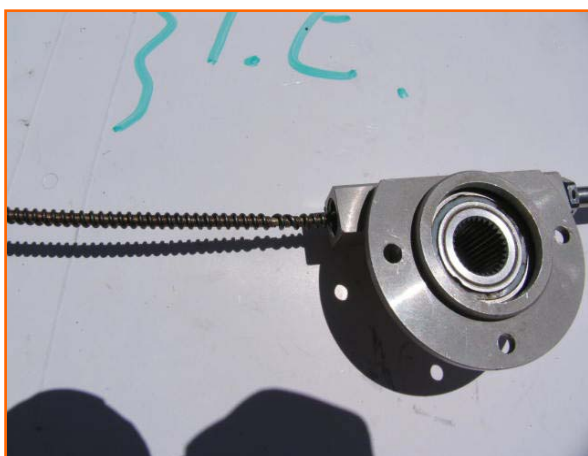
The investigation revealed that the Steering Control Cable was damaged during a previous installation, which resulted in wear damage to the gear inside the Steering Control Box resulting in slippage of the cable on the gear.

A view of the steering control box with the damaged control cable inserted and the outer cable casing removed to expose the damage to the cable.

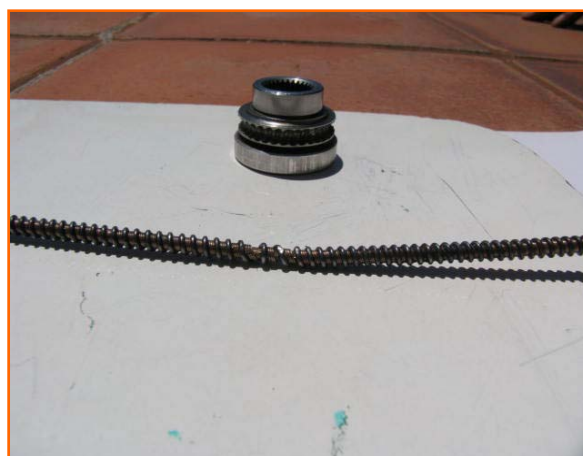
A view of the gear inside the steering control box, showing the damaged Control cable (Stretch & Kink) next to it

The tiller control with the meshing gear had been in service for 5973 cycles of operation since installation on 26/04/2006. This is an on condition unit and the cable is routed through the sleeve separately. The cable was probably kinked during this installation, resulting in the wear of the meshing teeth over the next 3 years of operation.

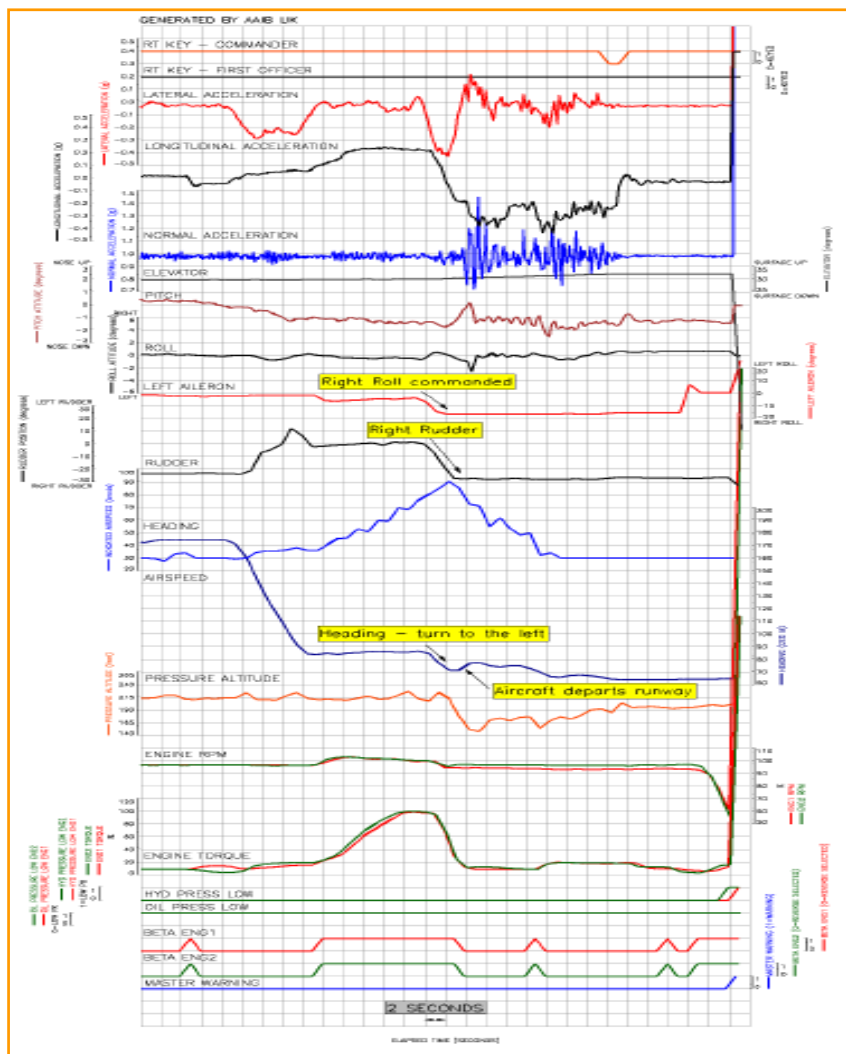
Fig 2: A schematic diagram showing the DFDR data that was downloaded following the incident.

1.11.3.2 12 Seconds after the aircraft entered the runway the captain moved his hand from the tiller to the control wheel.

IAS	12 Seconds: Accelerates from 40 Kts to approximately 80 Kts	and immediately started the take-off run without stopping at the threshold. Up to an IAS of approximately 70 Kts all parameters were apparently normal. At an IAS of approximately 70 Kts the hand-over from the Tiller to the Control wheel takes place. It was at this point where the aircraft started veering to the left.
Engine RPM (L)	12 Seconds: Accelerates from 95% RPM to 100% RPM	
Engine RPM (R)	12 Seconds: Accelerates from 95% RPM to 100% RPM	
Engine Torque (L)	12 Seconds: Increase from 20% Torque to 100% Torque	
Engine Torque (R)	12 Seconds: Increase from 20% Torque to 100% Torque

Parameter monitored	Reading	Note
Aileron	14 Seconds: -18°	When the aircraft started veering to the left at an IAS of approximately 70 Kts, the captain immediately applied full right rudder and full right aileron into the wind, in an attempt to arrest the veering to the left.
Rudder	14 Seconds: -20°	
IAS	2 Seconds: Accelerates from 80 Kts to approximately 90 Kts. 12 Seconds: Decelerate from 90 Kts to 30 Kts.	In addition the captain reduced the engine torque on both engines to a mere 20% Torque. However, the captain was not able to arrest the veering to the left and the aircraft finally left the runway and stopped 35m from the runway edge in some grass, with the aircraft on a heading of 65°M.
Engine RPM (L)	14 Seconds: Decelerates from 100% RPM to 95% RPM	
Engine RPM (R)	14 Seconds: Decelerates from 100% RPM to 95% RPM	
Engine Torque (L)	4 Seconds: Decrease from 100% Torque to 10% Torque. 8 Seconds: Constant at 10% Torque. 2 Seconds: Increase from 10% Torque to 20% Torque

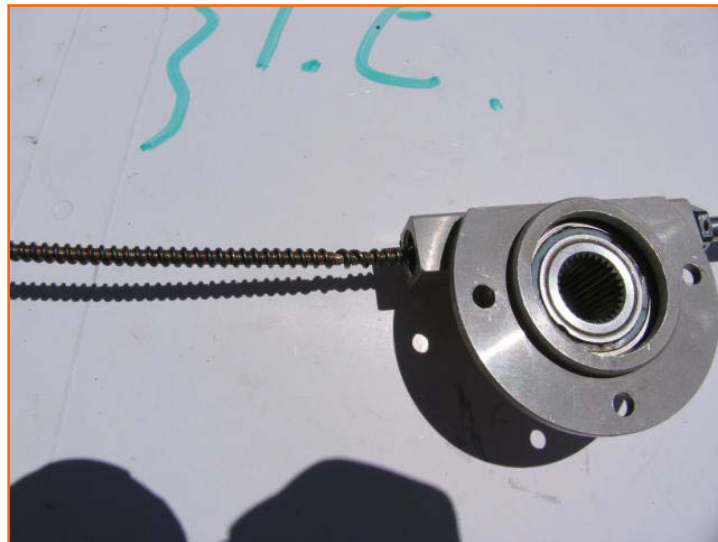
1.16.2 Following the results of the taxi test above it was decided to examine the steering system. Investigation revealed that the steering cable showed some stretch and kink marks. The cable was removed and replaced with a serviceable cable by qualified maintenance personnel. This cable has completed 5973 cycles since installation on 26/04/2006.

Fig 4: A view of the steering control box with the damaged control cable inserted and the outer cable casing removed to expose the damage to the cable.

- 1.16.6 Further investigation revealed that the Steering Control Cable slips inside the Steering Control Box when in certain positions. This was as a result of the damaged area on the cable moving over the matching area of the Steering Control Box Gear, which was found to be worn excessively in certain areas. Not only did the above account for the excessive free play that was noticed but also resulted in the tiller being pushed against the self-centering spring loaded cam when taxiing the aircraft.

- 2.2 It is the opinion of the IIC that the cable was probably kinked during the installation when it was replaced the last time. This kink in the cable resulted in excessive wear on the gear in the Steering Control Box over a period of time. When the wear became excessive on both the cable and the gear, the cable started slipping on the gear intermittently finally causing the loss of directional control during the take-off run at Port Elizabeth.

4.2 It is recommended that the manufacturer impose a life on the tiller mechanism or alternatively to devise inspection criteria and periodicity which would identify worn mechanisms.

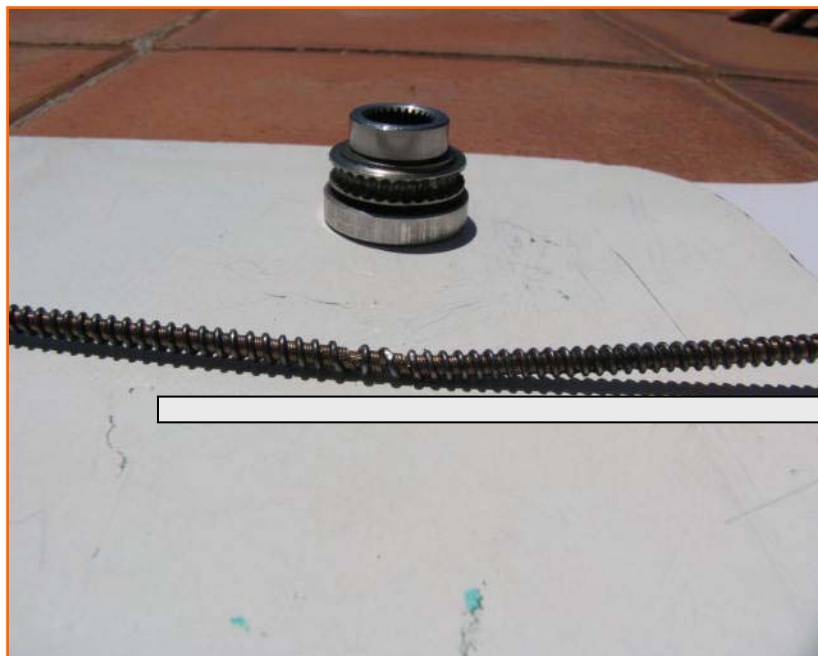
Fig 5: A view of the gear inside the steering control box, showing the damaged Control cable (Stretch & Kink) next to it.

- 1.16.8 The tiller control with the meshing gear had been in service for 5973 cycles of operation since installation on 26/04/2006. Replacement of the tiller control at that time followed on reports of the aircraft steering excessively. This is an on condition unit and the cable is routed through the sleeve separately. The cable was probably kinked during this installation, resulting in the wear of the meshing teeth over the next 3 years of operation. When the wear became excessive on both the cable and the gear, the cable started slipping intermittently on the gear.

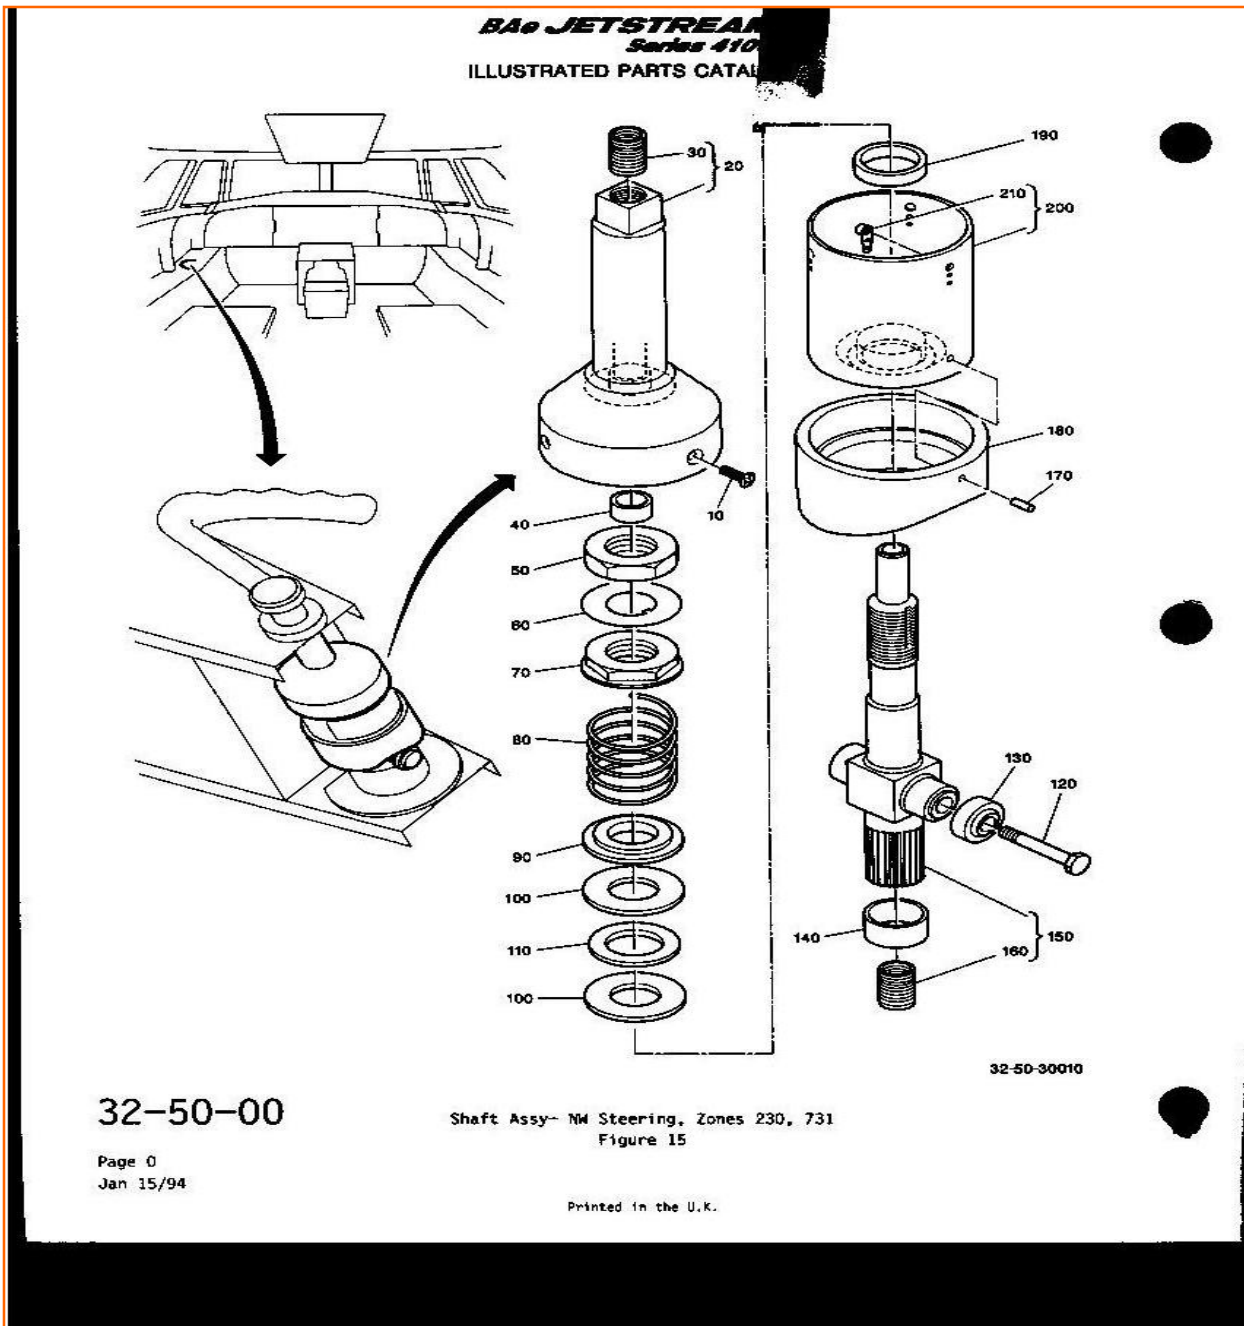
- 1.16.7 The tiller will centre itself when the hand-over takes place at 70 Kts. If the cable slipped previously, the nose wheels will not be centre but would rather be at an angle to either the left or the right (left in this case) resulting in the aircraft turning in the direction to which the slippage cause the off-set (left in this case).

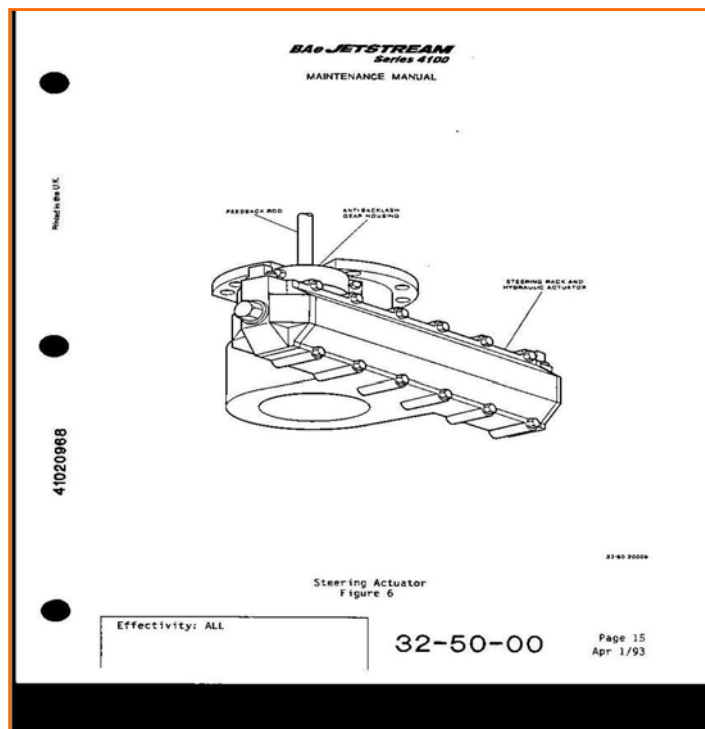
Fig 7: A view of the Steering Actuator.

- 1.18.1 A functional check was carried out on the Steering Actuator and it was examined for

hydraulic leaks, but no problems were observed.

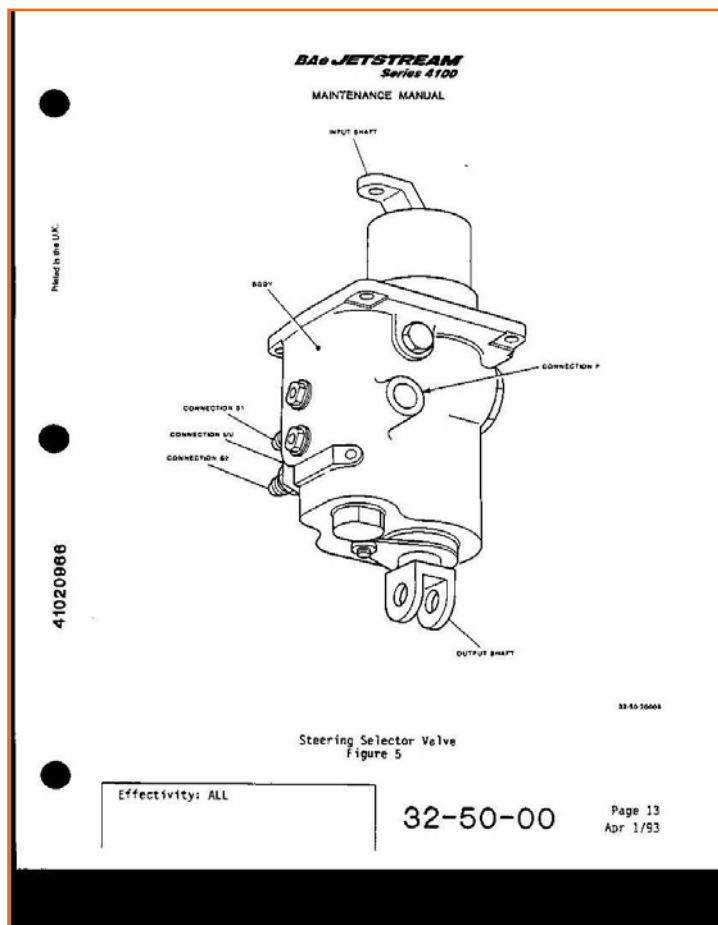
Fig 8: A view of the Steering Selector Valve.

1.18.2 A functional check was carried out on the Steering Selector Valve and it was examined for hydraulic leaks, but no problems were observed.
