## AIRCRAFT ACCIDENT REPORT AND EXECUTIVE SUMMARY

Reference:	CA18/2/3/8710	
<b>Aircraft Registration</b>	<b>ZS-IPA</b>	<b>Date of Accident</b>	24 November 2009	<b>Time of Accident</b>	1200Z	
<b>Type of Aircraft</b>	Piper Colt PA 22-108		<b>Type of Operation</b>	Private		
<b>Pilot-in-command Licence Type</b>		Airline Transport	<b>Age</b>	31	<b>Licence Valid</b>	Yes
<b>Pilot-in-command Flying Experience</b>		Total Flying Hours	5 358		Hours on Type	28
<b>Last point of departure</b>		Fly Inn private aerodrome (Gauteng province)				
<b>Next point of intended landing</b>		Springs aerodrome (FASI) (Gauteng province)				
<b>Location of the accident site with reference to easily defined geographical points (GPS readings if possible)</b>						
Open maize field near Springs at GPS coordinates S26°11.056' E028°23. 698', and elevation of 5 247 ft AGL.						
<b>Meteorological Information</b>		Temperature 27°C; CAVOK.				
<b>Number of people on board</b>	1 + 0	<b>No. of people injured</b>	0	<b>No. of people killed</b>	0

## AIRCRAFT ACCIDENT REPORT

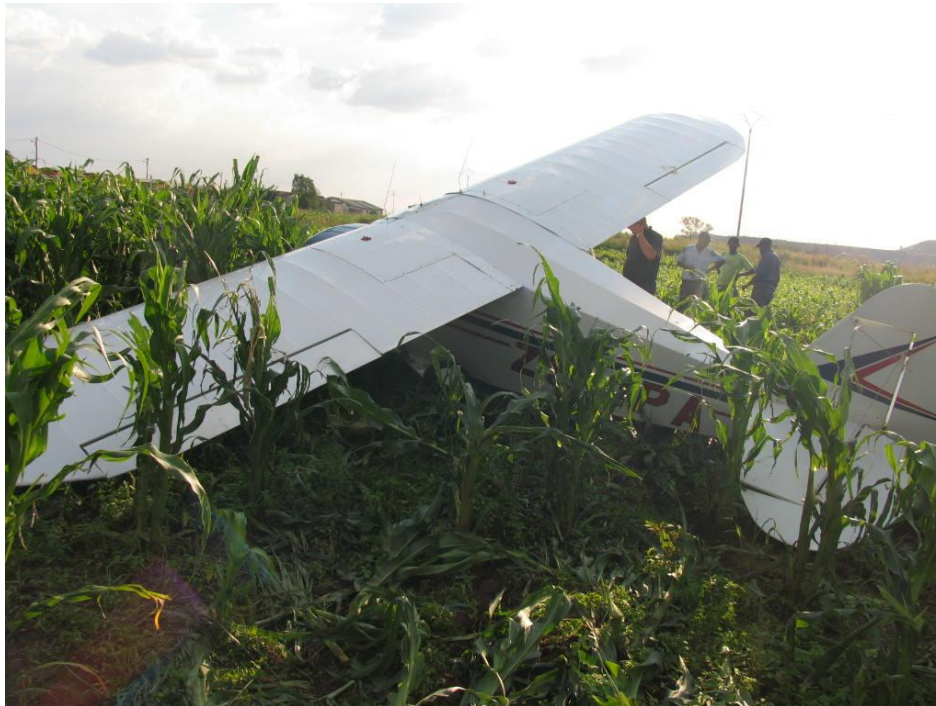
1.3.1 The aircraft sustained substantial damage.

Figure 1. The aircraft in the maize field.

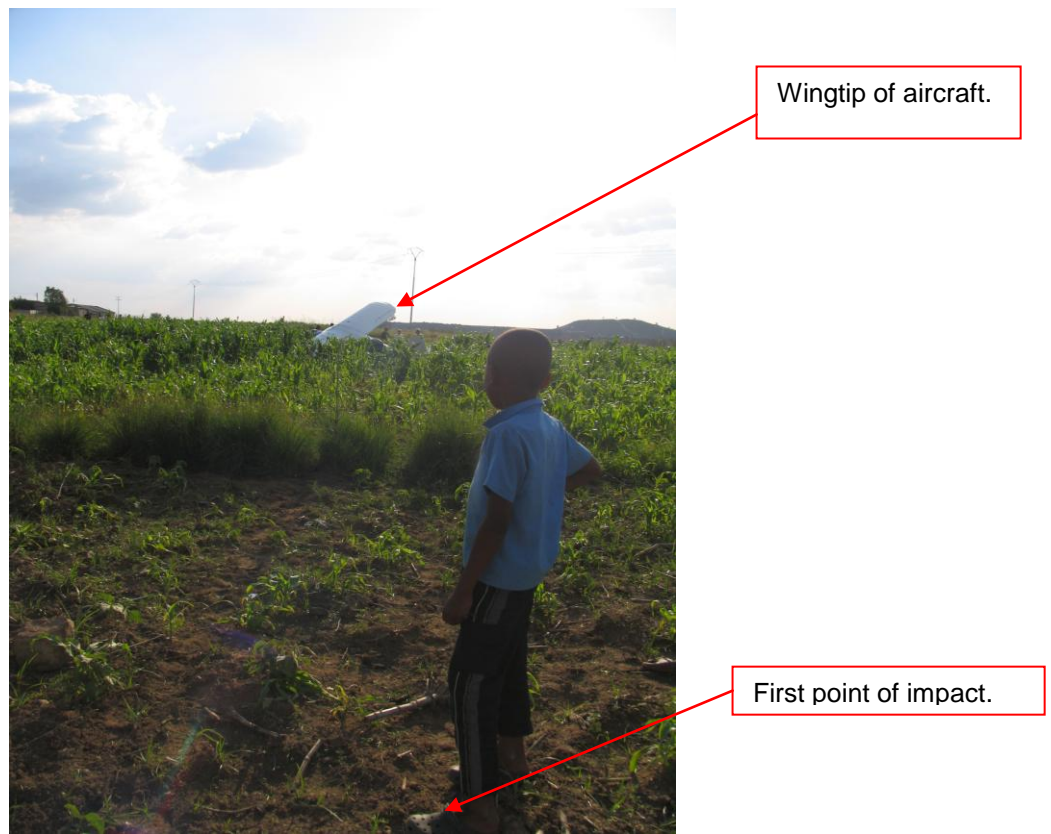
1.12.1 The accident occurred on an open maize field. The aircraft's left main gear broke off, the left wing was damaged and the nose gear strut was substantially damaged. Both tanks were still intact and contained a total of approximately 62 litres of fuel. The aeroplane came to rest about 85 m from the initial touchdown point. It remained in an upright position.

**Figure 2.** First point of impact and final position of the aircraft.

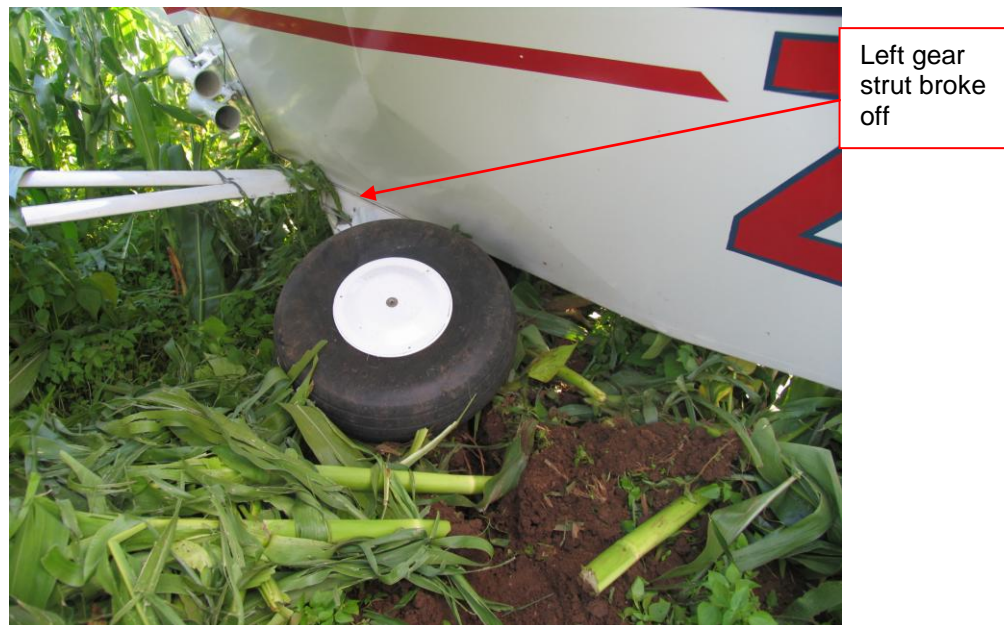
- 1.1.2 The pilot suspected that the engine was not getting fuel and changed the fuel selector from the left tank to the right. The RPM continued to drop, however, and he therefore initiated an emergency landing in a maize field. During the landing roll, the left main gear collapsed and the aircraft came to a halt approximately 85 m from the initial touchdown point.

**Figure 3.** The damaged left main gear.

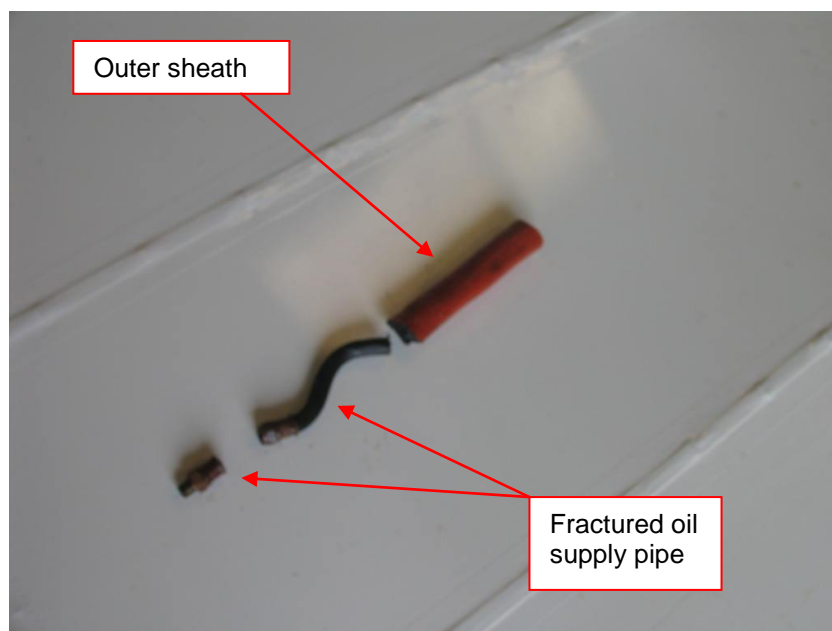
1.16.2 During the engine inspection, it was discovered that the flexible oil supply line pipe, which is covered with a sheath, had fractured, most probably due to extended operation and cracks. According to the manufacturer, this flexible oil pipe (part no. 71061-00) must not exceed 1 000 hours of service and must be inspected during maintenance intervals. This oil pipe had exceeded 1 000 hours and the inspection had just been carried out prior to the accident flight (see the signed inspection sheet on page 10 of the report with the engineer's initials).

**Figure 4.** The failed supply oil pipe and the outer sheath.

2.3 The pilot was properly licensed, had a total of 5 358 flying hours and had flown 28 hours on the aircraft type. After the recovery of the aeroplane, the logbooks were inspected. It was noted that the aircraft had been subjected to an MPI – performed by a CAA-approved AMO – on 4 November 2009 and that this was its first flight thereafter. The aircraft was recovered to Fly Inn private aerodrome for further investigation where it was discovered that the oil supply line pipe had fractured and the engine had lost oil and seized.

2.4 The AMO who performed the previous inspection on the aircraft do not have a record of when last this oil pipe was replaced. The aircraft had been maintained by this AMO since 2006. The last maintenance inspection conducted prior to the accident was a 100-hour Mandatory Periodic Inspection (MPI) certified on 4 November 2009. According to the maintenance inspection requirement in the Piper Colt, Model PA 22-108 service manual, all oil lines and fittings should be inspected during all inspection intervals and at pre- and post-flight inspections. A specific page applicable to the requirement was found, with the required signature, date, aircraft serial number and AMO stamp as required.

- 3.2.1 Unsuccessful forced landing following an engine power loss in flight.
- 3.2.2 **Contributory factor,**  
Failure by AMO to replace oil pipe line as required in the maintenance schedule.
