## AIRCRAFT ACCIDENT REPORT AND EXECUTIVE SUMMARY

Reference:	CA18/2/3/8711	
<b>Aircraft Registration</b>	ZS-SRV	<b>Date of Accident</b>	26 November 2009		<b>Time of Accident</b>	0803Z
<b>Type of Aircraft</b>	Robinson R22 Beta		<b>Type of Operation</b>	Training		
<b>Pilot-in-command Licence Type</b>		Commercial (Helicopter)	<b>Age</b>	39	<b>Licence Valid</b>	Yes
<b>Pilot-in-command Flying Experience</b>		Total Flying Hours	234		Hours on Type	141.7
<b>Last Point of Departure</b>		Rand Aerodrome (FAGM)				
<b>Next Point of Intended Landing</b>		Rand Aerodrome (FAGM)				
<b>Location of the Accident Site with Reference to Easily Defined Geographical Points (GPS readings if possible)</b>						
West of Runway 35 at Rand Airport						
<b>Meteorological Information</b>		Wind direction 260° at 14knots; Temperature: 28°; Visibility>10km; No significant cloud.				
<b>Number of People on Board</b>	1 + 1	<b>No. of People Injured</b>	1 + 1	<b>No. of People Killed</b>	0

**Name of Owner/Operator** : Henley Air (Pty) Ltd  
**Manufacturer** : Robinson Helicopter Company  
**Model** : R22 BETA  
**Nationality** : South African  
**Registration Marks** : ZS-SRV  
**Place** : Rand Airport  
**Date** :

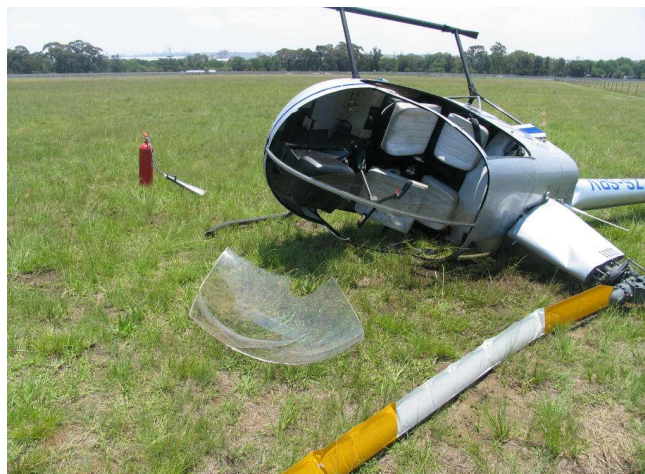
1.1.5 The helicopter sustained substantial damage to the main rotor blades and the tail boom. Both the flight instructor and the student sustained minor injuries.

**Figure 1:** Damage to the helicopter

1.12.2 The fuselage sustained damage on the left side only. The damage caused to the tail boom was limited to areas where it is fitted to the fuselage in front and tail rotor gearbox. Both left and right windshields broke and were separated from the airframe. The main and tail rotors also impacted the ground and sustained damage.

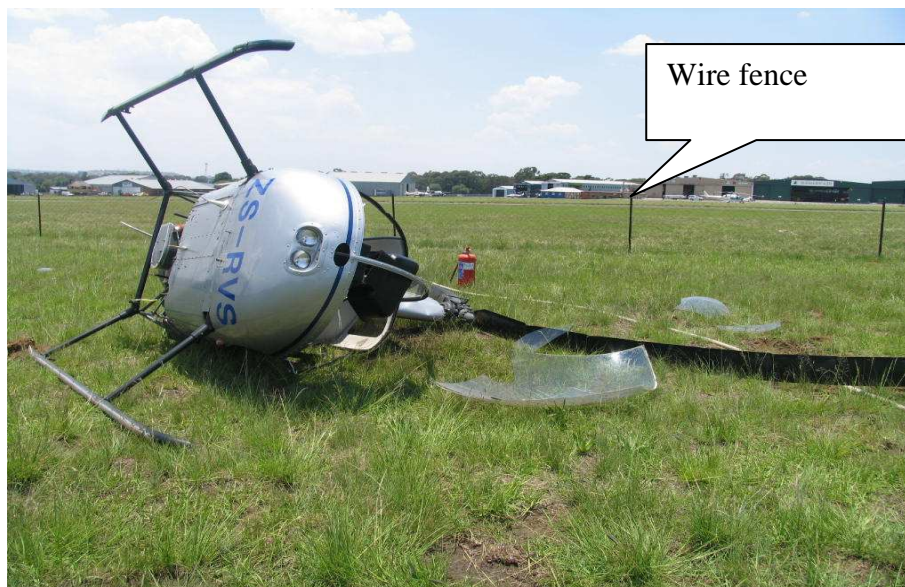
1.12.1 During a right turn to avoid colliding with a wire fence, the left skid dug into the grass surface, causing the helicopter to roll over onto its left side and impact the ground. As a result, the helicopter was substantially damaged.

**Figure 2:** The wire fence that the flight instructor avoided

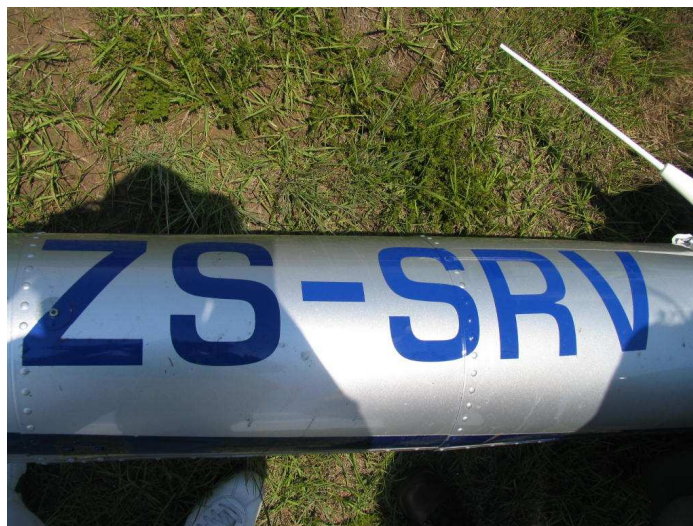
1.18.1 The helicopter had two different registration markings: ZS-SRV and ZS-RVS. According to the SACAA documentation the correct registration is ZS-SRV.

**Figure 3:** Registration marking of ZS-SRV

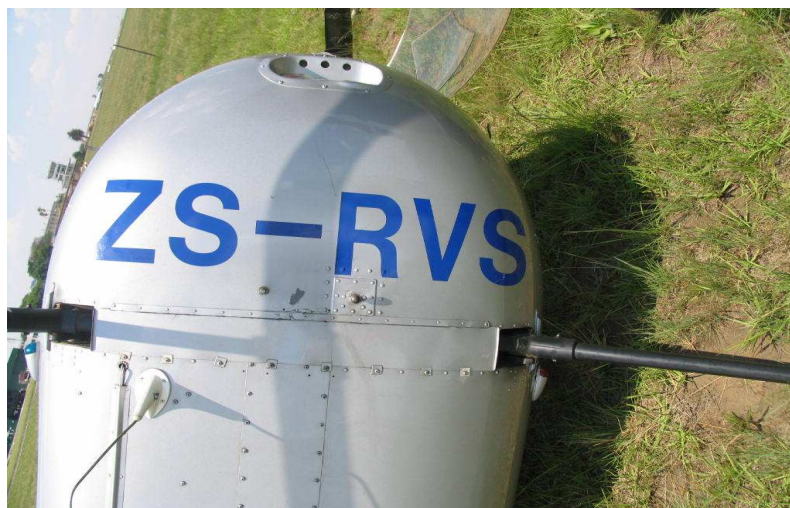
**Figure 4:** Registration marking of ZS-RVS
