AIRCRAFT ACCIDENT REPORT AND EXECUTIVE SUMMARY

| | | | | Reference: | CA18/2/3/8713 | |
| Aircraft Registration | ZS-JXD | Date of Accident | 28 November 2009 | | Time of Accident | 0955Z |
| Type of Aircraft | Cessna 177 | | Type of Operation | Private | | |

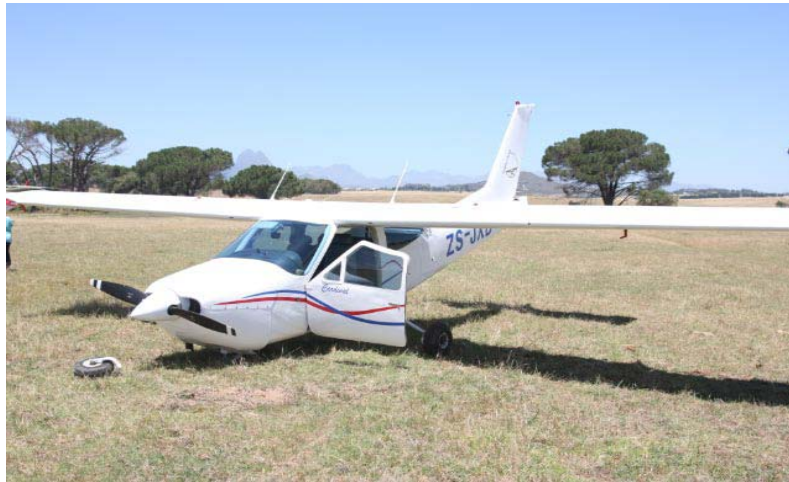
1.12.1 The pilot performed a forced landing on an open field. During the precautionary landing the aircraft ran on an uneven surface, causing the nose-wheel to collapse, break and separate from the aircraft.

Figure1: Showing the broken nose wheel

3.1.9 The aircraft landed on uneven terrain; as a result nose wheel collapsed, broke and got separated from the wreckage.

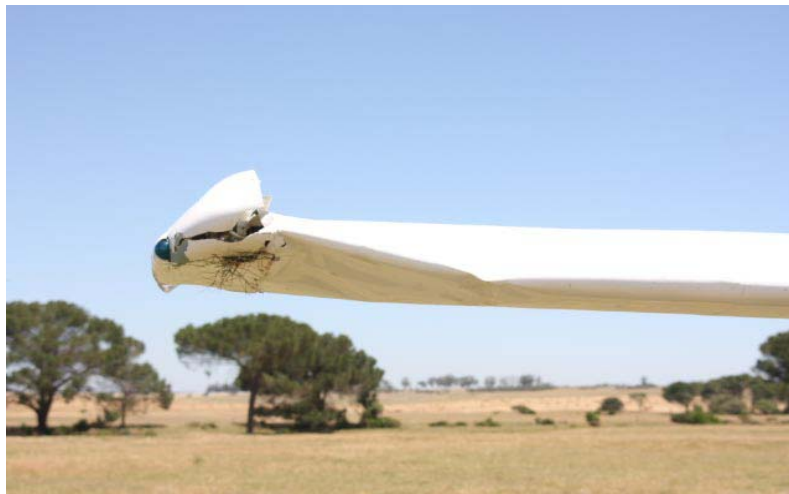
1.1.3 The pilot then decided to divert to Fisantekraal Aerodrome (FAFK) and squawked 7700 (the emergency squawk) on the transponder mode. The pilot then experienced a complete loss of power and performed a forced landing on an open field. The aircraft landed hard and the nose wheel broke, and the right wing impacted the ground and was damaged.

Figure 2: Showing damage to the right wing

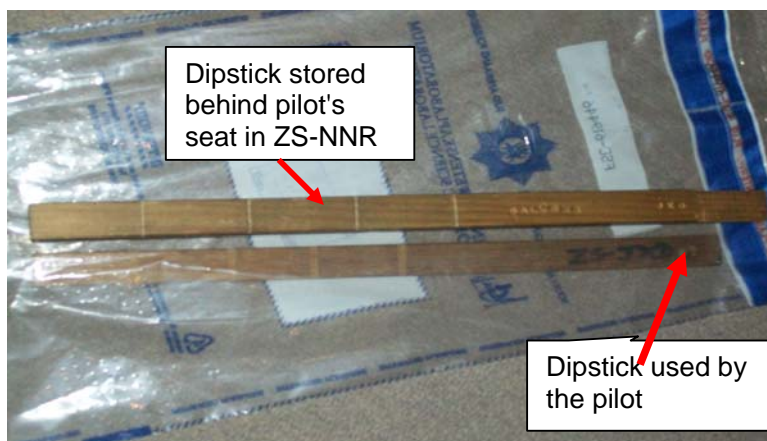
1.16.2 The pilot stated that he had used the dipstick marked ZS-JXD with a black marking pen. The information that the dipstick was incorrectly calibrated was brought to the pilot's attention after the accident. The pilot was notified that the correct dipstick (marked ZS-JXD) was stored behind the pilot's seat inside the aircraft with the registration ZS-NNR. The pilot used the second dipstick which was marked ZS-JXD and not calibrated correctly.

Figure3: The picture above shows the two dipsticks
Having the same aircraft registration: ZS-JXD

Using the other dipstick, the 7,5 US gallons mark will indicate 6,25 US gallons, which is 1,25 gallons less. Therefore the right hand-tank will indicate less than $\frac{3}{4}$ (18,75 US gallons) and the left hand tank will indicate less than $\frac{1}{2}$ (12,5 US gallons) and the total fuel on board will be 31,25 US gallons, which will give an endurance of 2h54min.

It is evident that the two dipsticks indicated a 6,25 US gallons difference.

- 2.4 The aircraft had two differently calibrated dipsticks, both with the same registration marks on the dipsticks. The two dipsticks were stored in two aircrafts, one in ZS-JXD (accident aircraft) and the other in ZS-NNR. The organisation did not inform the pilot of the situation regarding the incorrectly calibrated dipstick prior to the flight. The person responsible for aircraft was supposed to make sure that the incorrectly calibrated dipstick was removed from the aircraft.

4.1 It is recommended that the SACAA training department (part 141) should ensure that flying clubs implement effective control over the use of fuel dipsticks carried on board their aircraft. Flying clubs must develop a policy on the use, calibration and control of dipsticks and incorporate this policy in the club's operations manual. A proper fuel management log should be part of the flight plan.
