AIRCRAFT ACCIDENT REPORT AND EXECUTIVE SUMMARY

Reference:	CA18/2/3/8722	
Aircraft Registration	ZU-EXT	Date of Accident	13 December 2009		Time of Accident	0635Z
Type of Aircraft	Extra EA300		Type of Operation	Private		
Licence Type	Private		Age	38	Licence Valid	Yes
Flying Experience	Total Flying Hours		591.7		Hours on Type	21.0
Last point of departure	Rand aerodrome (FAGM) (Gauteng province).					
Next point of intended landing	Parys aerodrome (FAPY) (Free State province).					
Location of the accident site with reference to easily defined geographical points (GPS readings if possible)						
Walkerville area at GPS coordinates S26°21.150' E02 7°57.691' at an elevation of 5 170 ft AMSL.						
Meteorological Information	Temperature: 21°C; Dew point: 16°C; Wind: 320°/12 knots; Cloud cover: few @ 2000 ft; Visibility: 10 km.					
Number of people on board	1 + 1	No. of people injured	0	No. of people killed	2	
Synopsis	<p>On 13 November 2009, ZU-EXT, an Extra 300 aerobatic aircraft, departed Rand aerodrome under visual flight rules. According to the ATC at Rand, take-off was uneventful. The aircraft was next seen at Tedderfield aerodrome, where it performed a flypast above runway 29. A wi

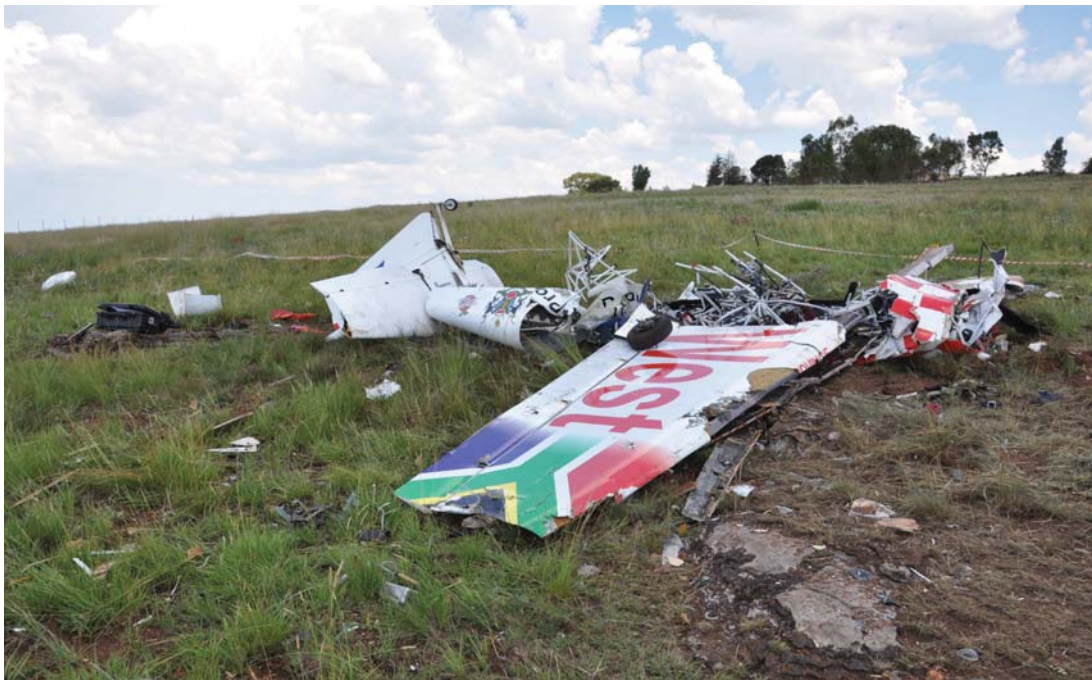
1.3.1 The aircraft was destroyed.

Figure 2: View of the wreckage at the site.

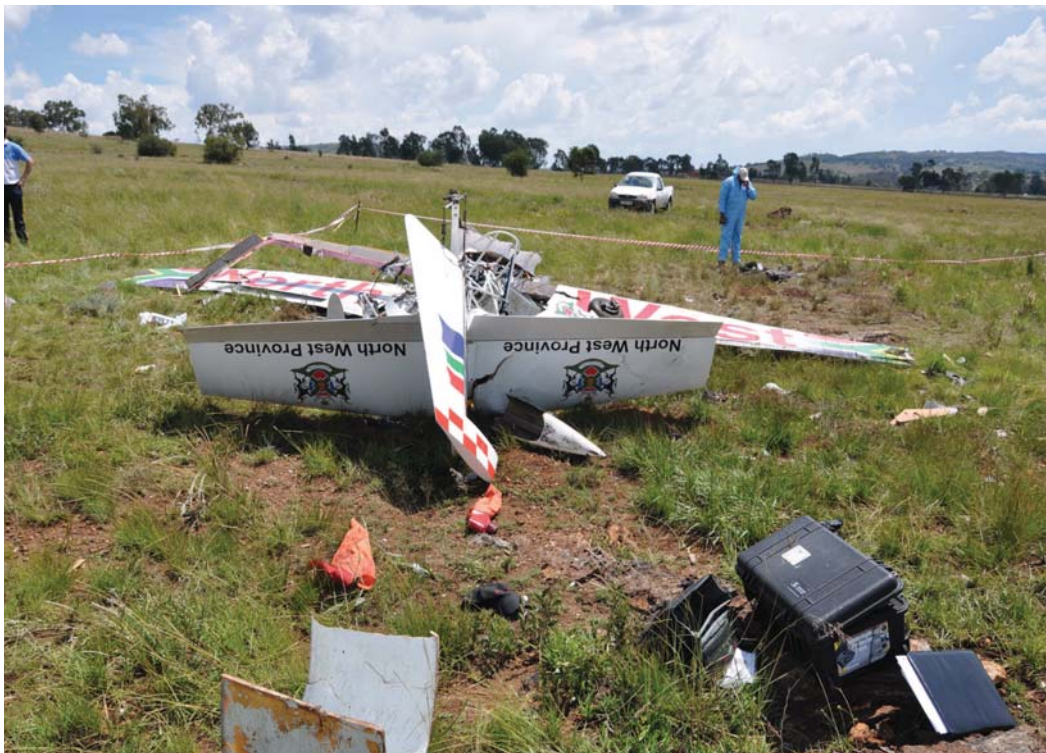
- 1.12.1 The aircraft crashed in an open field near the aerodrome. On-site examination of the wreckage revealed that the aircraft had struck the ground in a nose-down attitude. The propeller showed evidence of high power on impact. Due to the damage to the instruments, it was impossible to determine their readings and the position of all the switches at the time of impact. The engine, propeller, tail section, both wings and undercarriage were all severely damaged by the impact. Both fuel tanks had been ruptured and there was evidence of fuel at the site.

Figure 3: View of the wreckage.
