AIRCRAFT ACCIDENT REPORT AND EXECUTIVE SUMMARY

Reference:	CA18/2/3/8725	
Aircraft Registration	ZS-NKB	Date of Accident	18 December 2009		Time of Accident	1330Z
Type of Aircraft	Beech 95-B55 (Aircraft)		Type of Operation		Type conversion Training	
Pilot-in-command Licence Type		Airline Transport	Age	34	Licence Valid	Yes
Pilot-in-command Flying Experience		Total Flying Hours	2759.4		Hours on Type	42
Last point of departure		FAWB (Wonderboom) – Gauteng				
Next point of intended landing		FAWB (Wonderboom) – Gauteng				
Location of the accident site with reference to easily defined geographical points (GPS readings if possible)						
Near FAWB at GPS position S25° 39' 16.32" E028° 12' 49.43" at an elevation of 4065ft AMSL						
Meteorological Information		Fine weather conditions prevailed at the time of the accident with the wind at 340°TN, 5 Kts and the temperature at 34°C				
Number of people on board	2+0	No. of people injured	0	No. of people killed	2

Name of Owner/Operator : Loutzavia CC
Manufacturer : Beech Aircraft Corporation
Model : 95-B55
Nationality : South Africa
Registration Marks : ZS-NKB
Place : Near FAWB - Gauteng
Date : 18 December 2009
Time : 1330Z

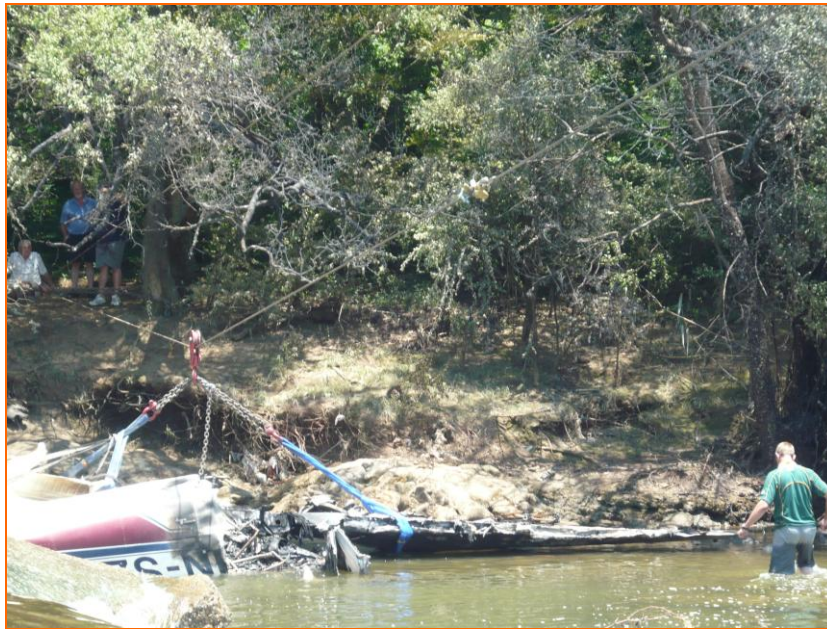
1.3.1 The aircraft was destroyed by the impact and the post-impact fire that erupted during the accident sequence.

Figure 1: View of the wreckage in the Apies River.

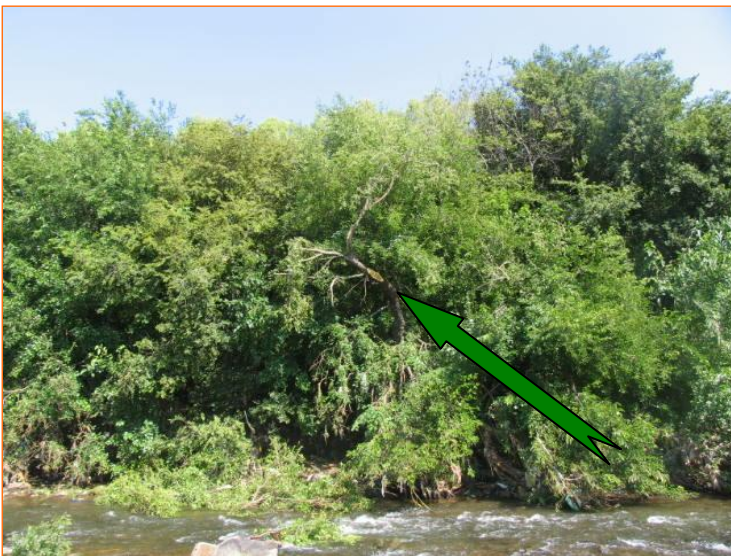
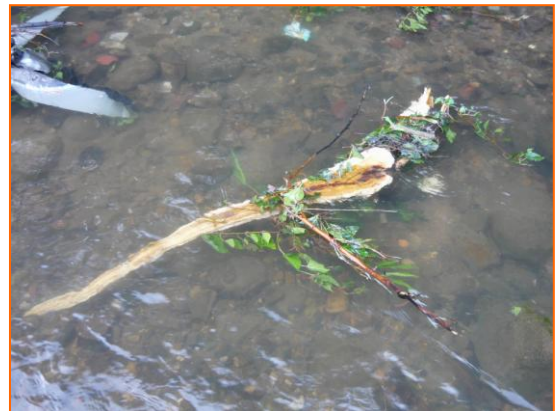
1.12.1 The left wing of the aircraft collided with vegetation prior to the impact in the river bed.

Figure 2: View of the tree branch (indicated by the arrow) with which the left wing collided before the aircraft crashed into the river bed

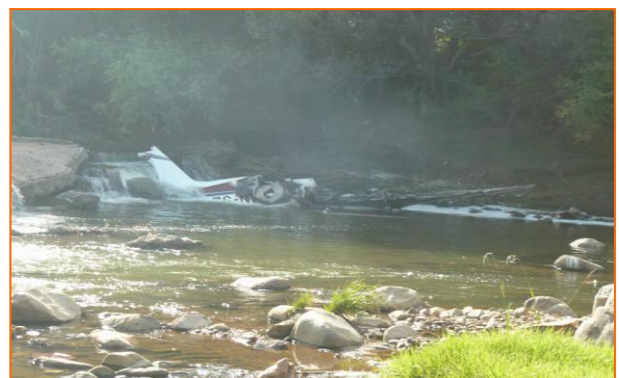
1.12.2 After the collision with the tree, the aircraft crashed into the river ending up against a retainer wall in the river. The aircraft was destroyed during the impact sequence.

Figure 3: View of the wreckage in the river with the empennage against a retainer wall in the river.

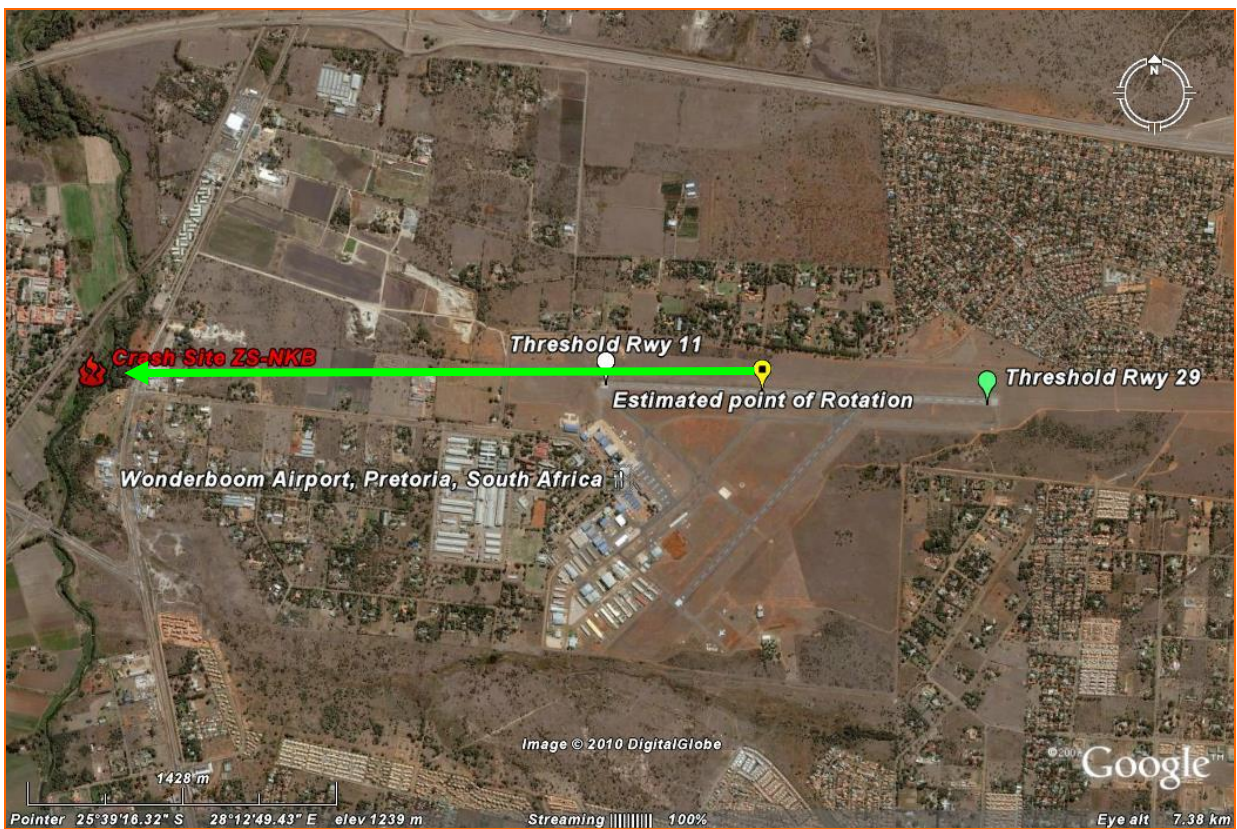
Figure 4: Aerial view of the flight path followed from takeoff on Rwy 29 to the accident site

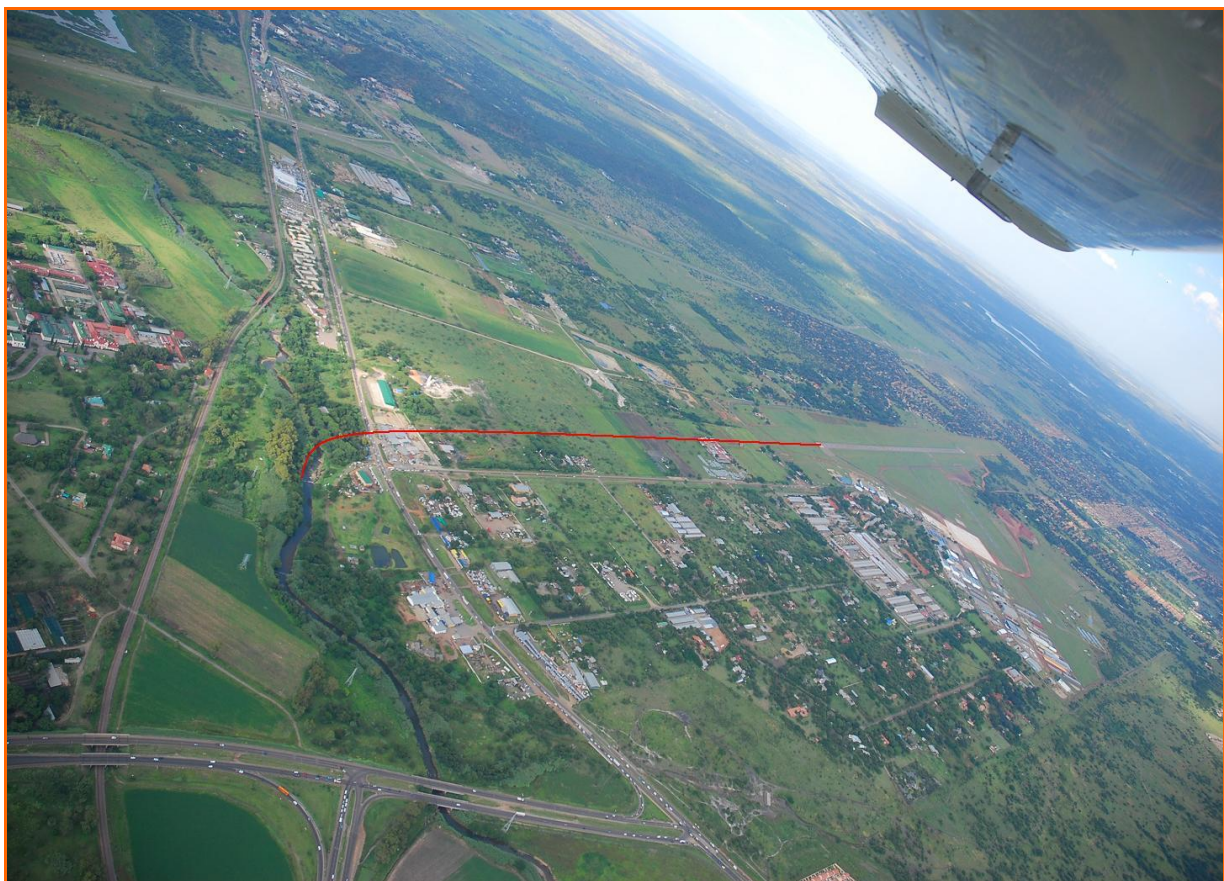
Figure 5: Another aerial view of the flight path followed from takeoff on Rwy 29 to the accident site. The red line indicates the flight path from the Threshold of Rwy 11 to the accident site.

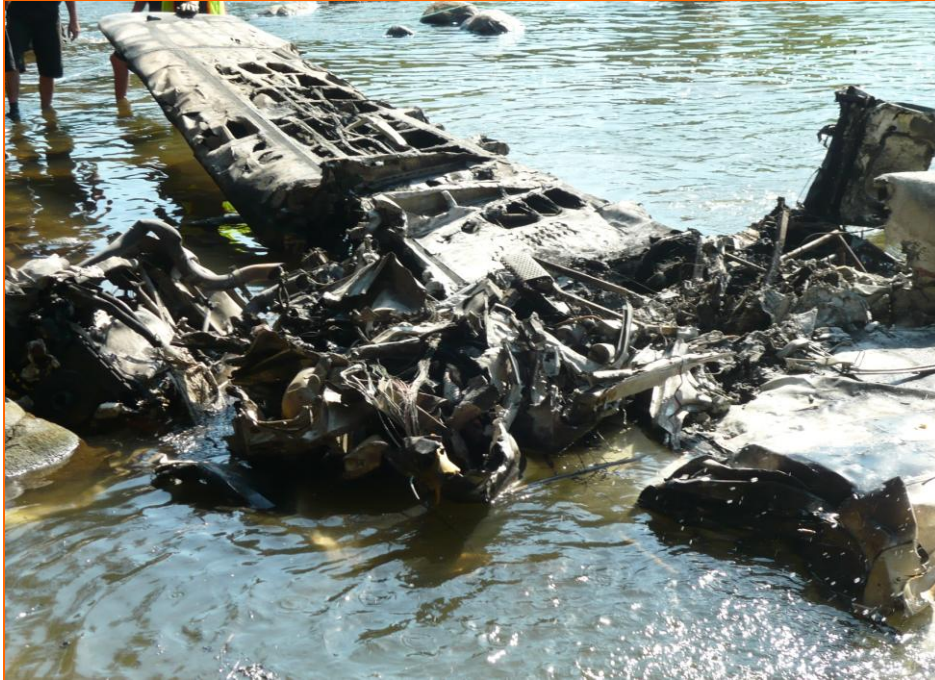
1.14.1 The aircraft erupted in fire during the impact.

Figure 6: The wreckage was destroyed by the impact damage and the ensuing fire after the impact.

1.14.2 The empennage was submerged in water and did not sustain any fire damage. The rest of the aircraft was destroyed as a result of the impact and the ensuing fire.

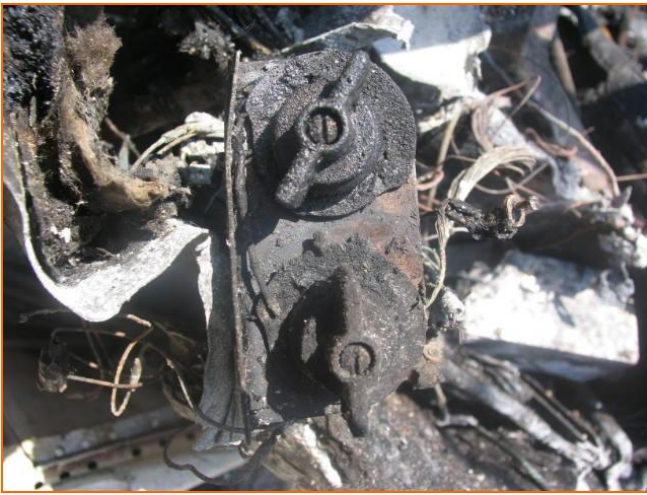
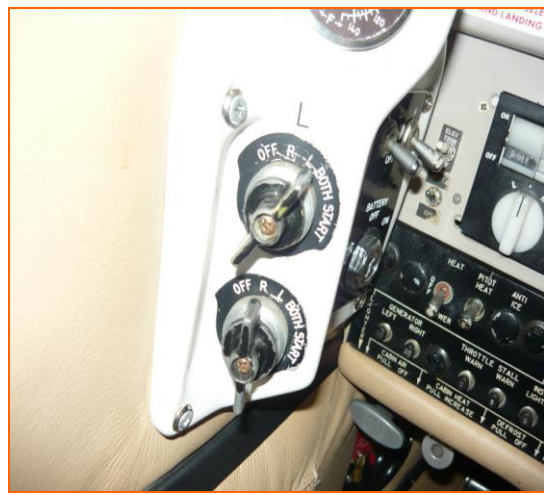
1.16.1 At the accident site it was found that the right-hand engine had been running on the right-hand magneto only and the left-hand engine on the left-hand magneto only. It was also found that the fuel booster pumps were selected in the high position.

Figure 7: The magneto switches on the wreckage: The left-hand engine was selected on the left magneto and the right-hand engine was selected on the right magneto.

2.1.2 On the accident site it was found that the right-hand engine was running on the left-hand magneto only and the left-hand engine was running on the right hand magneto only. It was also found that the fuel booster pumps were selected in the high position.

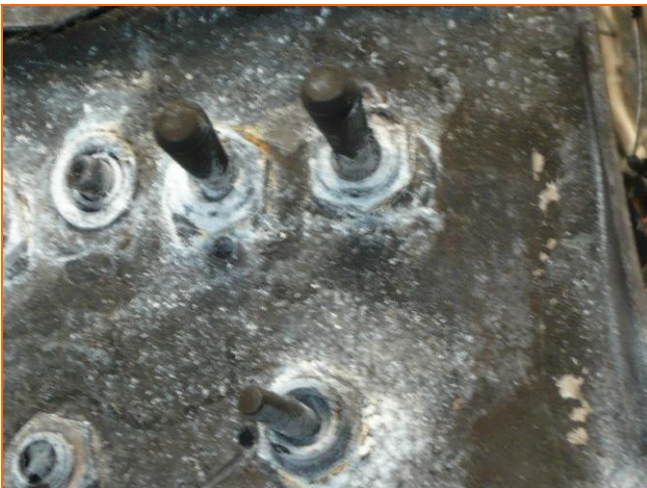
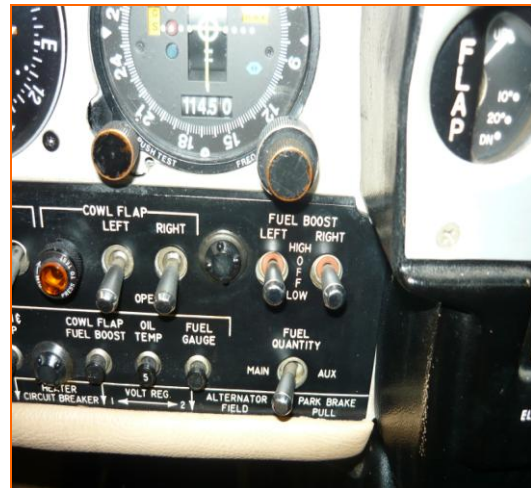
Figure 7: The fuel booster pumps on the wreckage were in the High position.

On the take-off roll the fuel boost pumps should be switched off. Being normal toggle switches, it is considered possible that the switches were accidentally switched to the HIGH position. This was the configuration in which the wreckage was found.

3.3.2 Switching the fuel boost pumps onto HIGH resulting in a negative rate of climb and an over-rich mixture setting on both engines, resulting in the engines failing to produce full power.

4.1.2.1 All fuel boost pump toggle switches be replaced with gated switches to prevent unintentional switching to the HIGH position.

4.1.2.2 Although the aircraft in the Kimberley accident was equipped with a gated switch, the pilot unintentionally switched the boost pump into the HIGH position. It is therefore recommended that warning lights be installed in an appropriate place in the aircraft to warn pilots when the fuel boost pumps are switched on in the HIGH position.
