AIRCRAFT ACCIDENT REPORT AND EXECUTIVE SUMMARY

Reference:	CA18/2/3/8727	
Aircraft Registration	ZS-NAF	Date of Accident	28 December 2009		Time of Accident	0755Z
Type of Aircraft	Beech Bonanza F33A		Type of Operation	Private		
Pilot-in-command Licence Type	Private Pilot		Age	61	Licence Valid	Yes
Pilot-in-command Flying Experience	Total Flying Hours	1 228.1		Hours on Type	Approx. 959.9	
Last Point of Departure	Vereeniging Aerodrome (FAVV), Gauteng					
Next Point of Intended Landing	Margate Aerodrome (FAMG), KwaZulu-Natal					
Location of the Accident Site with Reference to Easily Defined Geographical Points (GPS readings if possible)						
Platberg mountain, Free State (GPS co-ordinates: S28°15.44 E029°13.34 at an elevation of 6 194 ft)						
Meteorological Information	Surface wind 310° at 10 knots, visibility <1 000 m, temperature 20°, clouds BKN at 800 ft and 1 000 ft					
Number of People on Board	1 + 3	No. of People Injured	0	No. of People Killed	4

Name of Owner/Operator : Venter JA
Manufacturer : Beech Aircraft Corporation
Model : F33A
Nationality : South African
Registration Marks : ZS-NAF
Place : Platberg Mountain, Free State
 (GPS co-ordinates: S28⁰15.44 E029⁰13.34)
Date :

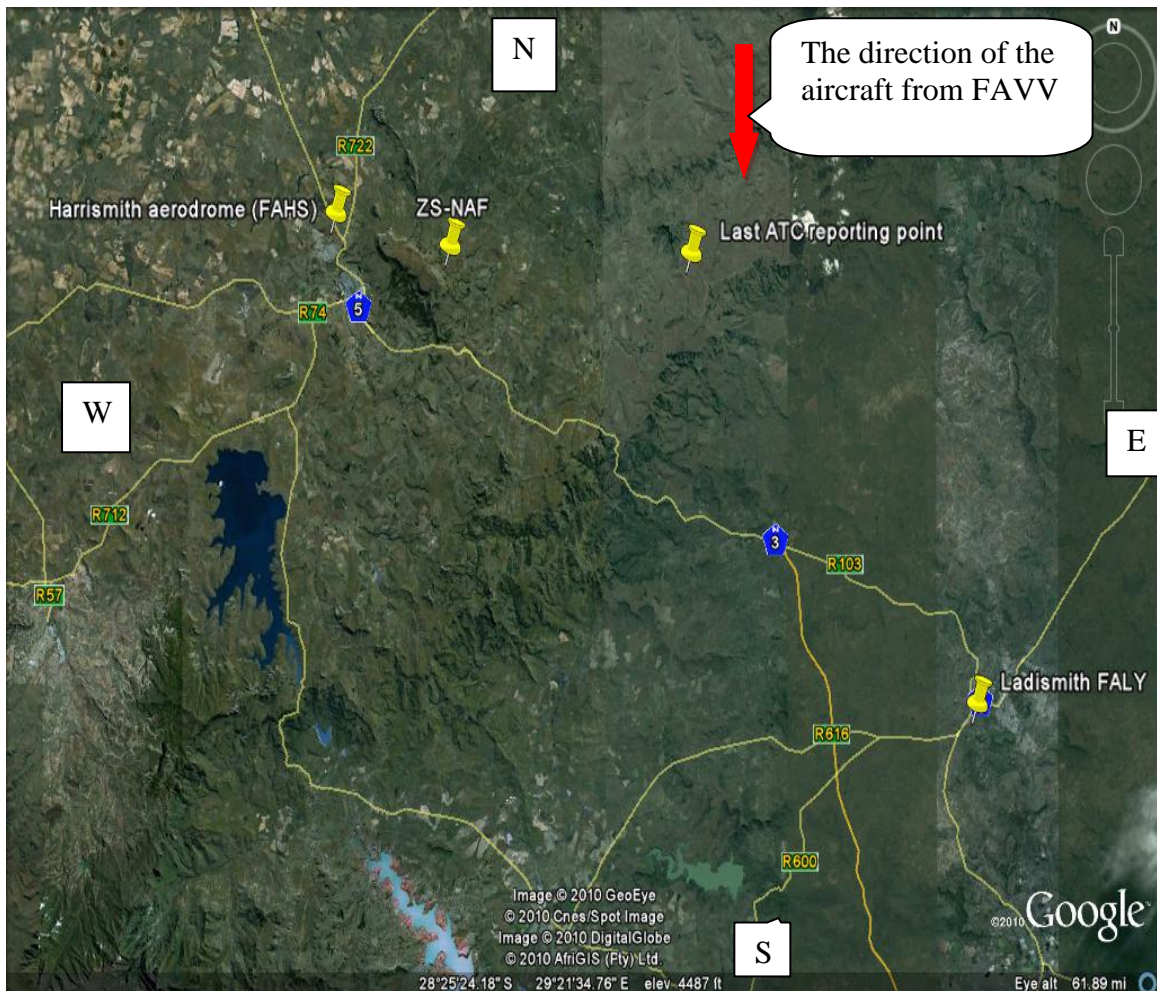
- 1.1.1 On Saturday, 28 December 2009, the pilot, accompanied by three passengers, flew the aircraft on a private flight from Vereeniging Aerodrome (FAVV) to Margate Aerodrome (FAMG). The pilot filed a flight plan with the Johannesburg Briefing department of the Air Traffic and Navigation Services (ATNS) company, which authorised him to perform an instrument flight rules (IFR) flight by day. The flight plan was activated by the air traffic centre at 0706Z. The flight was uneventful until the pilot broadcasted to Johannesburg East ('Information') to report that he was experiencing an electrical problem. The pilot informed the information centre of his intention to divert to Harrismith Aerodrome (FAHR); the aircraft was maintaining flight level (FL) 090 at that time and FAHR was approximately 12.7 nm to the right-hand side of the pilot. The pilot was flying in a southerly direction and had to make a right-hand bank turn to redirect the aircraft in the north-westerly direction back to FAHR.

- 1.1.3 The controller on duty observed the aircraft on the radar screen descending to FL074 and then suddenly disappearing from the radar screen at 0752Z. The controller on duty stated that he requested another aircraft, which was on the vicinity to look for the aircraft at FAHR. The other aircraft landed at FAHR and the pilot broadcasted to Johannesburg East that ZS-NAF was not at FAHR. The aircraft was unable to take off again to start the search for ZS-NAF due to the unfavourable weather conditions, namely lack of visibility.

Figure1: The flight path of ZS-NAF

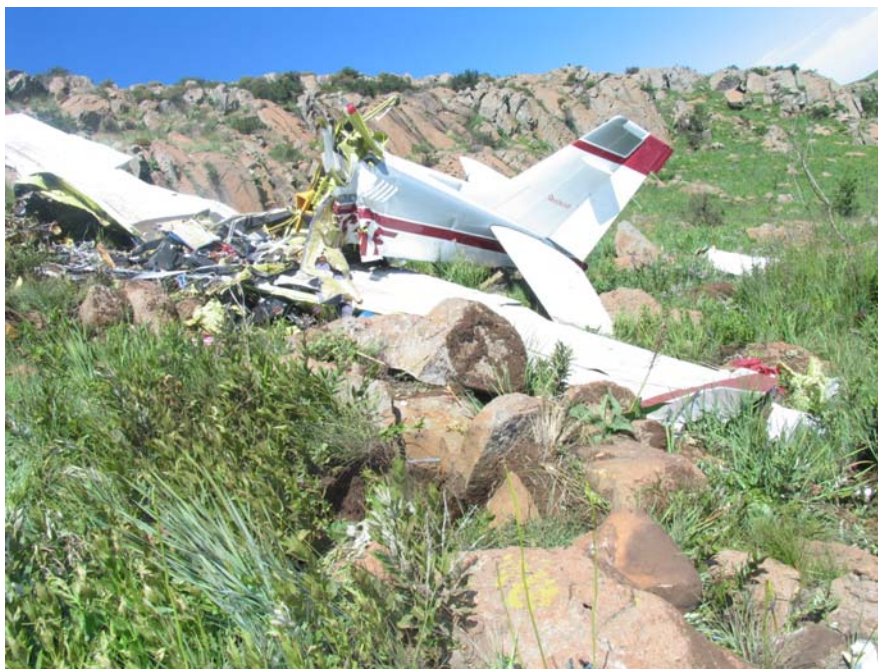
1.3.1 The aircraft was destroyed in the accident sequence.

Figure 2: The damage caused to the aircraft

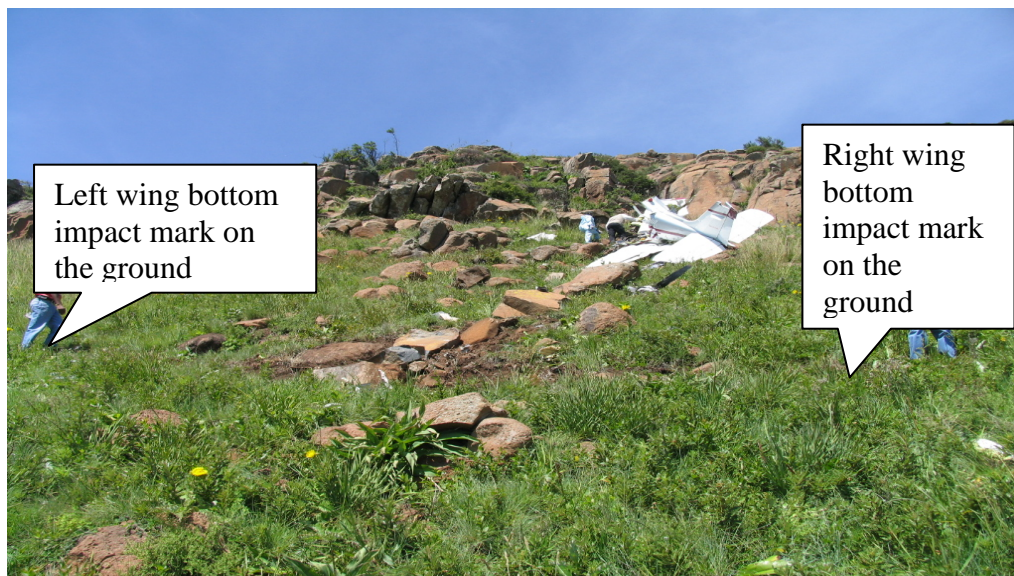
1.12.1 The location of the accident site was on Platburg mountain, GPS co-ordinates S28⁰15.44 E029⁰13.34 at an elevation of 6 194 ft. Evidence suggested that the aircraft was heading in north-westerly direction towards FAHR.

1.12.2 The aircraft broke up in the ground impact sequence, shedding its components and parts in the wreckage path. The location of the wreckage was approximately 5 m away from first point of impact.

Figure 3: The wreckage distribution

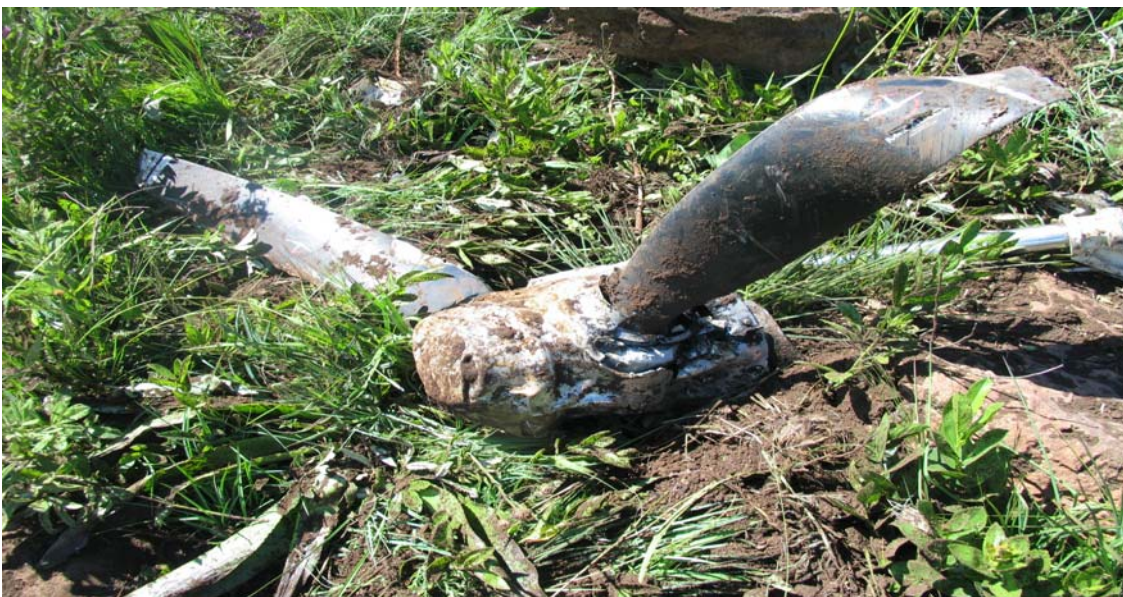
1.12.3 The location of the propeller was approximately 3 m from the main wreckage. The damage caused to the propeller indicated that it was rotating when it impacted the ground.

Figure 4: The damaged propeller

“The visual examination revealed propeller blades 1 and 2 with severed tips, propeller blade 3 fractured from the hub and the spinner severely damaged on impact. Cutting marks in the spinner suggest that as the spinner lost rotational speed on impact, propeller blades 1 and 2 impacted the spinner at the respective positions, thus signifying a non-stationary propeller on impact.

It was concluded that the propeller was rotating at the time of the accident but the percentage of power produced was not determined. This conclusion is based on the evidence of the propeller damages and the test above.
