Statens haverikommission
Swedish Accident Investigation Board

Final report RL 2011:16e

**Serious incident to aircraft SE-MAP
at Helsinki/Vantaa Airport in Finland,
on 11 January 2010**

Case L-07/10

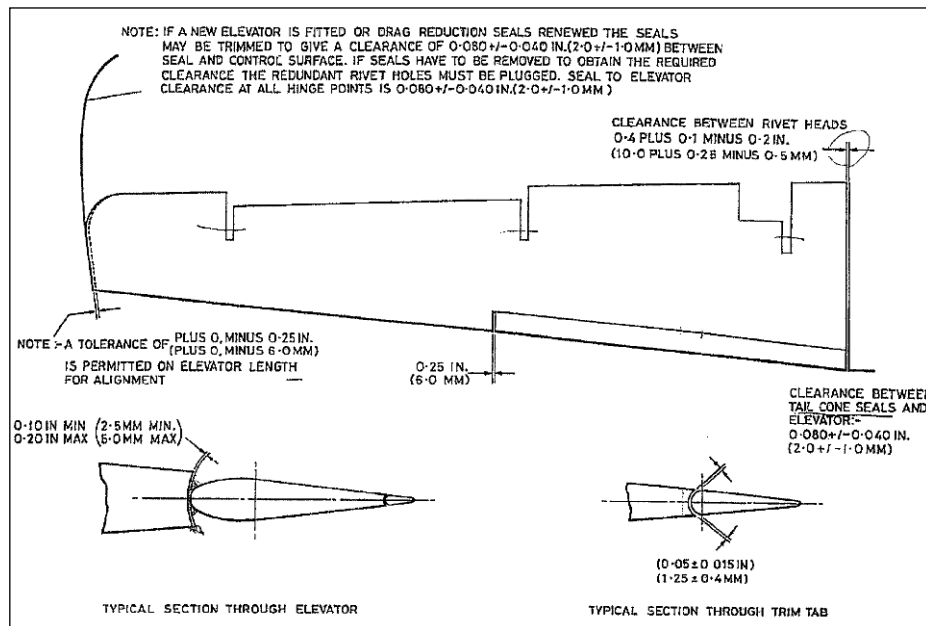
Figure 7. Tolerances for elevator clearance, according to AMM¹.

Each part of the elevator is hinged to the rear edge of the stabiliser using three bearings. There are specified tolerances for the permitted range of clearance of the elevator where it fits into the stabiliser's sockets, at both the front and side edges of the elevator, as shown in Figure 7. These measurements cannot be adjusted.

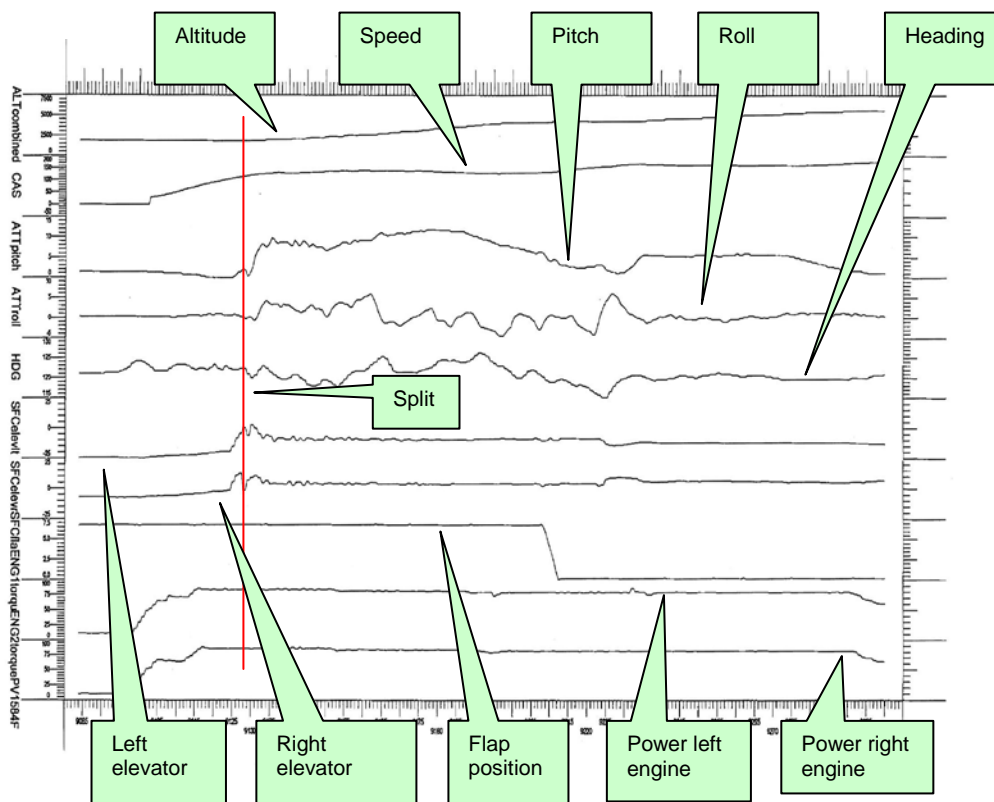
Fig. 8. Graphical representation of selected FDR parameters.

The graphic in Figure 8 is an FDR extract from one of the incidents – takeoff from Arvidsjaur, 23 December 2009. The co-pilot, who on this flight was in the right-hand seat, was to be PF. Conditions at the airport were visibility 3000 m in snowfall, so a two-step deicing had been carried out.

From the extracts we can see that a split took place approximately 25 seconds after the takeoff procedure started and the aircraft started moving down the runway. The left/right elevator split occurred at a speed (CAS³) of 115 kts, which is 15 kts over the calculated liftoff speed, V_r .

The angular difference between the two elevator halves was in this case 17.7 degrees at the moment when the systems separated (in this particular case it was the right-hand elevator half that was released). According to the pilot's report, the co-pilot, on reaching V_r , announced that something was wrong, at which point the commander took the decision to complete takeoff, and also helped in rotating the aircraft.

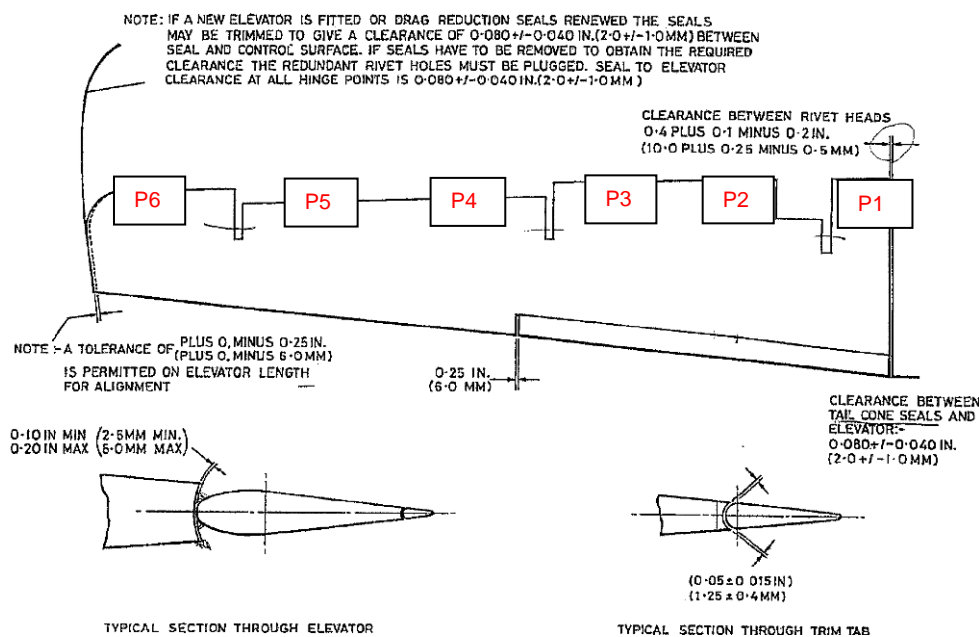
Fig.9. Measurement points

During the initial controls on certain aircraft, it was found that in certain positions, the gap between the stabiliser and elevator was less than the permissible minimum. In order to compare different individual aircraft, six measurement points were designated (P1 – P6 in Fig. 9) at certain positions along the gap.

When checking the measurement results from individual aircraft where the gap was below the permissible minimum, and comparing with those individual aircraft which had experienced incidents of the kind referred to here, a probable correlation was identified: of the individual craft which had experienced problems at rotation, the majority displayed – at one or more of the measurement points along the elevator hinge gap – measurements which were below the permitted minimum value for the gap, as laid down in the AMM. The following table summarises the sets of measurements carried out on certain individual aircraft from the fleets of the two operators.

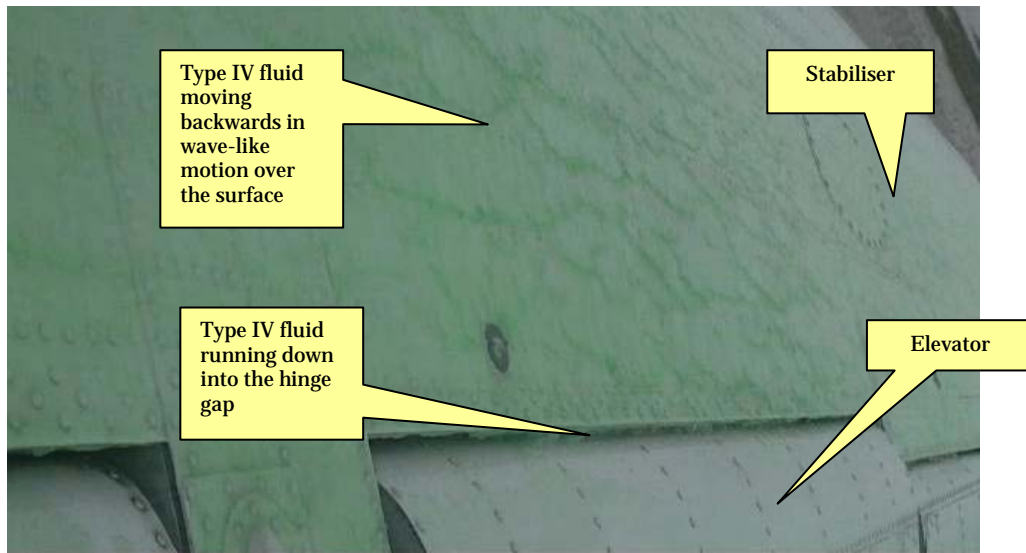
Figure 14. Picture from video while aircraft was taxiing out (upper surface). Speed approx. 20 kts.

In the first test it was observed via the upper camera that the fluid was moving backwards over the stabiliser's surface in a wave pattern. Most of the fluid that moved back across the stabiliser finished by running down into the elevator gap. The wave motion of the fluid during taxiing varied without there being any change in the aircraft's taxiing speed.

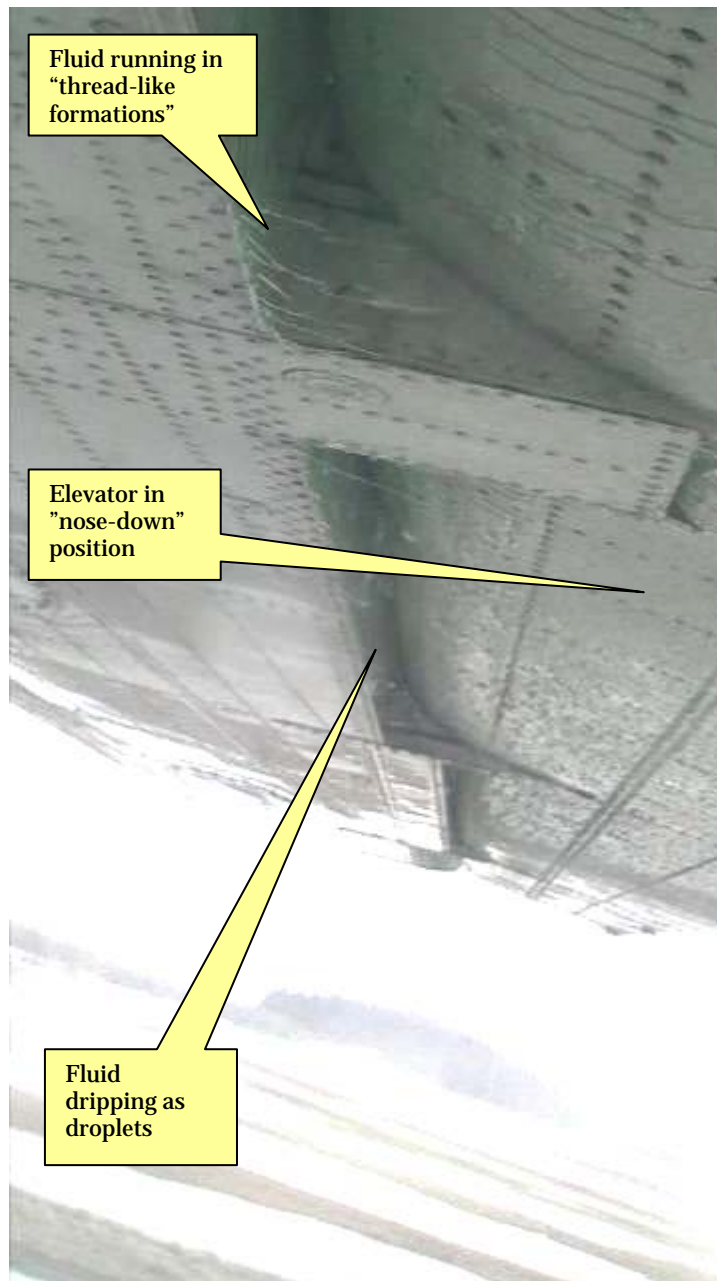
Figure 15. Picture from video while aircraft was taxiing out (underside). Speed approx. 20 kts.

On the underside of the stabiliser a fairly even dripping of fluid from the gap could be seen as the aircraft taxied out. The video also shows that the fluid drips from the gap both as droplets, and in longer, thread-like formations. It should be noted that during taxiing, the elevator is in "nose-down" position; in the cockpit this corresponds to the control column being in forward position. During the acceleration phase of takeoff – under the influence of increased air forces – the elevator's position moves towards the neutral position.

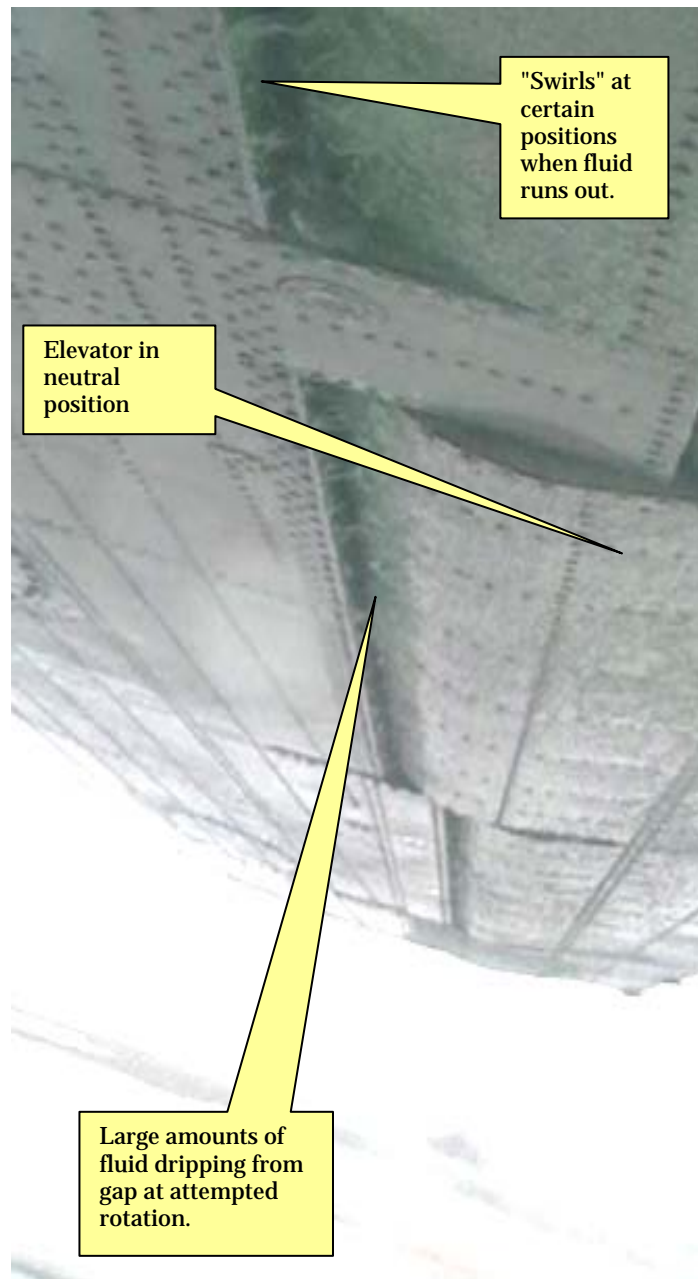
Figure 16. Picture from video at attempted rotation (underside).
Speed approx. 100 kts.

When rotation speed was reached the control column could not be pulled back further than the position corresponding to the neutral position of the elevator. As a result there was no rotation, and takeoff was aborted.

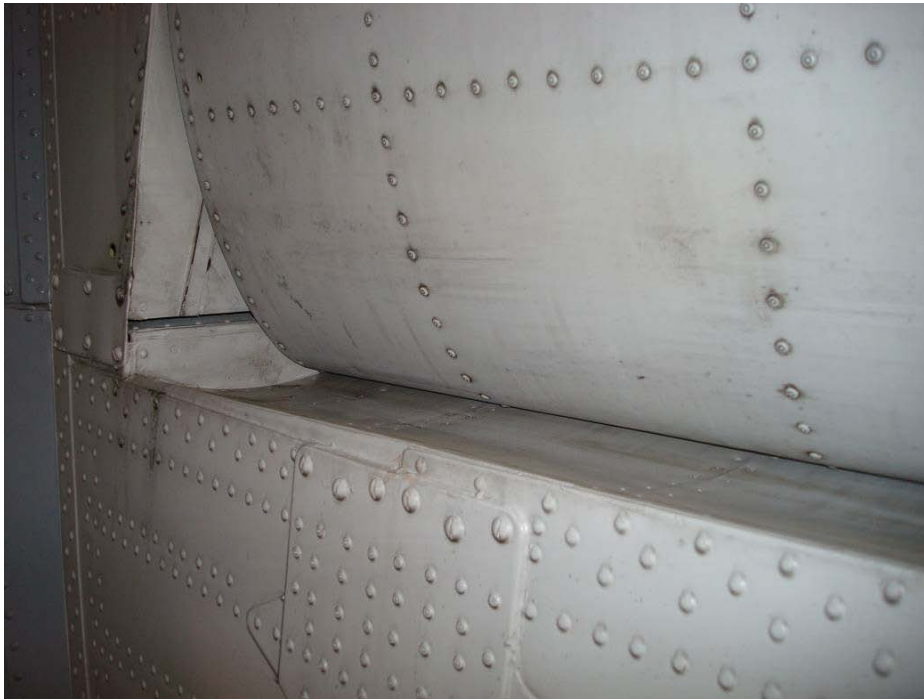
Fig. 20. Elevator clearance at position 1.

The aircraft's AMM stipulates maximum and minimum values for the permitted size of the gap, or clearance, between the stabiliser and the elevator. The permitted range of measurement can be said to lie between the limits for too narrow a gap (with a risk for mechanical contact, and thus physical restriction of movement), and too wide a gap (risk of aerodynamic changes which may affect performance). These relationships apply to operations under normal conditions.

The fact that measurements of the clearance were made in connection with the incidents has, however, changed the importance accorded to the size of the gap. The measurements made after the incidents suggest that there is a connection between too narrow a gap and the restricted manoeuvrability of the elevator experienced by the pilots concerned. In the vast majority of the cases, the gap measured was, at one or more points, narrower than the permitted minimum of 2.5 mm.

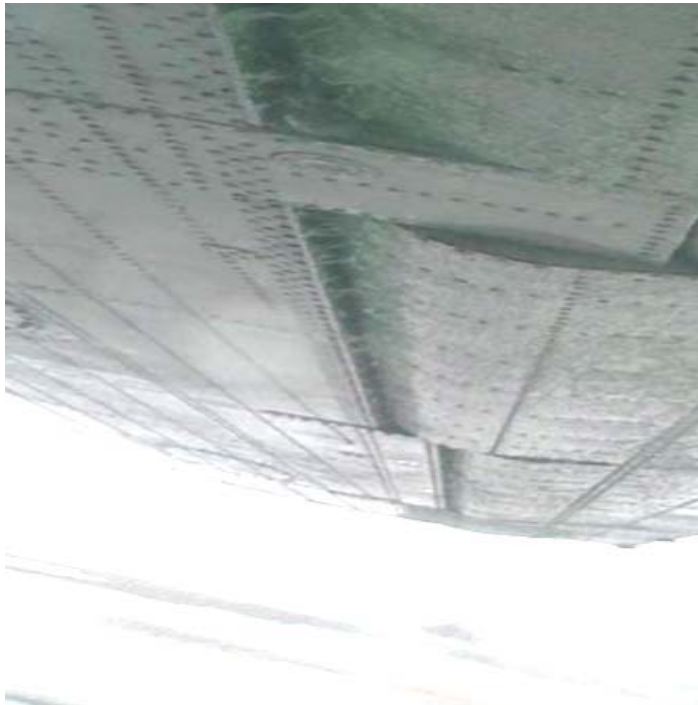
- Residual deicing fluid of Type II or IV,
- average elevator clearance below permitted minimum for aircraft type,
- unknown impact of propeller slipstream around the stabiliser,
- remnant fluid in the hinge gap, where the polymers probably have not been fully affected by the airflow's shear forces,
- altered/restricted flow of air through the gap,
- altered aerodynamic pressure conditions around the stabiliser.

Fig. 21. Picture from the rotation phase (underside). Speed: approx. 100 kts.

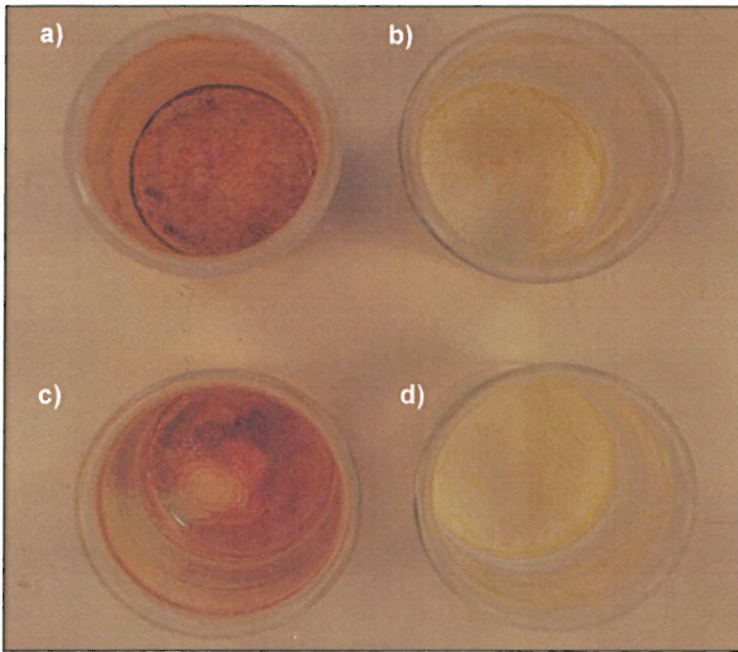
Figur 3. Indunstningsrester.

- a) Safewing® MP I Eco Plus (80) med provnummer 2010-9178, resten motsvarade ca 0,2 mass% och var orangeröd.
- b) Safewing® MP II Flight med provnummer 2010-9179, resten motsvarade ca 0,7 mass% och var gulvit.
- c) Typ I vätska av fabrikket Kilfrost ABC 2000 med provnummer 2011-797, resten motsvarade ca 0,1 mass% och var orangeröd.
- d) Typ II vätska av fabrikket Kilfrost ABC 2000 med provnummer 2011-798, resten motsvarade ca 0,7 mass% och var gulvit.
