Final report RL 2012:21e

**Serious incident on 16 of January 2010 to
aircraft EP-IBB at Stockholm/Arlanda
Airport, Stockholm county, Sweden**

Ref.no. L-02/10

2012-12-28

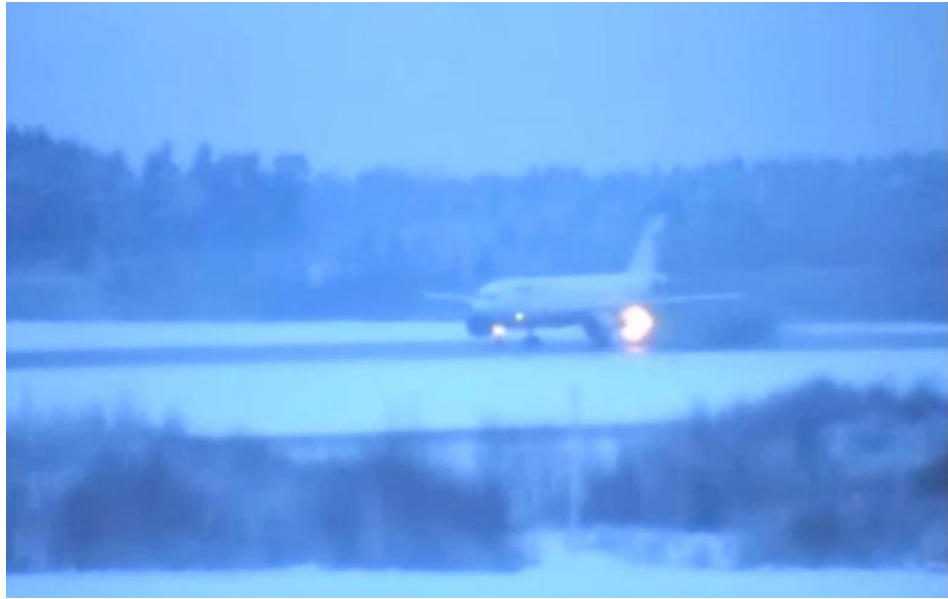
Fig. 2. Image from video. Photo: Saeid Cedighi Chafjiri.

The speed when the engine failure occurred was approximately 54 knots, but the aircraft continued to accelerate to approximately 59 knots (110 km/h). The incident occurred after rolling approximately 250 metres along the runway. The image in Figure 2 above has been obtained from a private video taken from the viewing terrace at Arlanda Airport during the sequence of events. The engine failure started with a puff of smoke and was quickly followed by three flames of varying size within the space of 0.77 seconds.

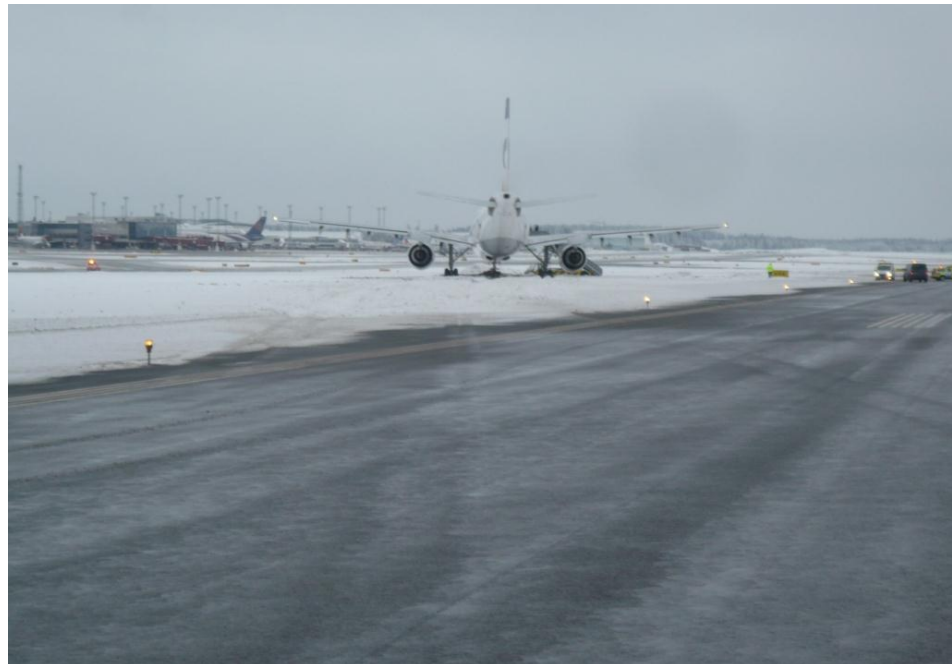
Fig. 3. The aircraft after the excursion. Photo: Swedavia.

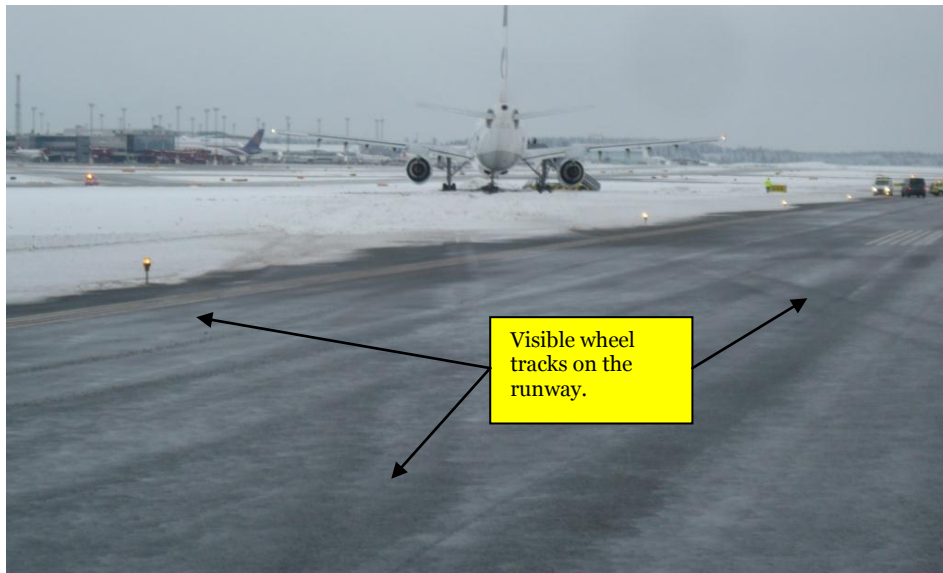
Both SHK and the airport staff have photographed the runway and the aircraft after the incident, see figs. 35b and 50. Judging by the images, the runway seems to have been covered with a grey contamination, in contrast to the appearance of the runway in the video recordings. Tracks from the aircraft's wheels are clearly seen in the contamination on the runway and in the snow outside of the runway. The landing gear is fitted with wheels mounted in pairs with a common axle and the main landing gear each has two pairs of wheels mounted in tandem. Double wheel tracks from main landing gear and nose landing gear can be seen on the runway surface in the images.

Fig. 35b. Tracks on the contaminated runway surface. Photo: Swedavia.

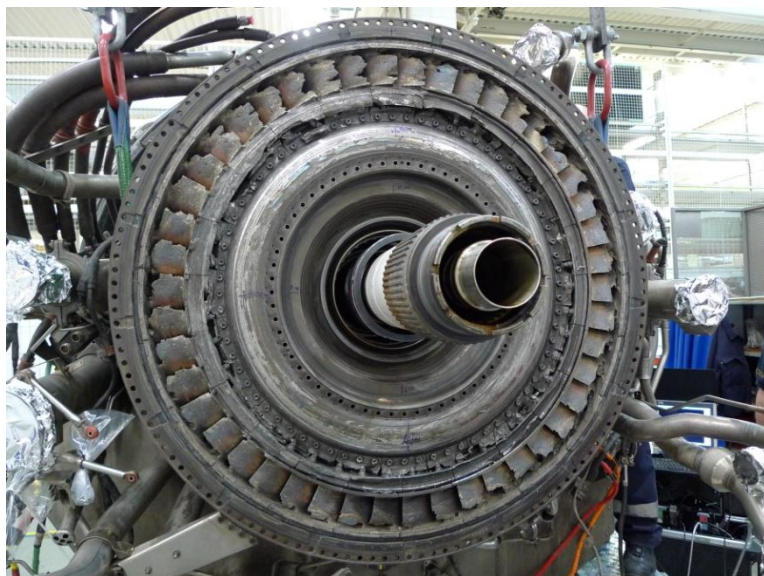
All HPT nozzle guide vanes had extensive impact damage from the “turbine side”. Its rear edges were severely mangled and partly torn away. Extensive mechanical impact damage was also found on the sheet-metal windage covers, which cover the guide vanes’ mounting bolts and hold them in place. Section 1.16b.9 discusses the parts of the diffuser aft air seal that were originally located between HPT stage one, guide vanes and turbine.

Fig. 36. HPT guide vanes stage one. Photo: SHK.

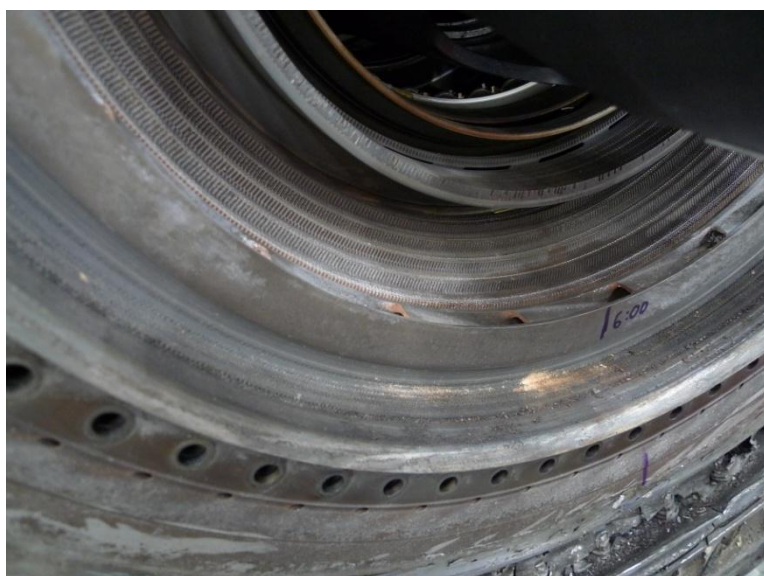
Sealing surfaces for the diffuser’s forward seal (Diffuser Front Seal) were intact and had normal wear. Sealing surfaces in the form of the stationary honeycomb for the diffuser’s aft seal (Diffuser Aft Air Seal) were torn away. The bolts which hold together the forward and aft seals against the diffuser were overstressed and sheared off. The edge of the seal normally lies parallel with the engine’s longitudinal axis, but in this case it was angled outwards at 45°. Extensive impact damage was ascertained on the parts of the module that were directed towards the HPT disc stage one.

Fig. 37. Stationary seal, forward and aft (honeycomb completely torn away). Photo: SHK.

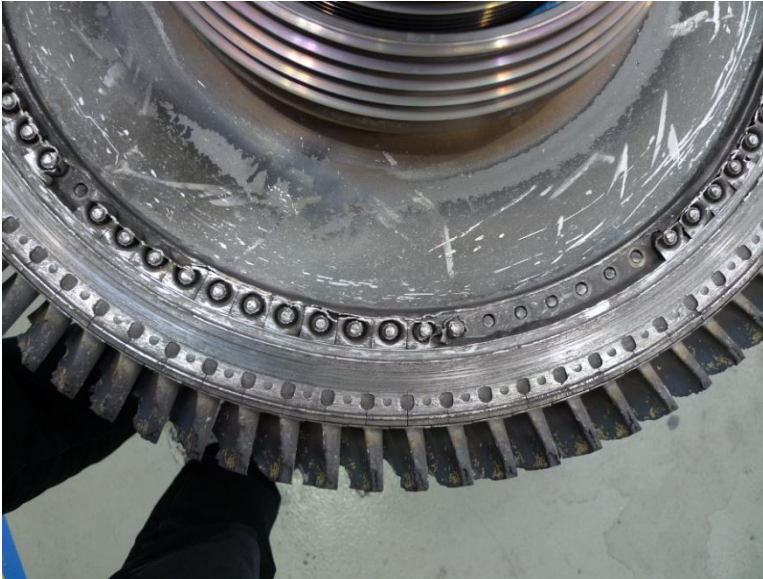
All blades were damaged through mechanical impact. The tops of the blades were entirely or partly torn away.

Fig. 38. HPT disc and turbine stage one with Diffuser Front Seal.
Photo: SHK.

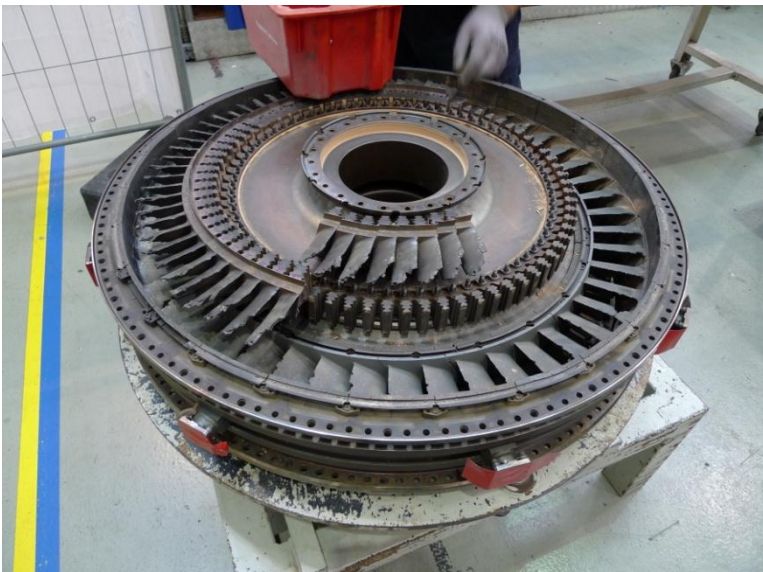
Seven of the eighty bolts which axially secures the stage 1 HPT Blade retainer to the stage 1 disk, also known as the 1st stage HPT blade retainer “Hook Bolts”, were found broken just under their windage cups. Six of these seven bolts were adjacent to each other. One broken bolt was located 12 bolt holes beyond the others.

Fig. 39. HPT stage two. Photo: SHK.

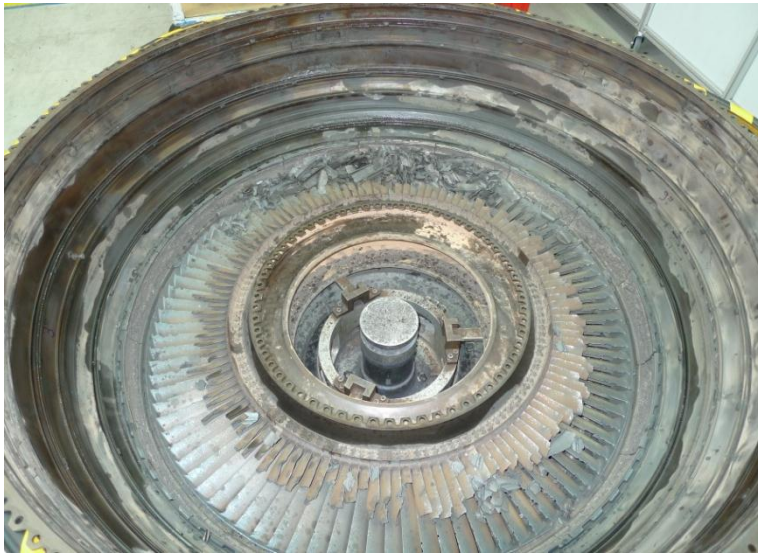
Throughout all five stages of the low pressure turbine, impact damage to both the low pressure turbine blades and guide vanes were observed. The amount of damage decreased further back in the low pressure turbine module. The low pressure turbine case was examined and found to have penetrations measuring around five by five millimeters. It has not been possible to conclude if debris passed through the holes. The LPT case was also observed with a number of case deformations in the radial direction.

Fig. 40. LPT guide vanes and turbine blades stage two. Photo: SHK.

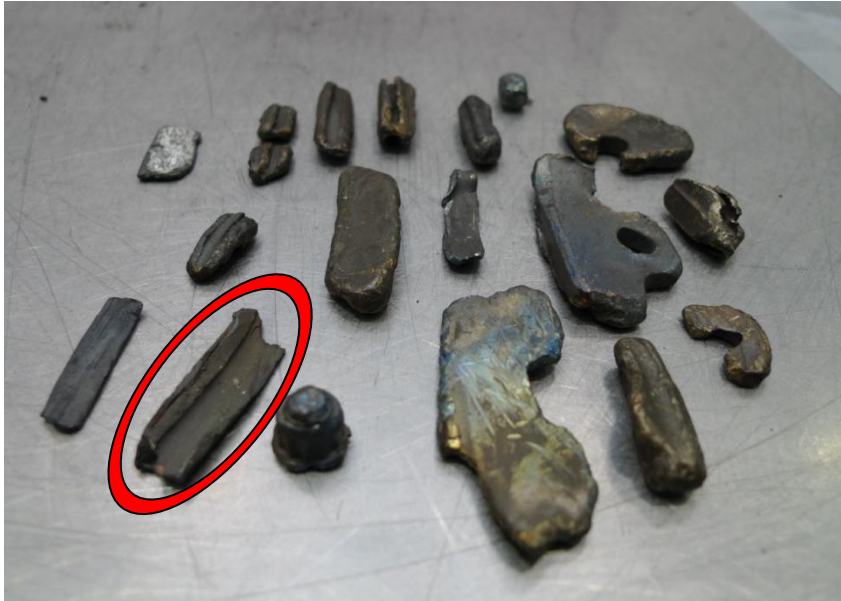
Fig. 44. Fragments analysed by Volvo Aero Corporation. The piece marked in red is a piece of the edge of the diffuser aft air seal. Photo: SHK.

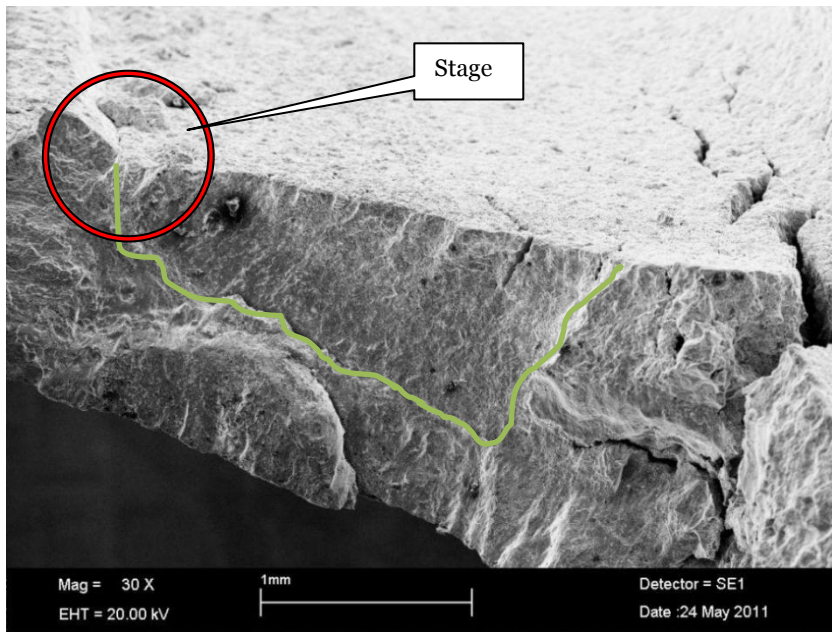
The overall assessment of the investigation results suggests that the fatigue had started in the repaired seam at the diffuser aft air seal teeth. All documented cases of CF6-80C2 diffuser aft air seal failures have been seals that had been previously repaired.

Fig. 45. Section of the knife edge in the diffuser aft air seal – one of four edges. Fatigue zone with crack initiation. Photo: VAC.

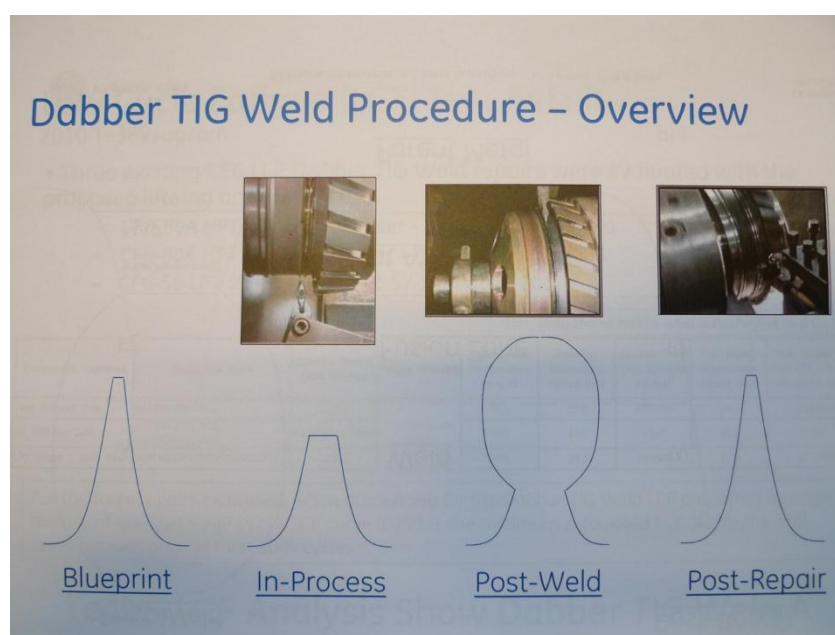
The seal material is Inconel 718. During a repair, the seal edges are dabber-welded in an age-hardened state (aged). The risk for crack formation is thereby greater in weld and heat-affected zones. For newly manufactured engine parts using TIG Weld operations, however, Inconel 718 is always welded in a solution-heated state. The material is then more ductile and has lower hardness.

Fig. 48. Repair with the GE method “Dabber⁵⁵ TIG Weld”.

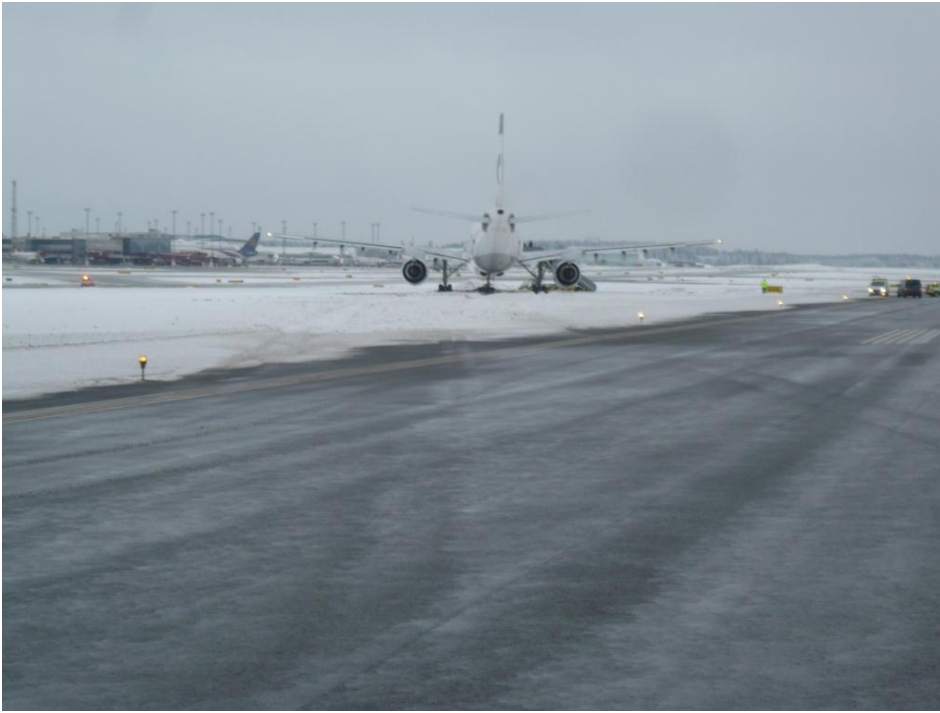
The contaminated surface must be concluded to have affected the friction negatively, however not to the extent of causing aquaplaning since the aircraft speed was too low for that.

Fig. 50. (See also fig. 35b). Tracks on the contaminated runway surface. Photo: Swedavia.

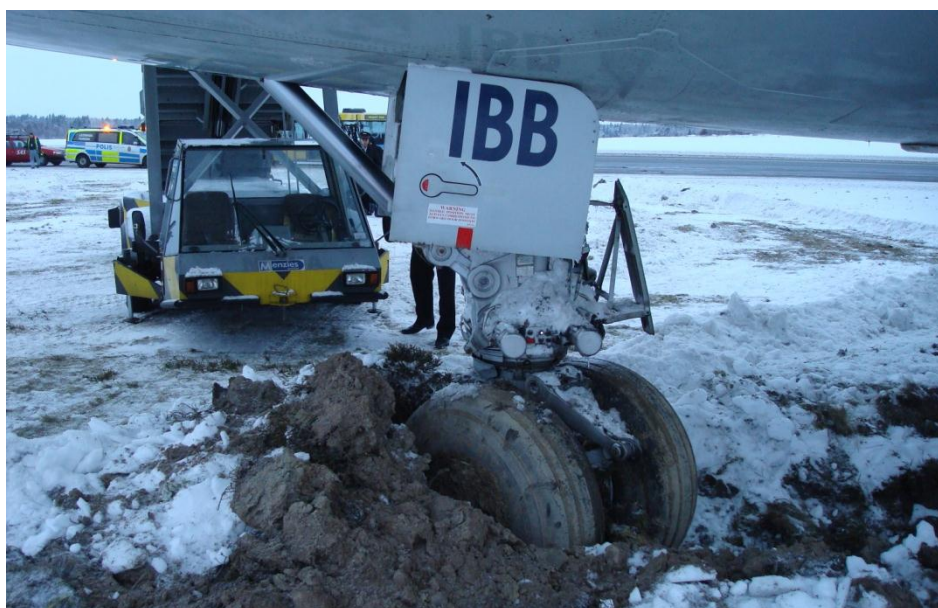
steering wheel (tiller) in the cockpit. These facts are supported by the fact that the aircraft – after having stopped – was found with the nose wheel at an angle fully to the right.

Fig. 51. The nose wheel angled to the right. Photo: Swedavia.

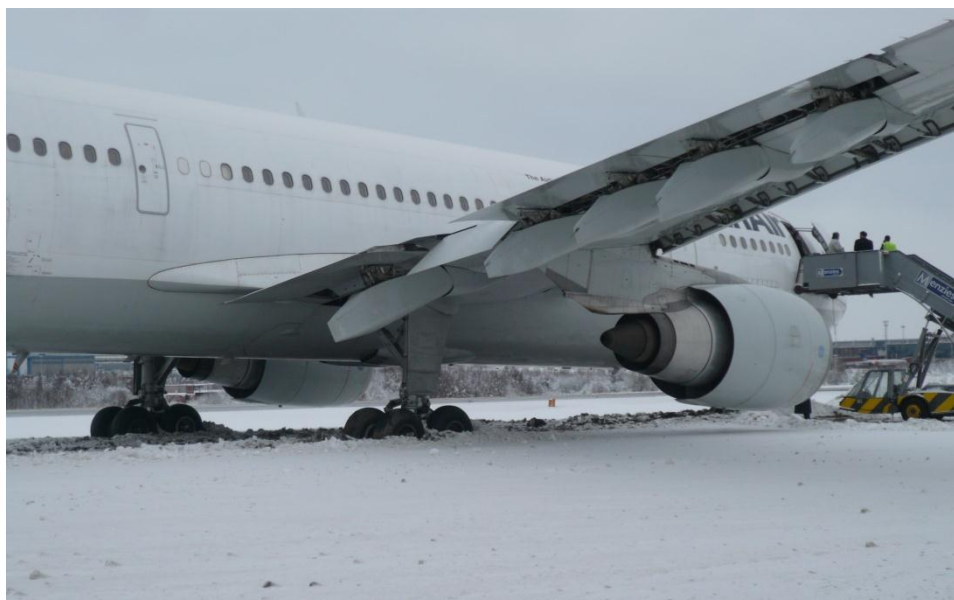
During the final stage of the aircraft’s path, the nose wheel buried itself approximately half a metre into the ground, partly due to the nose wheel being maximally angled to the right. The steering wheel for the nose wheel steering is not intended for use during the take-off sequence as steering via the rudder pedals is considered to be sufficient. However, when an aircraft is about to run off the runway, it is fully understandable that all means are used by the pilots in attempt to prevent an accident.

Fig. 52. The aircraft after evacuation. Photo: SHK.

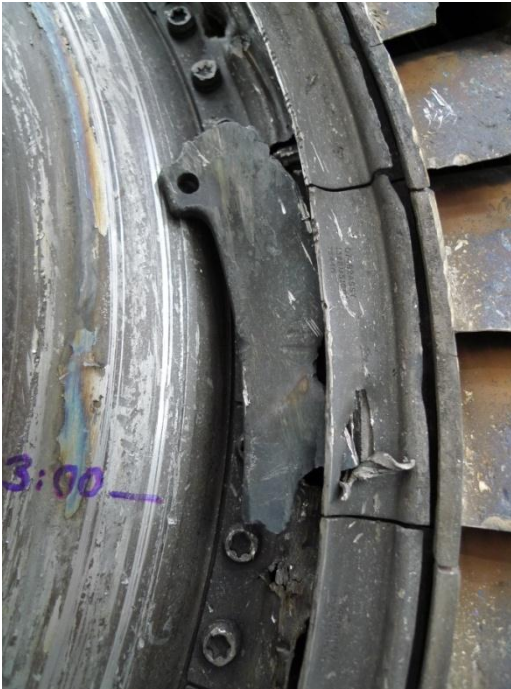
Once the crack was long enough in one or more of the four teeth in the air seal, the loads were transferred to the nine rotating diffuser assembly bolts. Bolts sheared which liberated the aft air seal radially outward contacting the nozzle support structure with debris fragments entering the cavity forward of the stage 1 HPT disk and aft of the stage 1 HPT nozzle. At the time of the aft air seal separation, the HPT rotor speed was approximately 10,000 RPM.

Fig. 57. HPT guide vanes stage one with fragments of the diffuser aft air seal. Photo: SHK.

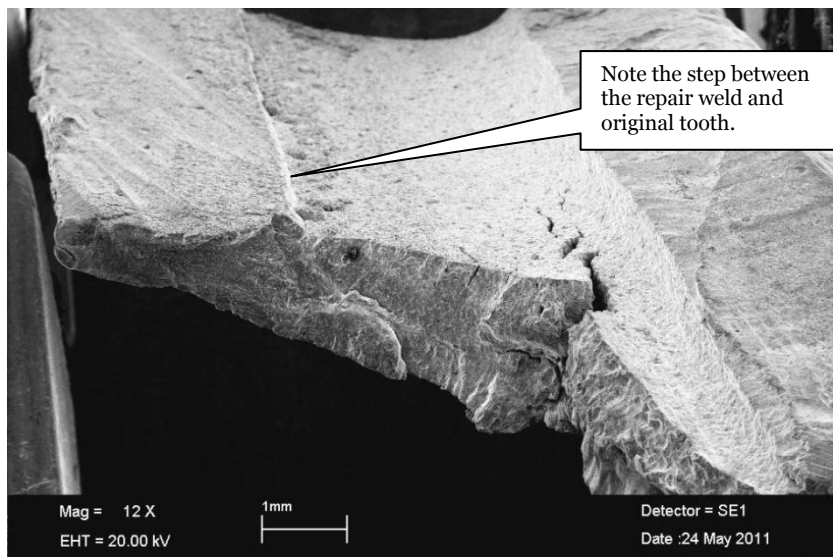
Fig. 58. Section of one of the edges in the diffuser aft air seal. See also fig. 45. Photo: VAC.

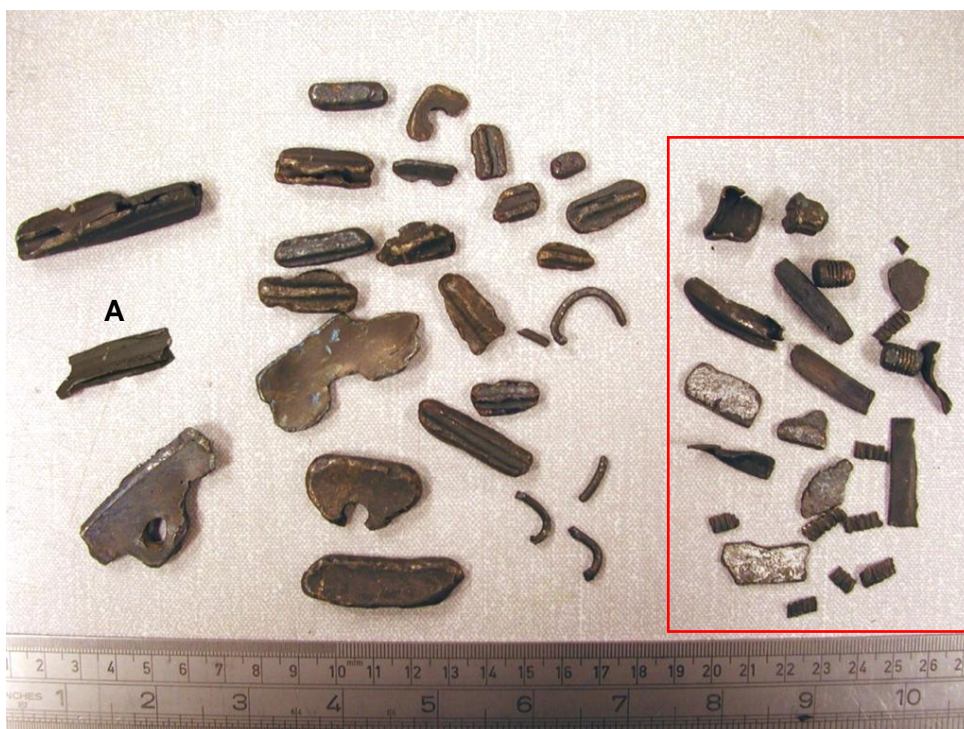
Photo No 1. Content of the plastic bag. The pieces within the red marking are not believed to be from the Diffuser Aft Seal based upon visual appearance and geometry. The piece marked "A" is from the aft tooth of the seal.

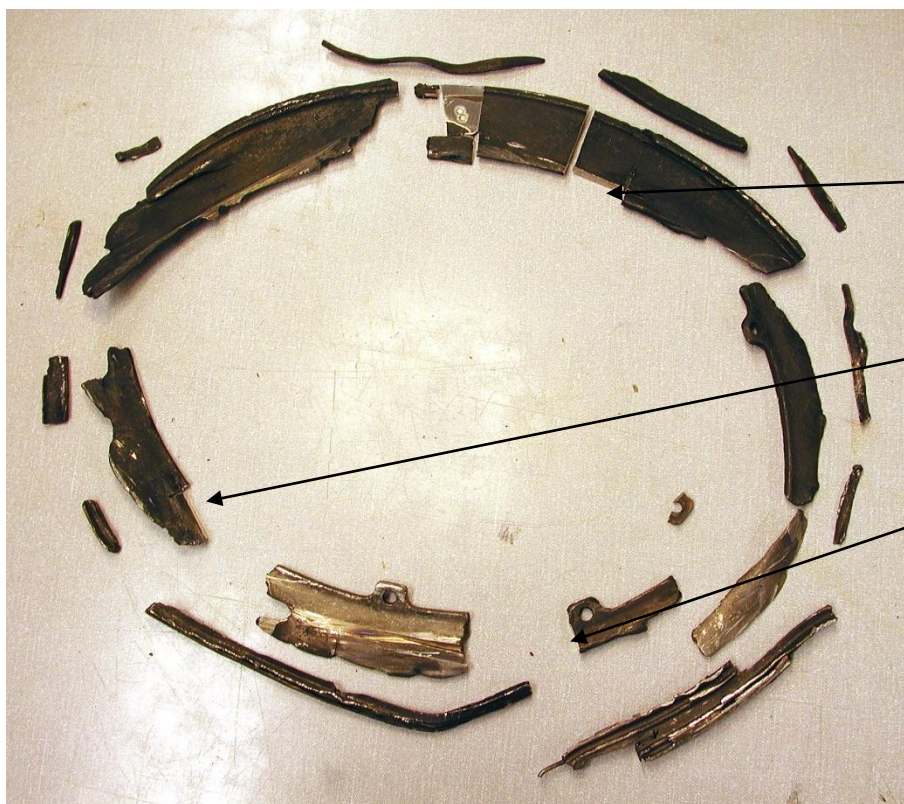
Fracture surfaces from lug are missing.

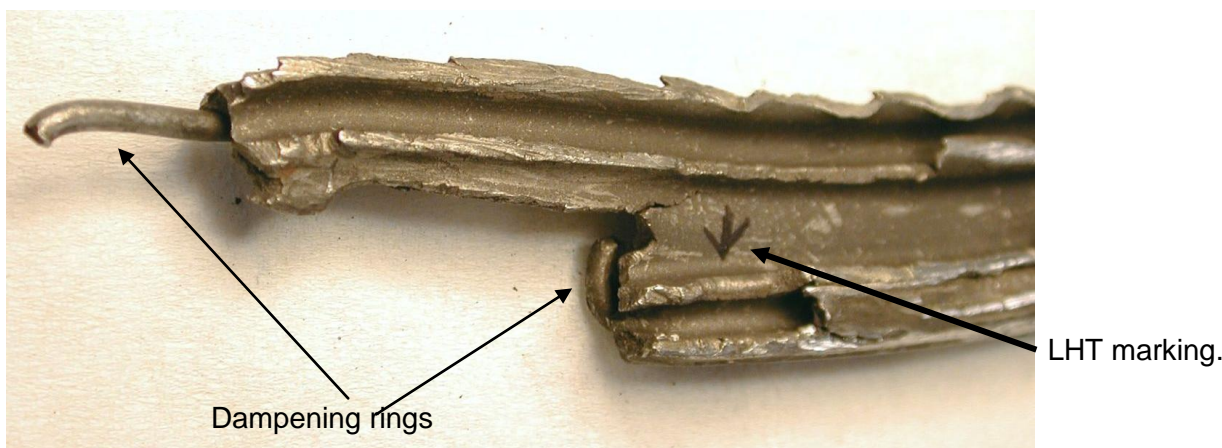
Photo No 6. Both dampening rings were in place at the failure.

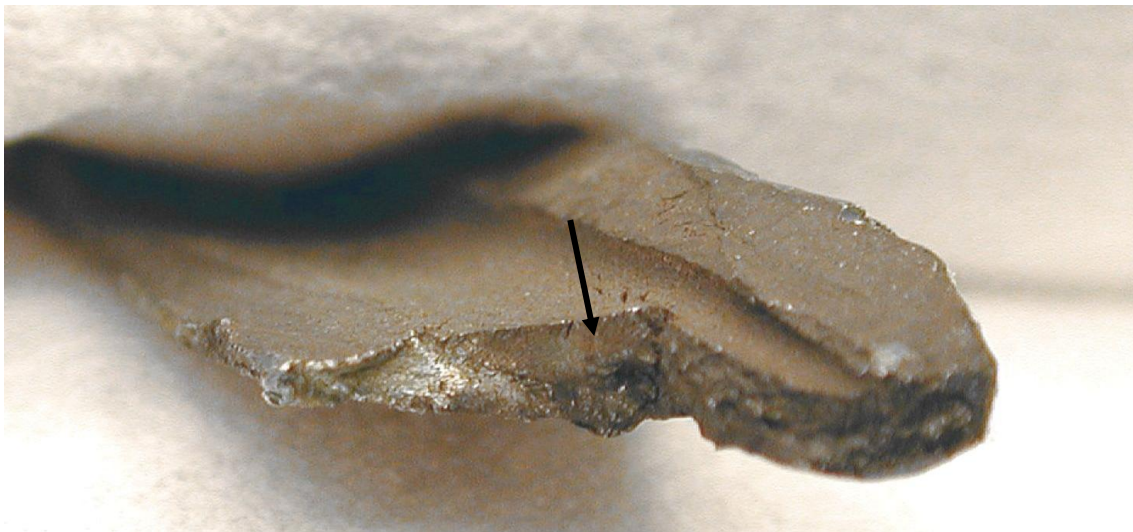
Photo No 8. The left end of the tooth in photo no 7 shows a fatigue crack (arrow). The bright appearance of the crack surface suggests it to be a secondary crack, developed during the engine break down.

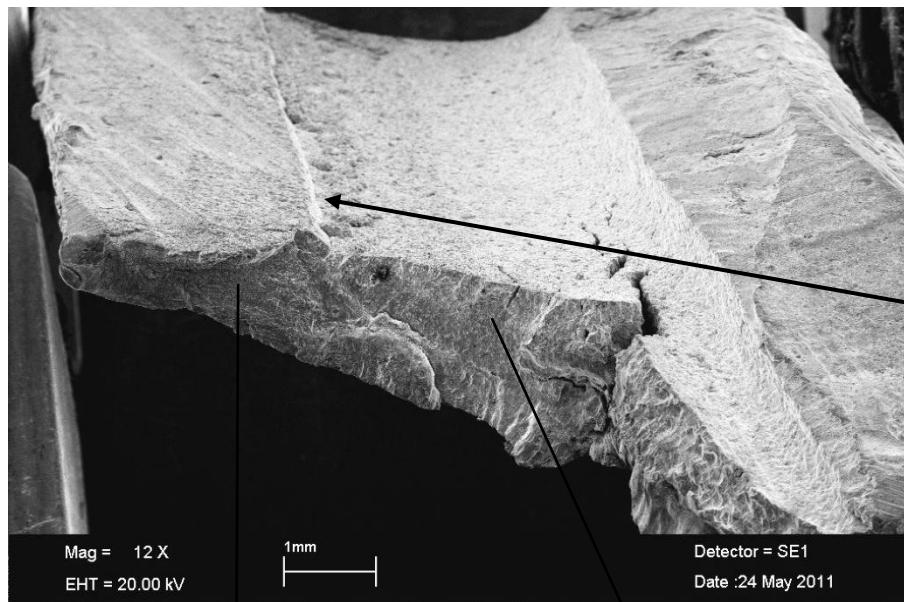
Note the step between the repair weld and original tooth.

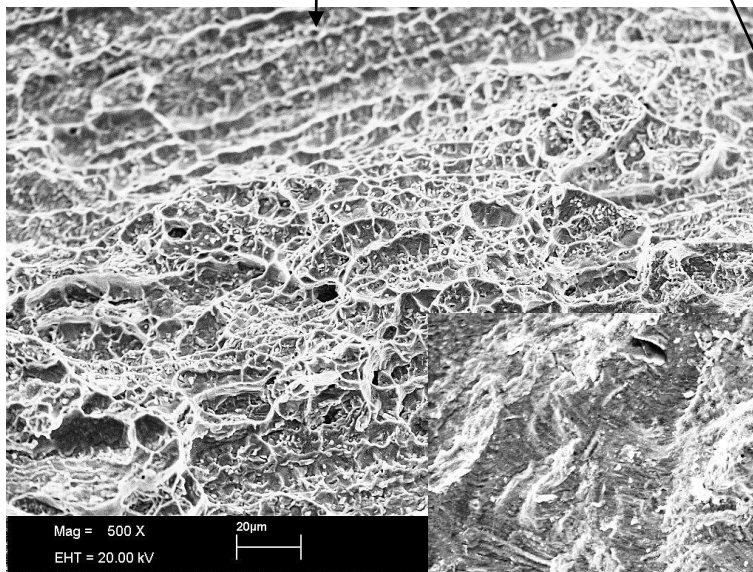
Photo No 10. Tensile overload (weld) structure.

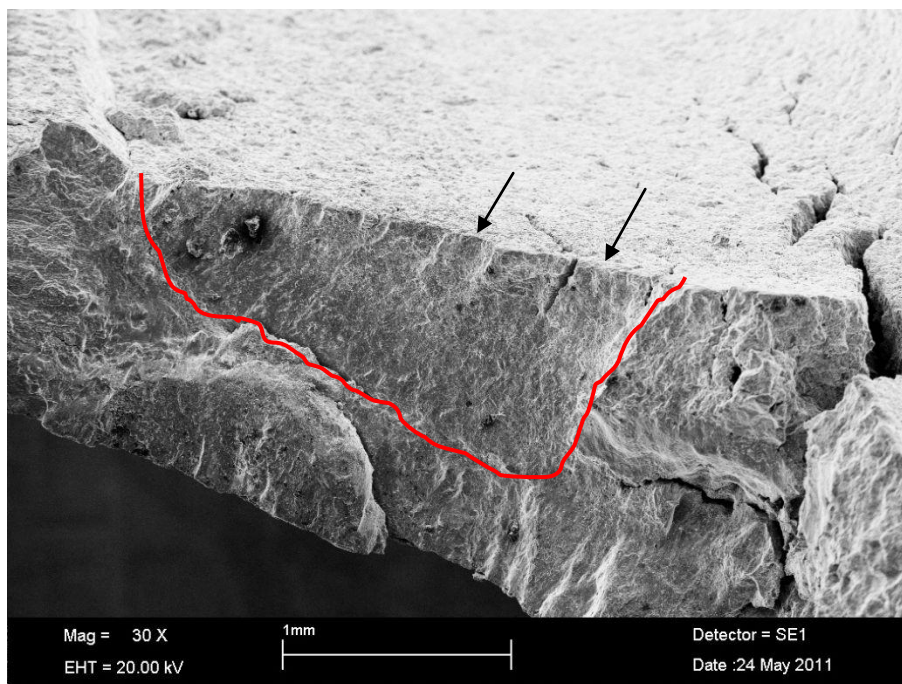
Photo No 12. Fatigue surface outlined with red. Arrows show two crack initiation points.

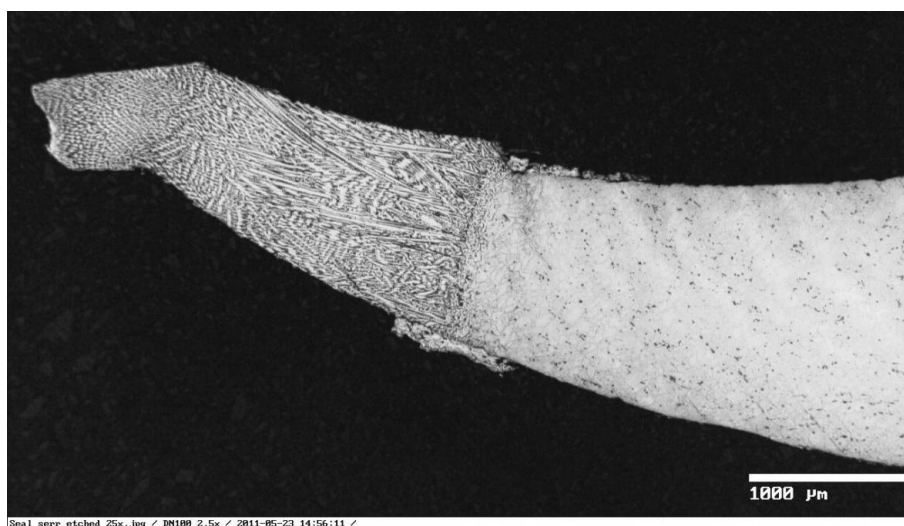
Photo No 13. Cross section, in etched condition, shows the seal tooth with the dabber weld repair.

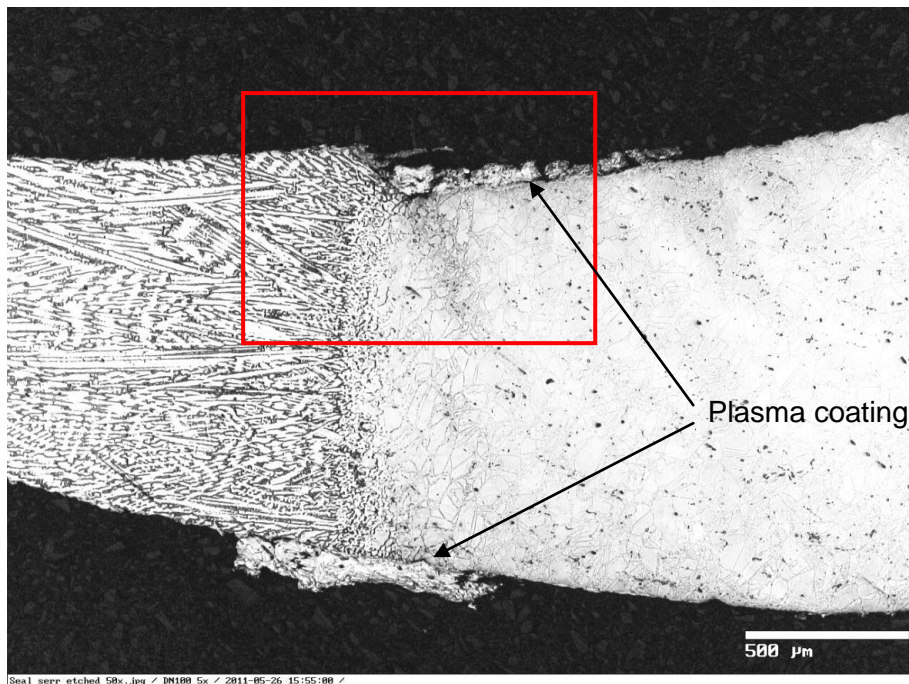
Photo No 14. Higher magnification of the dabber weld interface.

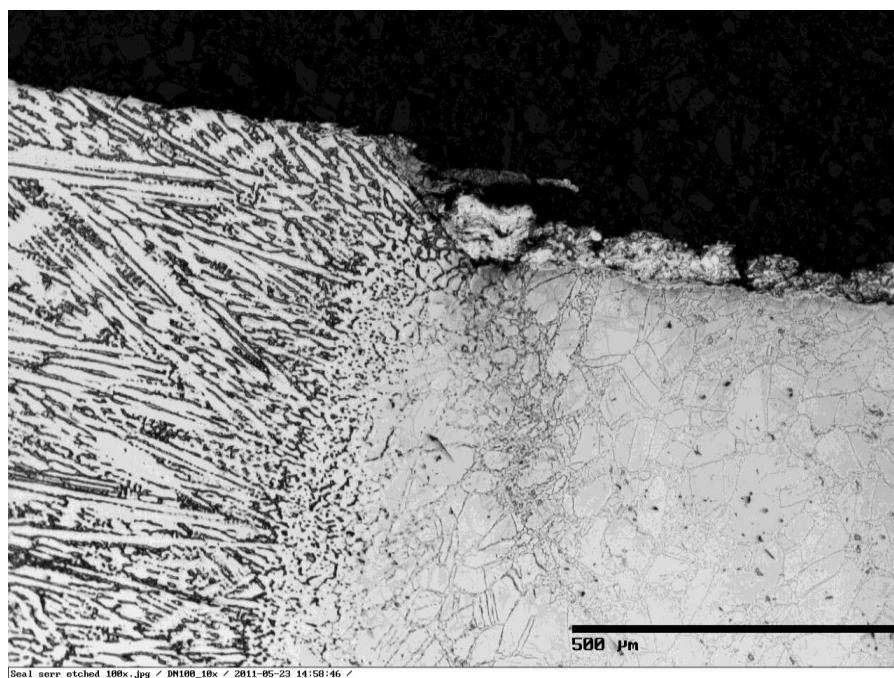
Photo No 15. Higher magnification of the area in the red rectangle in previous figure shows the machining step between the original seal and the repair weld.

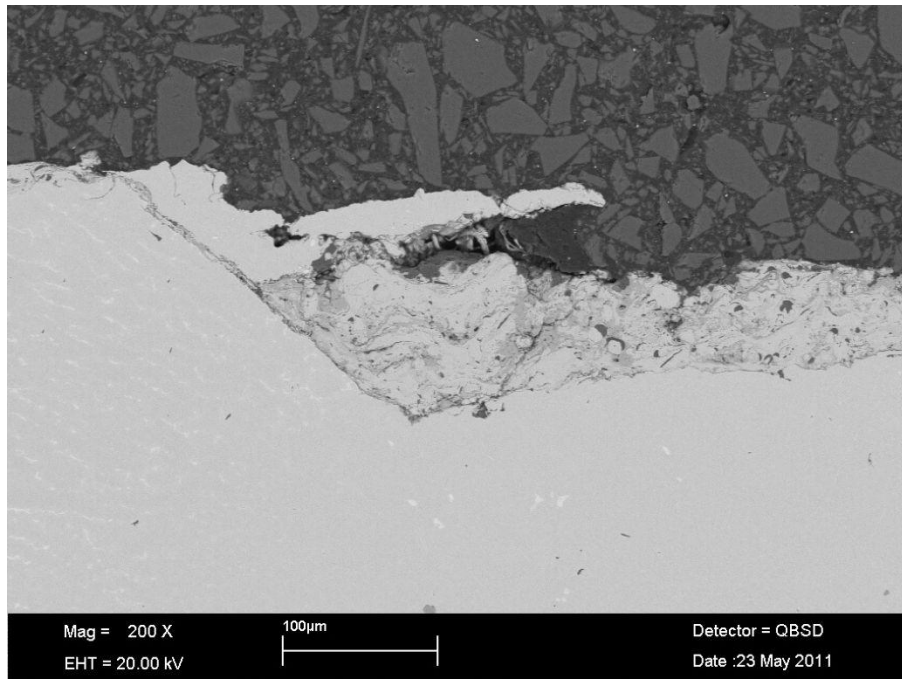
Photo No 16. SEM-photo in 200X shows that the bottom of the machining step between the original seal and the repair weld is considered to be a sharp corner.

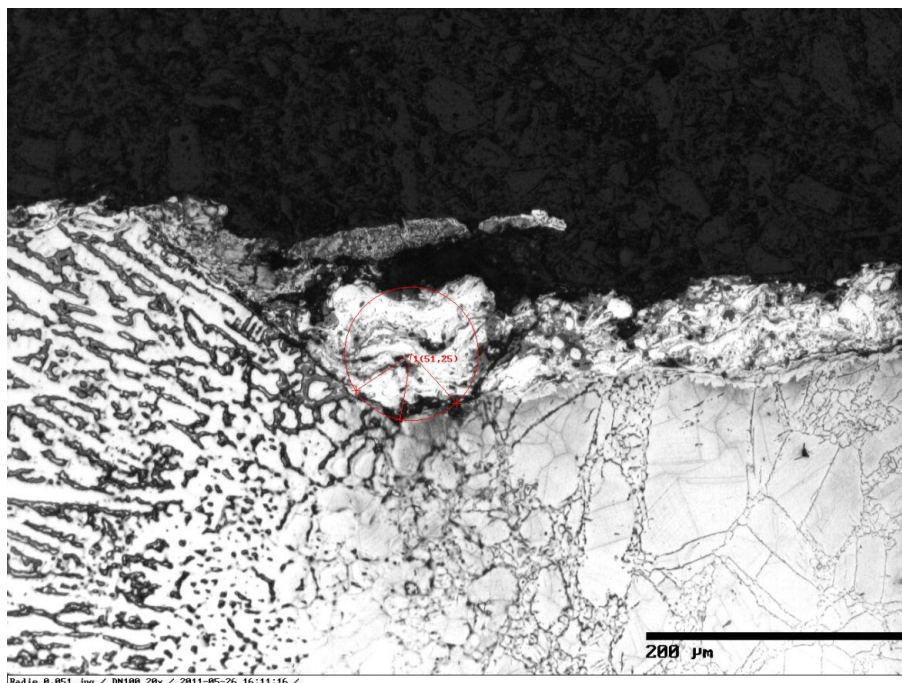
Photo No 17. The radius of the machining step is measured to be 0.05mm.

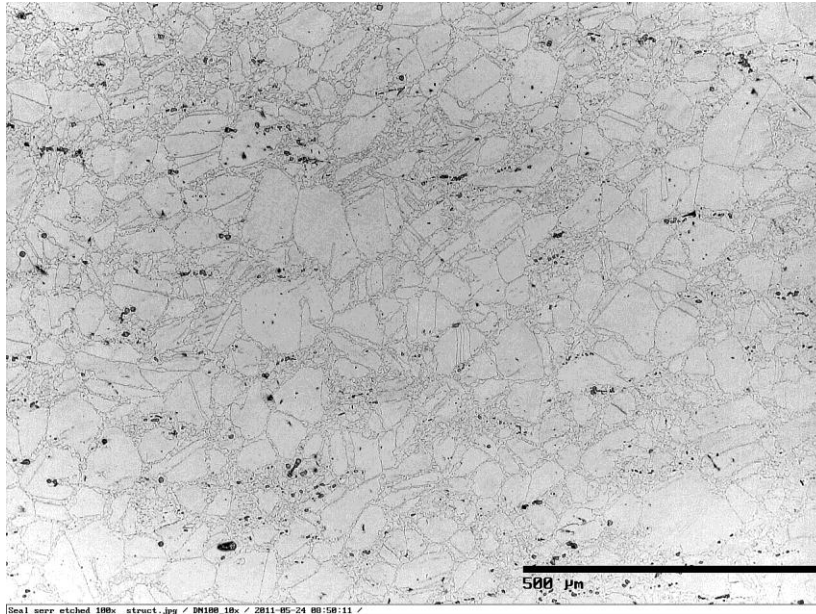
Photo No 19. Microstructure of the seal tooth, about 3 mm from the weld interface.
