AIRCRAFT ACCIDENT REPORT AND EXECUTIVE SUMMARY

Reference:	CA18/2/3/8745	
Aircraft Registration	ZS-HWH	Date of Accident	1 February 2010	Time of Accident	1000Z	
Type of Aircraft	Hughes 269C (Helicopter)		Type of Operation	Training		
Pilot-in-command Licence Type		Commercial (H)	Age	21	Licence Valid	Yes
Pilot-in-command Flying Experience		Total Flying Hours	202.9		Hours on Type	176.3
Last point of departure		Wonderboom Aerodrome (FAWB) Gauteng				
Next point of intended landing		Wonderboom Aerodrome (FAWB) Gauteng				
Location of the accident site with reference to easily defined geographical points (GPS readings if possible)						
Helicopter landing zone at Wonderboom Aerodrome (GPS coordinates S 25°39'35.24" E 028°12'57.52")						
Meteorological Information	Wind: southerly at 5 kts; Visibility: >10 km; Temperature: 28 °C; Cloud cover: nil					
Number of people on board	2+0	No. of people injured	1+0	No. of people killed	0	
Synopsis						
<p>On 01 February 2010 at approximately 1000Z the pilot, accompanied by a flight instructor, were preparing for take-off on a training flight to assess the skills level of the pilot for a game rating.</p> <p>During the magneto-check at approximately

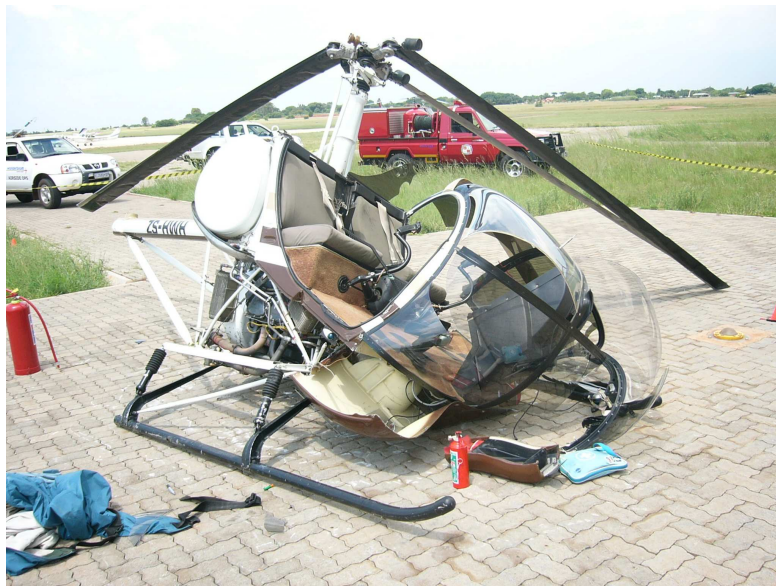
The fuselage was destroyed during the sequence of the accident. **(See Figure 1.)** The tail boom was severed from the fuselage and was found approximately 2 metres from the main wreckage. The left-hand rear landing gear damper's bottom attachment point on the landing gear skid was broken while the left-hand front gear damper's top attachment point on the damper was broken. **(See Figure 2.)** These broken attachment points were caused by the accident sequence.

Figure 1 Damage caused to the fuselage of the helicopter

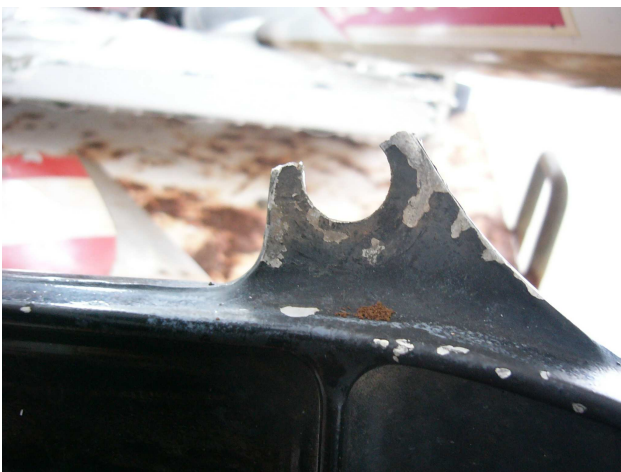
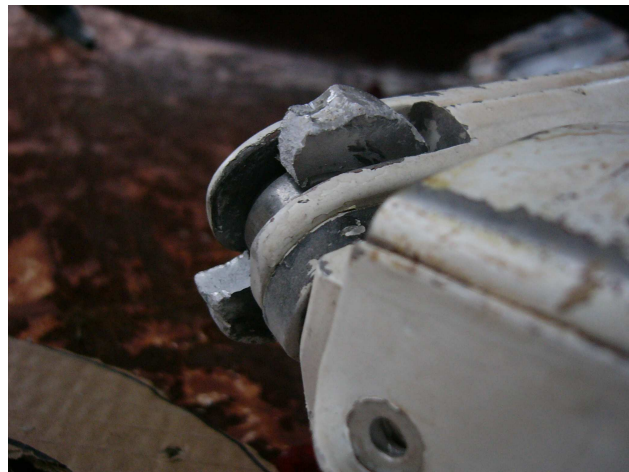
Figure 2 Damage to the left-hand rear (a) and left-hand front (b) damper attachment points

- 2.4 A landing gear damper load stroke test done on all four dampers after the accident revealed all four dampers were improperly charged. The left-hand front and rear damper mounting points were broken after the accident because of the accident sequence.

Failure of the landing gear damper attachment points as a result of the severe ground resonance.

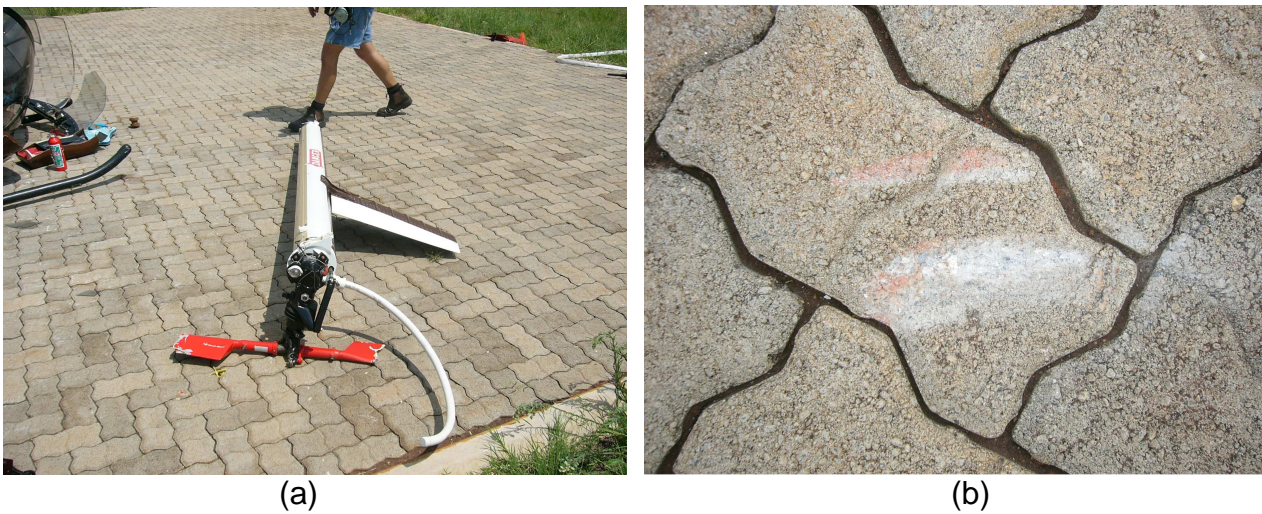
The rotor blades were still attached to the rotor mast although all three main rotor drag dampers were destroyed. Damage to the main rotor blade tips indicated that the main rotor blades had made contact with the brick-paved helicopter landing pad. Impact damage marks were visible on all three main rotor blades. The tail rotor blades were destroyed during the accident sequence. Marks indicating that the tail rotor blades had made contact with the landing surface were clearly visible on the landing surface. **(See Figure 3.)**

Figure 3 Damage to the tail rotor blades (a) and contact marks (b) with the landing surface

- 2.5 The effect of excessive pressure in the dampers is a loss of damping and a lack of attenuation of main rotor oscillations.
- 2.6 Marks indicating that the tail rotor blade had made contact with the landing surface were clearly visible on the scene of the accident.

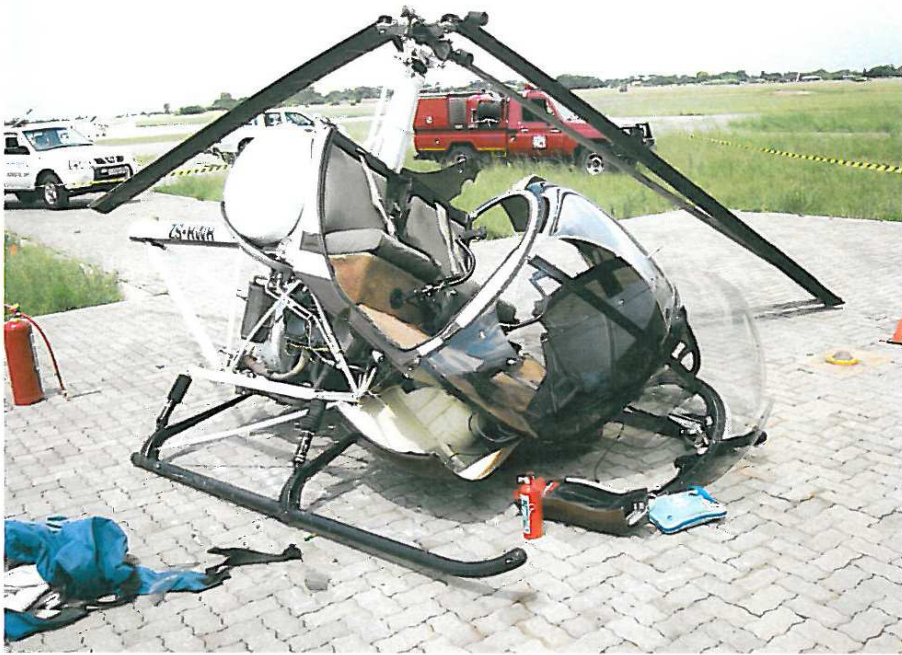
Fig. 1 General view of wreckage at site (CAA Photo)

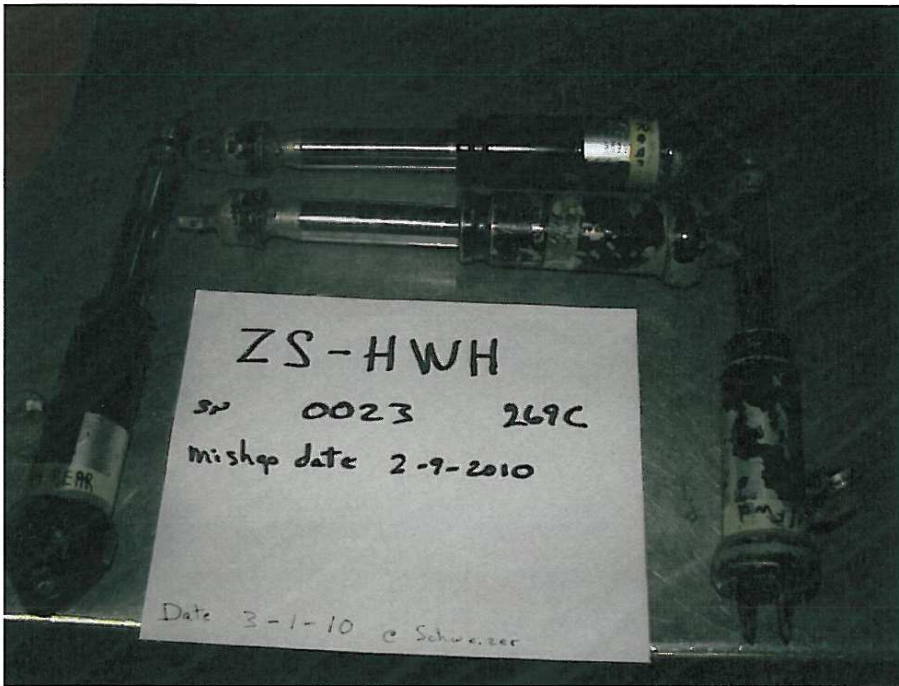
Landing gear dampers load stroke tested at Schweizer Aircraft Corporation. Dampers were received with boots removed, two caps were removed and other two were loose. All 4 had masking tape identifying aircraft location. CAA reported "I had the landing gear dampers checked by Precision Aviation Services in South Africa. Unfortunately they only make sure the dampers were under pressure and not deflated." It is unknown what tests were performed during this check.

Fig 2 Dampers as received at Schweizer for load stroke testing

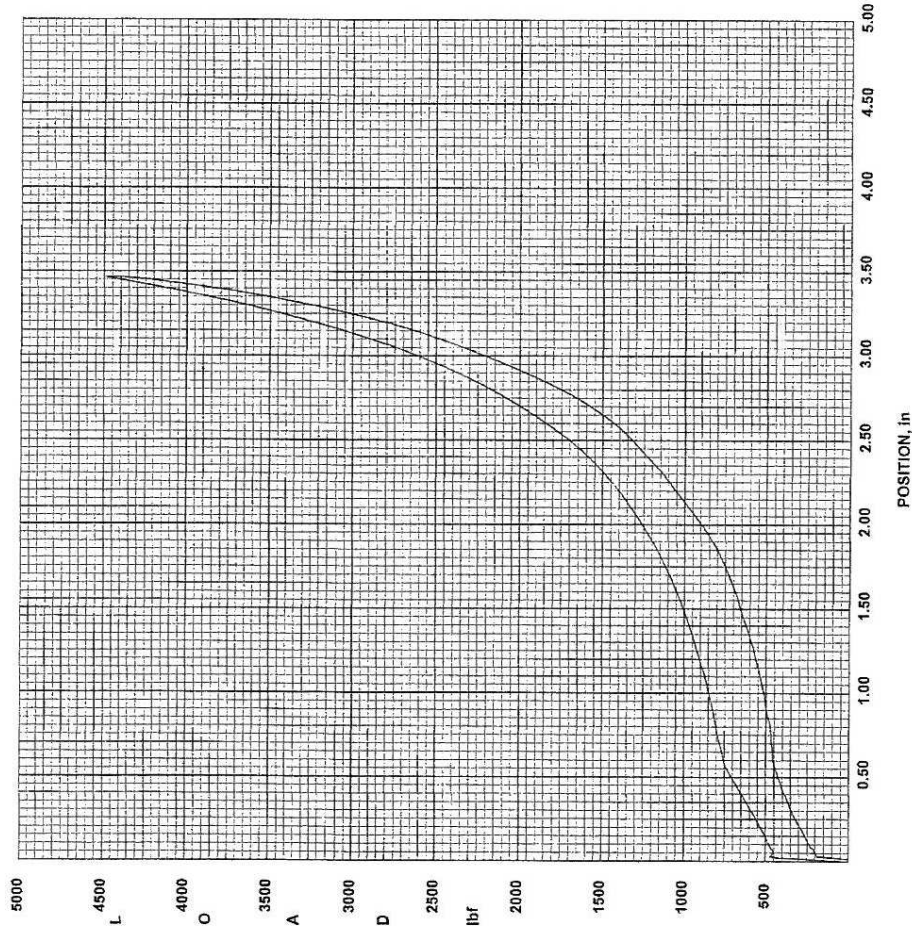
Serial No.: S1448 L H R e s s
 Dash #: 21
 Yield PL, lbf: 464
 Position @ 814lbf+, in: 0.84
 Position @ 814lbf-, in: 1.87
 Ultimate, lbf: 4488
 Ult Distance, in: 3.46

Test Failed

Fig 3 Left rear damper load stroke chart

The subject aft dampers exceeded the maximum load rating to reach full stroke (compression). The intermediate reference points were also exceeded. These conditions indicate the dampers were likely serviced with an excess amount of hydraulic fluid but charged near the standard gas pressure of 725 psi. The right forward damper exceeded the full stroke load value. The intermediate reference points were also exceeded. These conditions indicate excessive gas pressure.

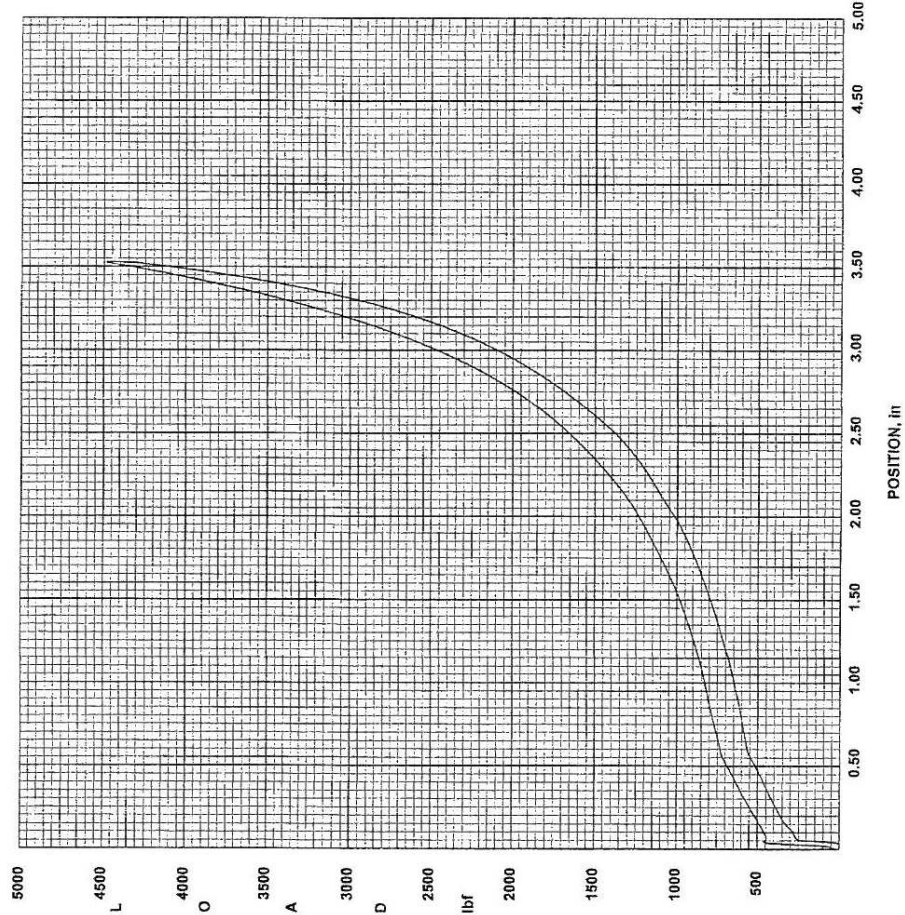
Serial No.: S972 R H R
 Dash #: 21
 Yield Pt., lbf: 432
 Position @ 814lbf, in: 0.93
 Position @ 814lbf-, in: 1.55
 Ultimate, lbf: 4483
 Ull Distance, in: 3.53

Test Failed

Fig 4 Right rear damper load stroke chart

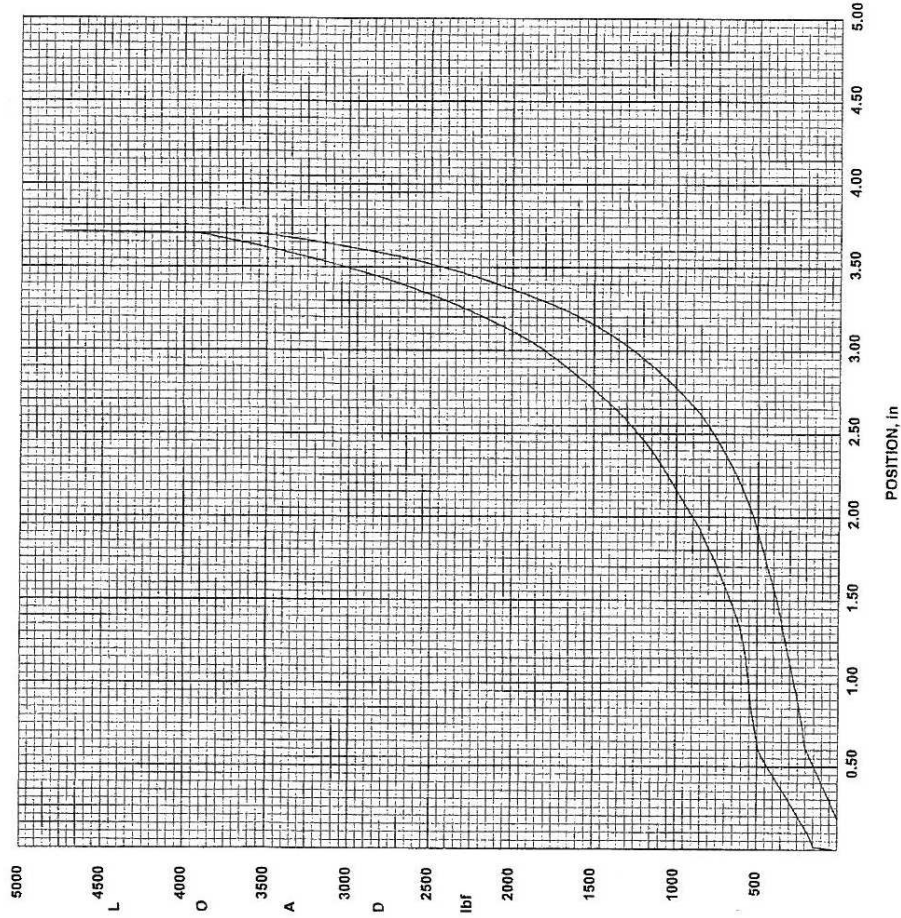
Part Number	269A3150-
Temperature	70 °F
Operator	Sherm
Test Setting	Damper 19-23
Load Speed, in/min	1.75
Unload Speed, in/min	-1.75
Test Date	03/01/2010
Serial No.:	S01 R U F W d
Dash #:	19
Yield Pt., lbf	151
Position@487lbf+, in:	0.59
Position@487lbf-, in:	1.86
Ultimate, lbf:	3916
Ult Distance, in:	3.7

Test Failed

Fig 6 Right forward damper load stroke chart

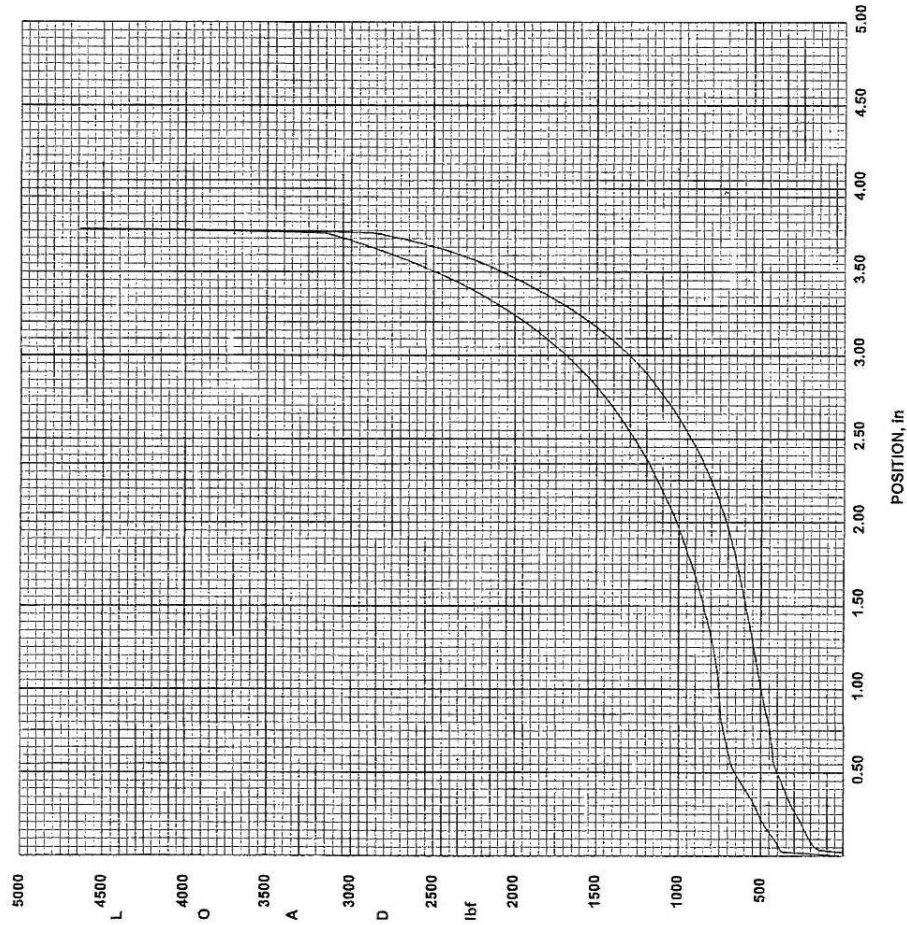
Serial No.: S02 L H F W 6
 Dash #: 19
 Yield Pt., lbf: 363
 Position@487lbf, in: 0.19
 Position@487lbf, in: 0.93
 Ultimate, lbf: 3144
 Ult Distance, in: 3.73

Test Failed

Fig 7 Left forward damper load stroke chart

The left forward damper full stroke load fell within the allowable limits. The intermediate reference points were exceeded. This condition is comparable to an aft damper with proper fluid and low gas charge.
