AIRCRAFT ACCIDENT REPORT AND EXECUTIVE SUMMARY

Reference:	CA18/2/3/8747	
Aircraft Registration	ZU-FDC	Date of Accident	02 February 2010	Time of Accident	0600Z	
Type of Aircraft	Windlass Aquilla (Microlight)		Type of Operation	Agricultural		
Pilot-in-command Licence Type		Commercial	Age	38	Licence Valid	Yes
Pilot-in-command Flying Experience		Total Flying Hours	1 715.50		Hours on Type	1 605.10
Last point of Departure		Ballito Microlight Aerodrome, KwaZulu-Natal				
Next point of Intended Landing		Ballito Microlight Aerodrome; KwaZulu-Natal				
Location of the Accident Site with Reference to Easily Defined Geographical Points (GPS readings if possible)						
SAXE Private farm approximately 4 km north-west of Ballito Microlight Aerodrome						
Meteorological Information		Surface Wind: SE/5kt ; Temperature 23°C; Visibility: CAVOK				
Number of People on Board	1 + 0	No. of People Injured	1	No. of People Killed	0	
Synopsis						
<p>On 2 February 2010 at approximately 0600Z, the pilot took off from Ballito Aerodrome with a load of 90 kg of chemicals in order to carry out a crop-spraying operation on a private farm (SAXE) north-west of Ballito Aerodrome.</p> <p>The pilot stated that altho

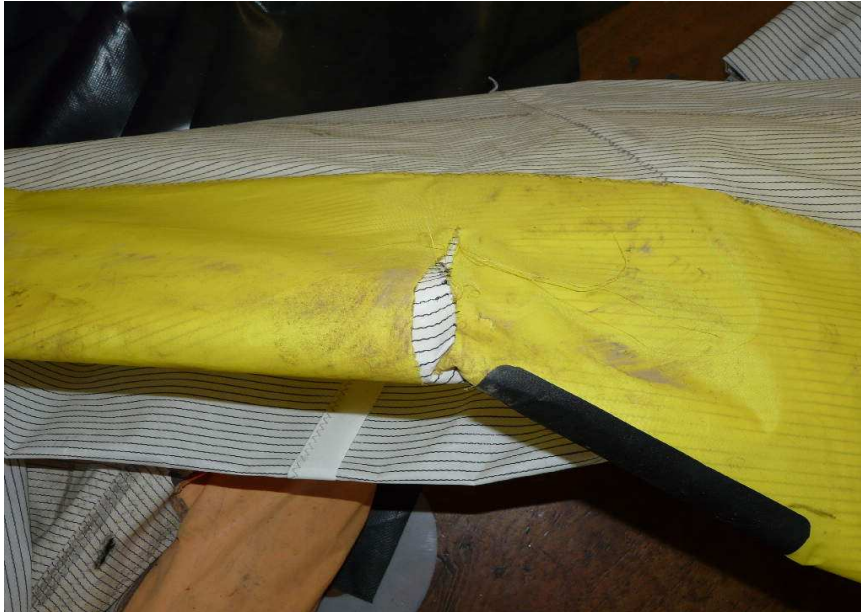
1.3.1 The aircraft sustained substantial damage to the landing gear structure, wings and propeller.

Figure 1: The wing, which was recovered to manufacturer

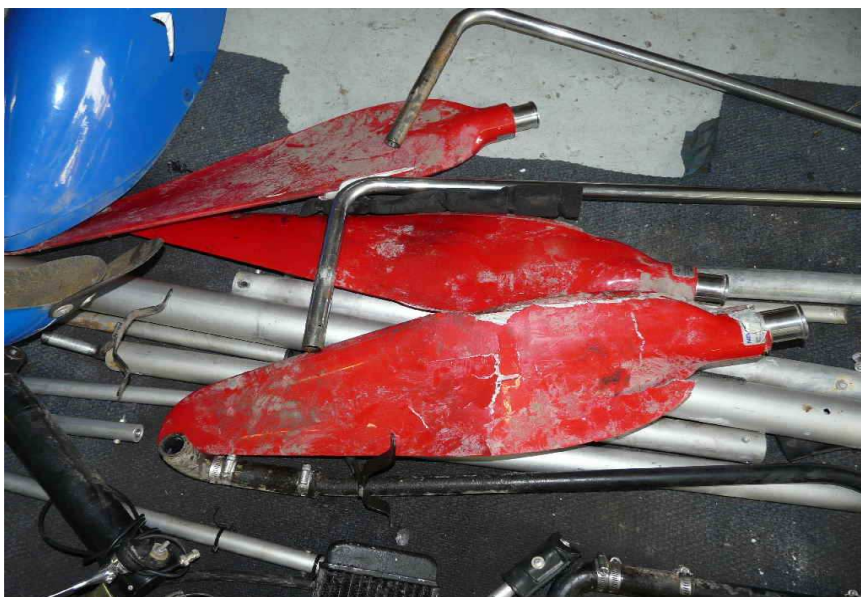
Figure 2 : The propeller blades and frames
