TAKE-OFF FROM TAXIWAY

Amsterdam Airport Schiphol
10 February 2010

The Hague, December 2011

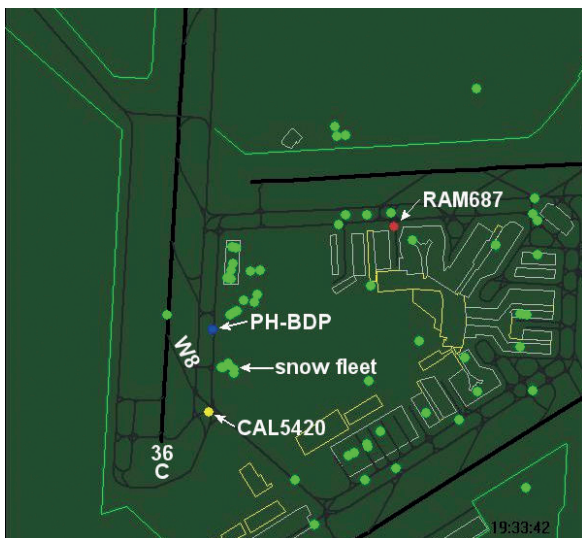
Figure 3: Traffic situation²⁸ on taxiways Alfa and Bravo near runway 36C at 20:33:42 (source: LVNL ground radar)

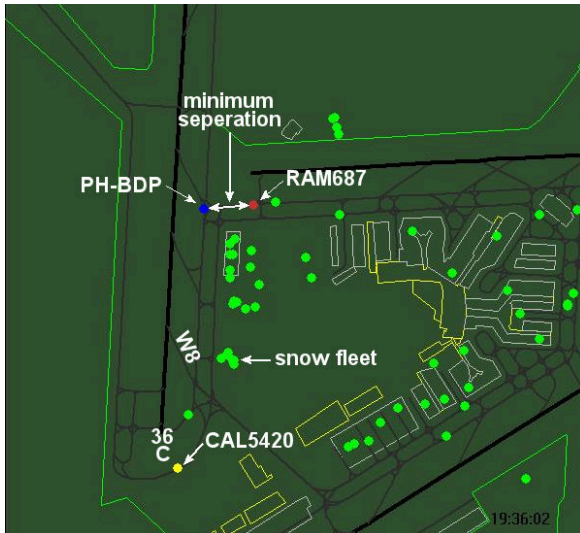
Figure 5: PH-BDP take-off from taxiway Bravo (source: LVNL ground radar)

According to FDR data, the aircraft started to accelerate for its take-off run at 20:35:22. Assistant 1 was looking at his ground radar screen and noticed the PH-BDP's unusually high speed on the taxiway. He pointed out to the runway controller that PH-BDP was taking off from the taxiway. According to their statements, the aircraft was located just south of Apron J at that time and was not in any immediate risk of collision. In view of PH-BDP's high speed, the runway controller decided to allow the aircraft to continue its take-off run. Other officers saw the aircraft lift off the ground just after assistant 1 had notified the runway controller.

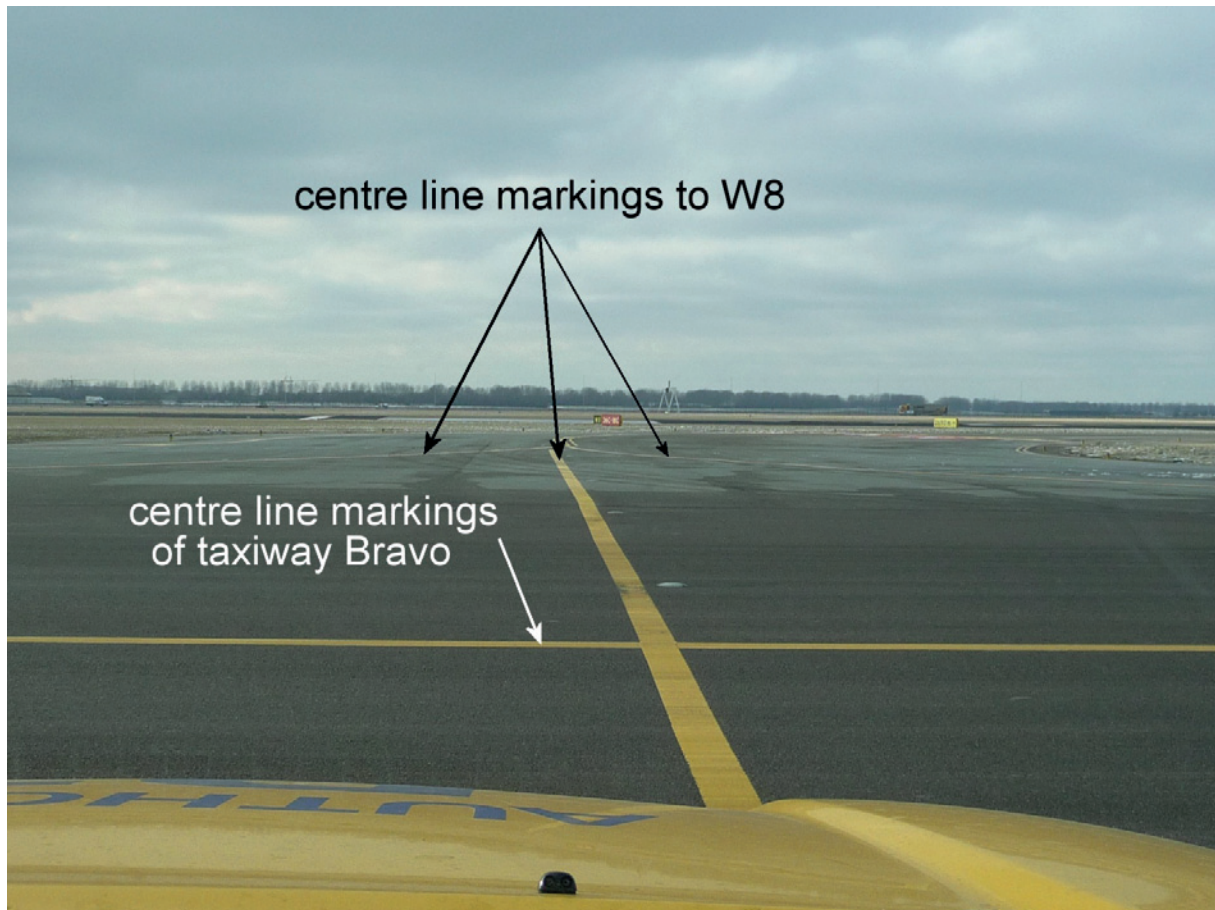
Figure 7: Yellow marking lines (centreline markings) during daylight on the intersection of interconnecting taxiway A25 with taxiway Bravo viewed into the direction of runway 36C.

The centre of a take-off or landing runway features a broken white line. The taxiways feature a continuous yellow line in the centre of the taxiway (see figure 7). This also applies to interconnecting taxiways such as A25 and entries W8, W9 and W10 to runway 36C. There usually is a clear difference between the white broken lines on a runway and the continuous yellow lines on taxiways. When it is dark, however, the yellow line cannot be clearly distinguished by the beam of a Boeing 737's taxi lights. In addition, the yellow lines could not be seen clearly because of the thin layer of snow on the taxiways, according to the crew on board flight CAL5420.

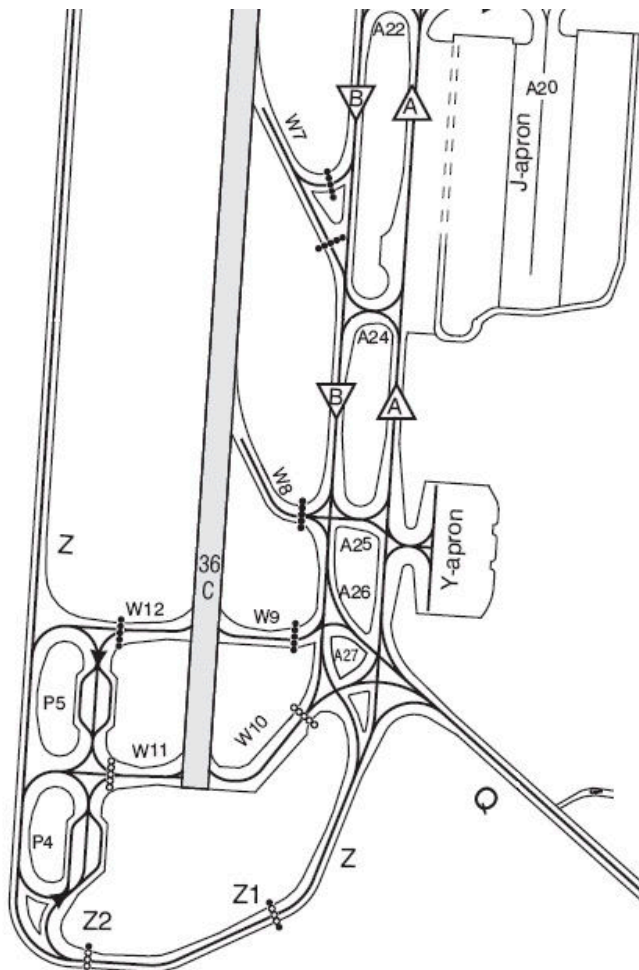
In addition, a taxiway junction is located near entries W9 and W10, which leads to these entries, to taxiways Zulu and Quebec and to taxiways Alfa and Bravo (see figure 9). The junction can cause confusion among flight deck crews as was the case with the crew on board CAL5420, who consequently taxied too far in order to turn into entry W10 safely. It has emerged that crews feel that at some locations the taxiway system, particularly at junctions like the ones near entries W9 and W10, has an unclear layout. This junction has therefore been identified as a hot spot and has been communicated as such to aeronautical personnel in the AIP.

Figure 9: Overview of the entries and layout of the taxiways near runway 36C (source: AIP)

As has previously emerged from incidents in other countries, the layout of parallel runways and taxiways involves the risk of runway confusion. At Amsterdam Airport Schiphol when taxiway Alfa is used the risk of runway confusion increases because taxiway Bravo can be confused with take-off runway 36C.

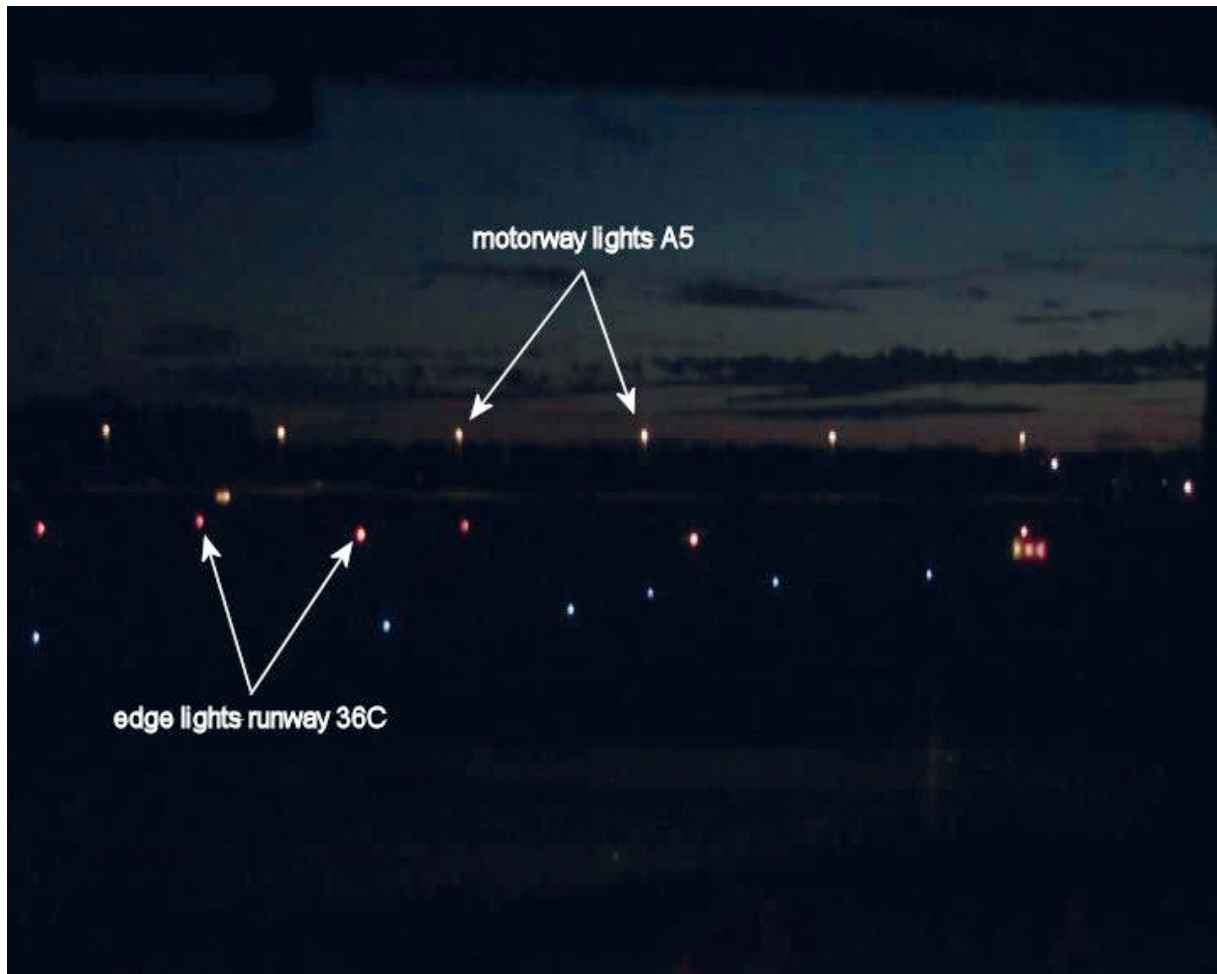
Footage was shot from a taxiing Boeing 737 outside the Uniform Daylight Period (UDP) for the purpose of determining aspects such as the visibility of runway 36C. Coming from taxiway Alfa and looking down interconnecting taxiway A25 to take-off runway 36C, it emerged that not only can the edge lights of the take-off runway indeed be seen but also the lights of a motorway in the background (see figure 10).

Since the depth of field cannot be seen when it is dark, the edge lights consequently form patterns with the lights in the background and they therefore cannot be clearly distinguished. The lighting on taxiway Bravo, on the other hand, is indeed clearly visible, as a result of which there is an increased risk that crews will confuse taxiway Bravo with take-off runway 36C.

Figure 10: Patterns of the edge lights on runway 36C and the lights of the A5 motorway

It can be established that the background lights at and surrounding the airport contribute to the factors of 'poor vision' and 'confusing lights' shown in figure 8 in respect of the visibility of the runway.

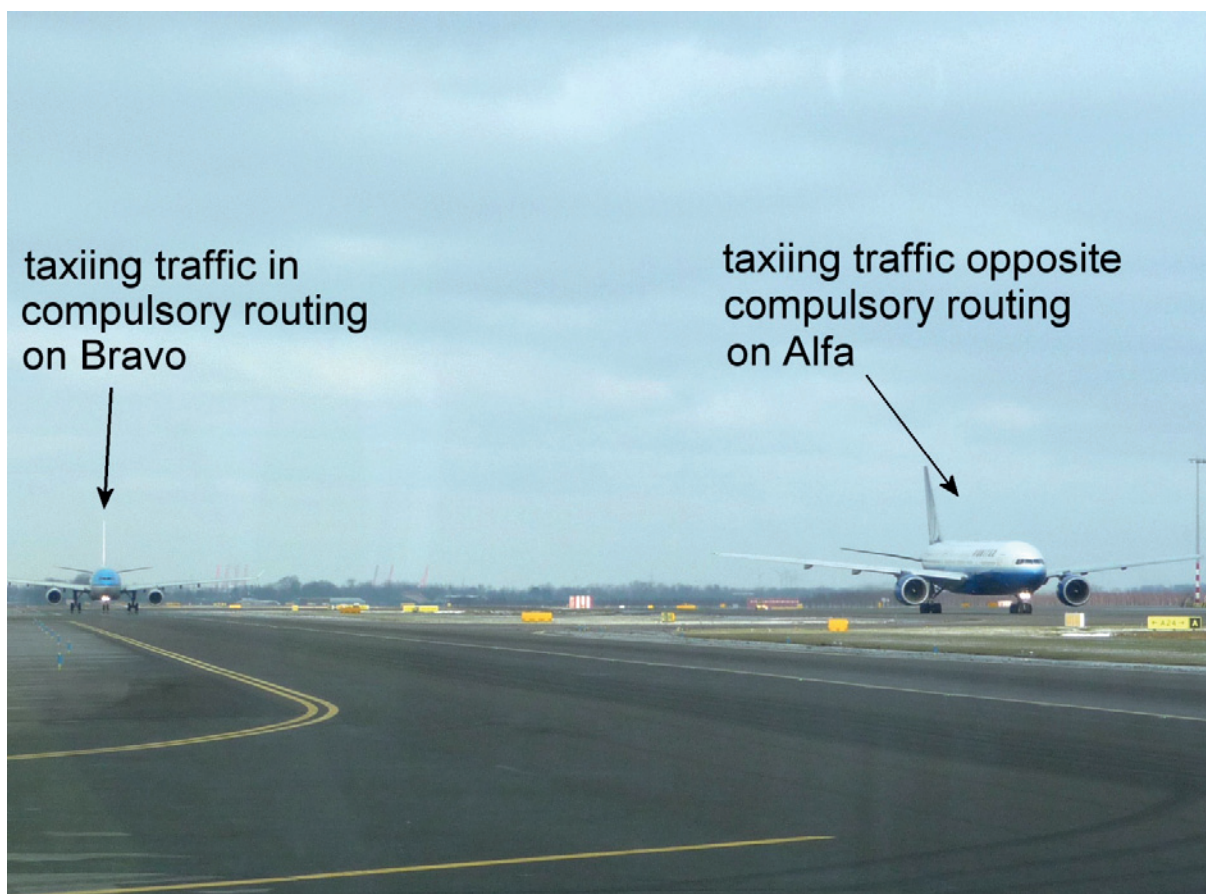
Figure 11: Traffic travelling on taxiways Alfa and Bravo in a southerly direction at Schiphol

Since apron Juliet, the de-icing apron, is located alongside taxiway Alfa, when using entry W10 of runway 36C, the most obvious taxi route to follow is taxiway Alfa in a southerly direction. The taxi routes that the CAL5420 and PH-BDP were instructed to follow were in accordance with the applicable procedures.⁴⁶ These procedures do not incorporate the safety measures in place to prevent aircraft from taxiing along the incorrect route. However, on the basis of their experience air traffic controllers do assess the traffic that they expressly wish to monitor. In that sense risks are weighed up.

The result of not taxiing in accordance with the specified – or standard - direction of travel is that the aircraft is required to cross a parallel taxiway for an intersection take-off. The risk of incidents occurring consequently increases. This also corresponds with the findings of the Flight Safety Foundation (see appendix L), who have stated that deviating from standard taxi routes and performing intersection take-offs may form contributing factors in the occurrence of runway confusion incidents. In respect of the situation at Amsterdam Airport Schiphol it has not been established – and it is therefore unclear - how these risks are controlled.
