AIRCRAFT ACCIDENT REPORT AND EXECUTIVE SUMMARY

Reference:	CA18/2/3/8758	
Aircraft Registration	ZS-MRD	Date of Accident	16 February 2010		Time of Accident	1224Z
Type of Aircraft	Cessna 177 RG		Type of Operation	Private		
Pilot-in-command Licence Type		Private Pilot Aeroplane	Age	41	Licence Valid	Yes
Pilot-in-command Flying Experience		Total Flying Hours	2 127.4		Hours on Type	12.7
Last point of departure		Lanseria Aerodrome (FALA)				
Next point of intended landing		Heidelberg Aerodrome (FAHG)				
Location of the accident site with reference to easily defined geographical points (GPS readings if possible)						
Runway 06R at Lanseria Aerodrome (FALA)						
Meteorological Information		Fine weather prevailed. Temp: 27°C; Wind speed: light and variable; Visibility: CAVOK				
Number of people on board	1 + 0	No. of people injured	0	No. of people killed	0	
Synopsis						
<p>The pilot was engaged in a private flight from Lanseria aerodrome to Heidelberg aerodrome. During the approach for landing at Heidelberg, the undercarriage failed to extend. The pilot decided to fly back to Lanseria where he performed a wheels-up landing on runway 06 Right. The aircraft skidded for approximately 100 m

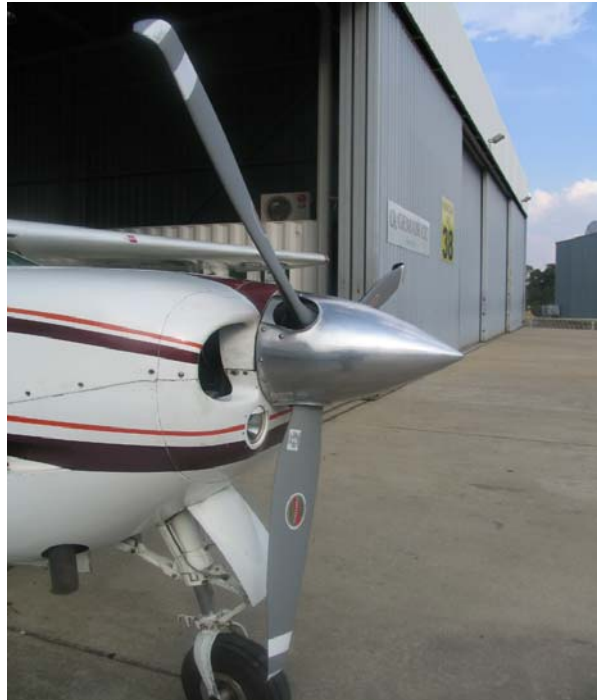
1.3.1 The propeller tips were bent, and the lower fuselage antenna and sheet metal on the belly were slight damaged.

Figure 1. The bent propeller tips.

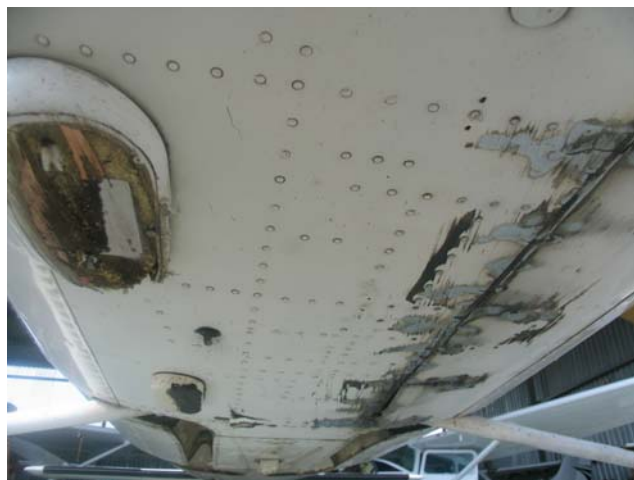
Figure 2: Damage to the belly and antenna.

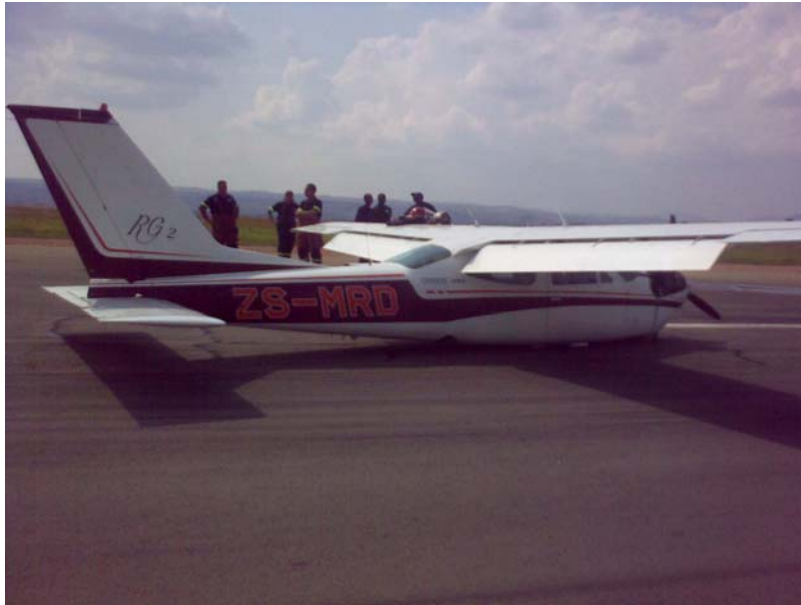
1.12.1 The pilot landed in a wheels-up configuration. The aircraft skidded for approximately 100 m before coming to a halt. Damage was sustained to the belly, propeller blade tips and bottom fuselage antenna.

Figure 3. Aircraft on runway 06R/24L after belly landing.

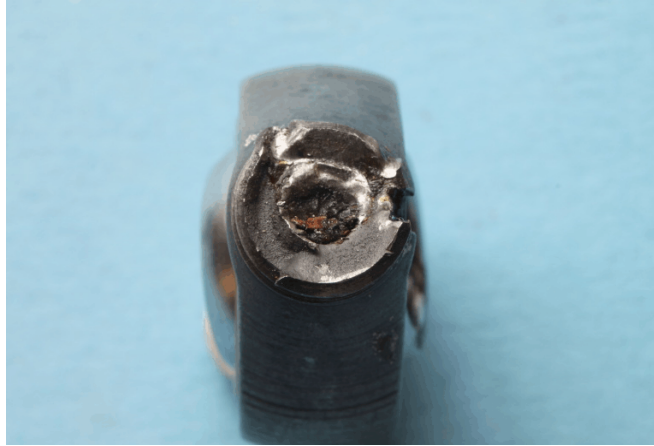
1.16.2 The rod-end had broken in the first thread adjacent to the ball housing (see Figure 4). On close examination, it was determined that the fracture surface was of the ductile overload type and had initiated in a thread root (see Figures 4 and 5). It was noted that the threaded half of the fracture surface was severely battered (see

Figure 4. The ball-joint end fracture surface showing ductile overload.

1.16.3 It is believed that this ball joint failed due to dynamic overload when the aircraft landed on a previous occasion without the undercarriage being fully extended. The battered condition of the one fracture surface supports this supposition.

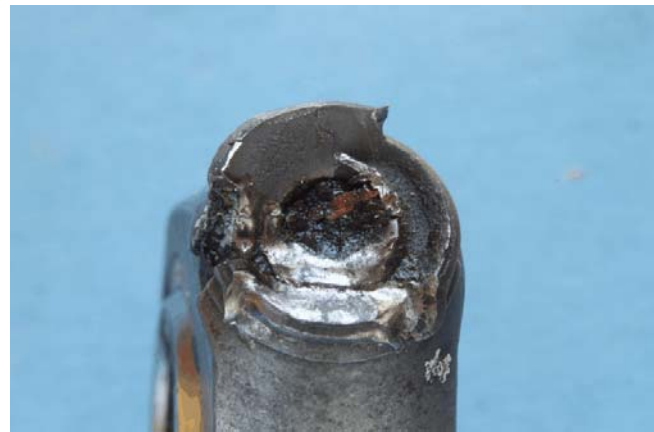
Figure 5. Another view of the ball-joint end fracture surface.

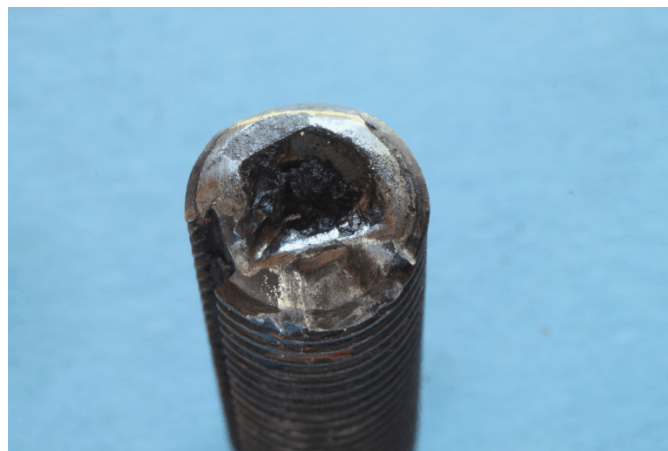
Figure 6. The threaded end of the fracture showing severe battering.

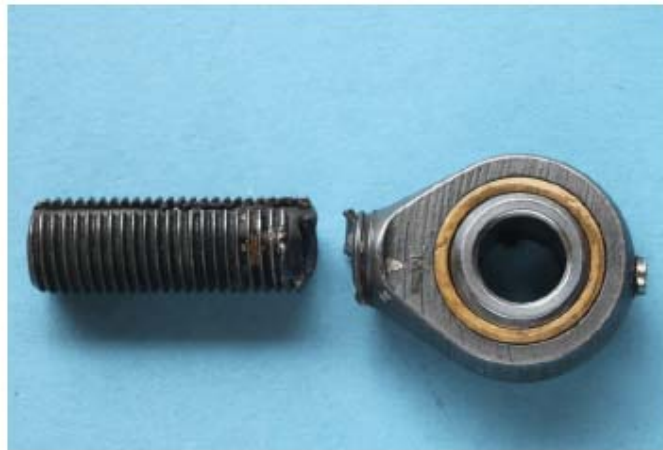
The rod end had broken in the first thread adjacent to the ball housing, figure 1.

Figure 1. The rod-end as submitted, showing the location of fracture.

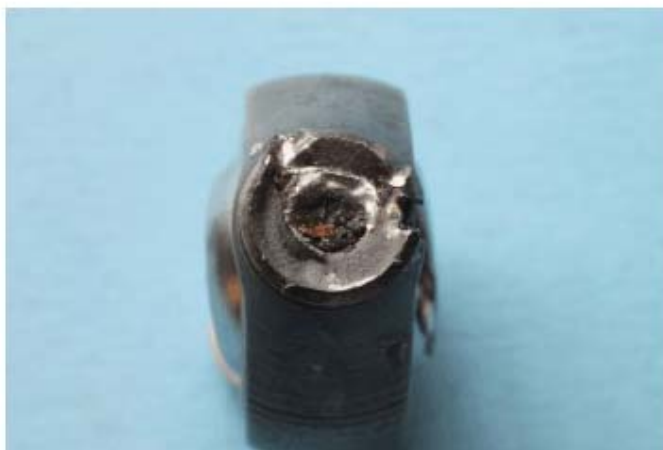
On close examination, it was determined that the fracture surface was of the ductile overload type, figures 2 & 3, initiating in a thread root. It was noted that the threaded half of the fracture surface was severely battered, figure 4.

It is considered that this ball joint failed by dynamic overload upon impact suffered by the aircraft when it was landed without the undercarriage extended. The battered condition of the one fracture surface supports this.

Figure 2. The ball-joint end fracture surface showing only ductile overload features.

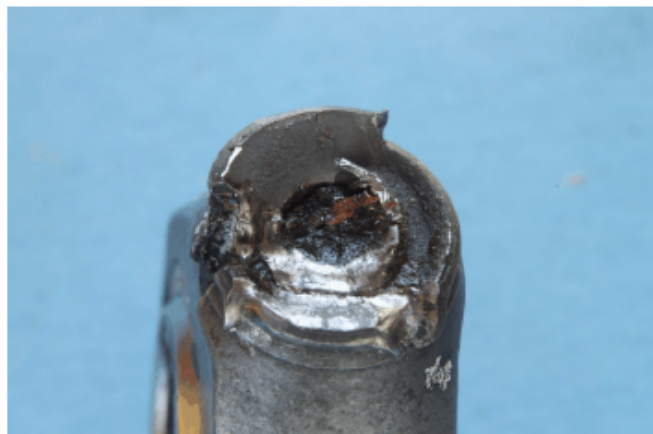
Figure 3. The ball-joint end fracture surface showing only ductile overload features.

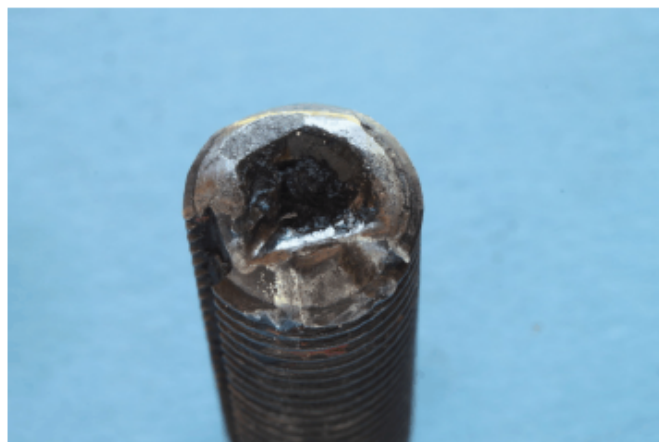
Figure 4. The threaded end of the fracture showing severe battering.

It is therefore considered that this failure is consequential to another failure, that of the undercarriage deployment mechanism. It is recommended that the system be further examined to determine the cause of failure of the system to fully deploy to the down and locked condition before landing.
