AIRCRAFT ACCIDENT REPORT AND EXECUTIVE SUMMARY

Reference:	CA18/2/3/8757	
Aircraft Registration	ZS-HAI	Date of Accident	16 February 2010		Time of Accident	0640Z
Type of Aircraft	Robinson R22 Beta		Type of Operation	Training		
Pilot-in-command Licence Type		Commercial	Age	29	Licence Valid	Yes
Pilot-in-command Flying Experience		Total Flying Hours	2764,7		Hours on Type	62,4
Last point of departure		Rand Aerodrome (FAGM)				
Next point of intended landing		Rand Aerodrome (FAGM)				
Location of the accident site with reference to easily defined geographical points (GPS readings if possible)						
Rand Aerodrome (GPS position South 26° 14' 59.7" East 028° 08' 49.9")						
Meteorological Information		Surface wind; 360°/8kts; temperature; 20 °C; visibility; CAVOK.				
Number of people on board	1 + 1	No. of people injured	1 + 0	No. of people killed	0	
Synopsis						
<p>A flight instructor accompanied by a student pilot took off from Rand Aerodrome (FAGM) on visual flight rules (VFR) training. The training included autorotation emergency sequences in all phases of flight. During the autorotation exercise at a height of approximately 500 feet above ground level (AGL) the main rotor rpm decay

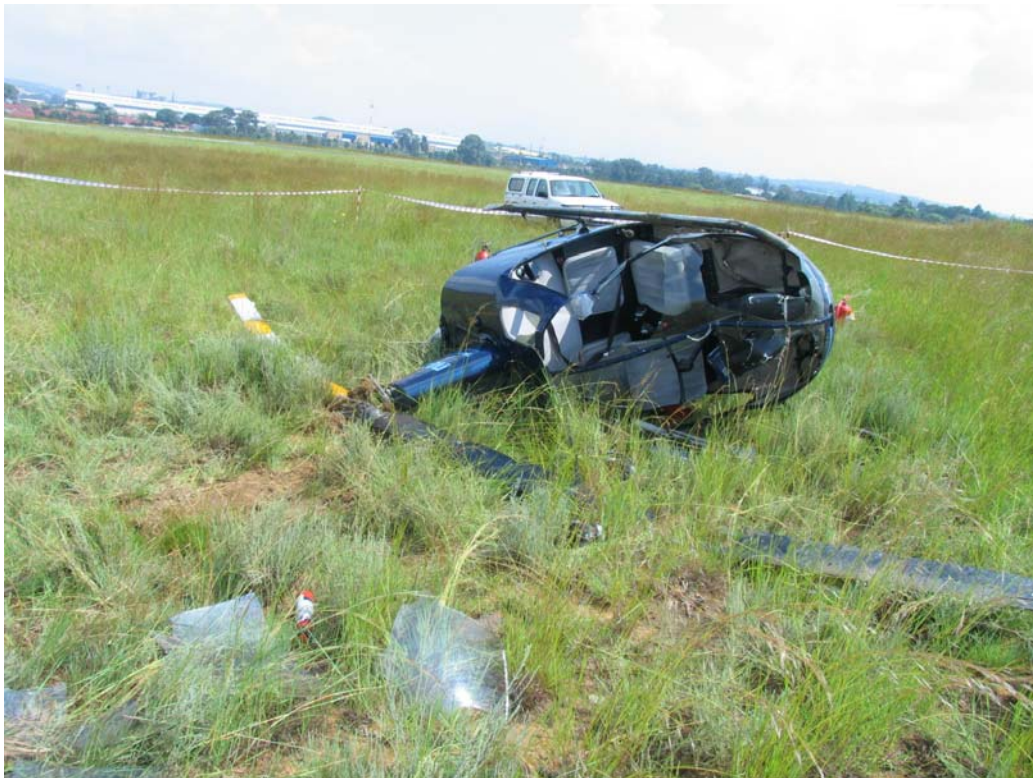
1.3.1 The helicopter sustained substantial damage to the main rotor blades, tail boom and skid.

Photo 1: Wreckage of the aircraft

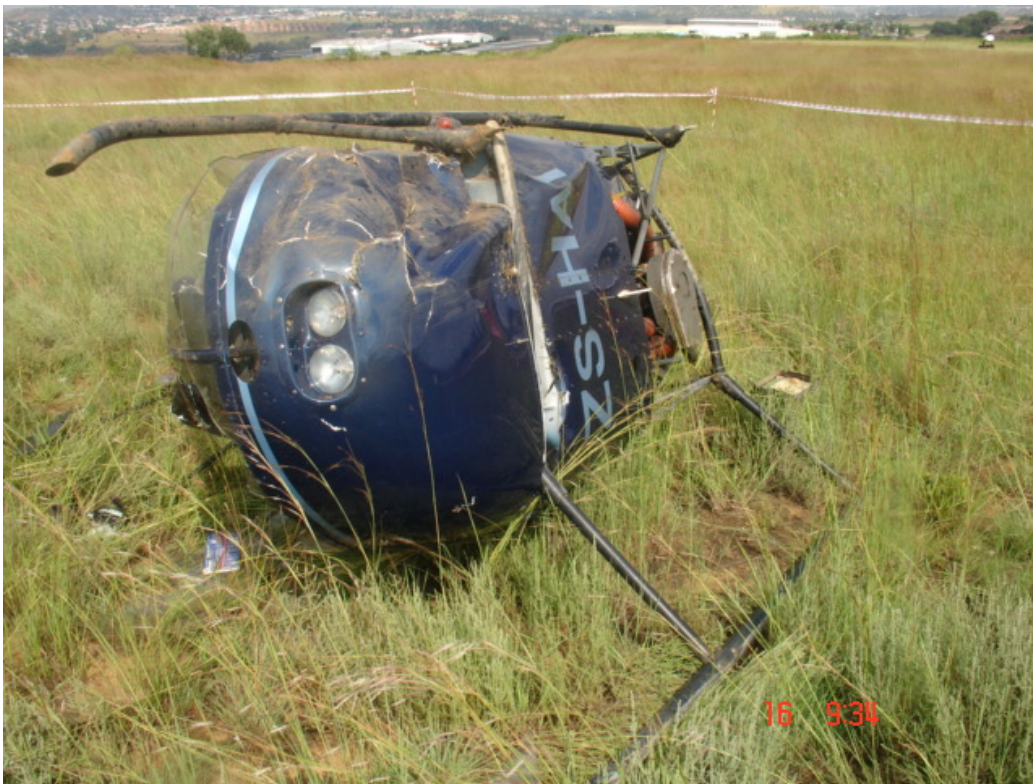
1.12.1 The flight instructor and the student pilot were executing an autorotation on downwind, and while turning into base leg for final, the helicopter's main rotor rpm decayed. During the recovery from the situation, the student pulled the collective pitch lever, which exacerbated the situation. The left skid struck the ground and the aircraft rolled on its right hand side. The helicopter sustained substantial damage to the main rotor blades, tail boom and skid. During the onsite investigation there were no abnormalities of the controls.

Figure 1: indicate the wreckage of the aircraft
