## AIRCRAFT ACCIDENT REPORT AND EXECUTIVE SUMMARY

Reference:	CA18/2/3/8761	
<b>Aircraft Registration</b>	ZS-PTC	<b>Date of Accident</b>	20 February 2010		<b>Time of Accident</b>	1055Z
<b>Type of Aircraft</b>	Beech Baron E55		<b>Type of Operation</b>	Private		
<b>Pilot-in-command Licence Type</b>	Private		<b>Age</b>	53	<b>Licence Valid</b>	Yes
<b>Pilot-in-command Flying Experience</b>	Total Flying Hours	± 9792.3		<b>Hours on Type</b>	± 4093.13	
<b>Last point of departure</b>	Hoopstad aerodrome (FAHP) – Free State					
<b>Next point of intended landing</b>	Bloemfontein/New Tempe (FATP) – Free State					
<b>Location of the accident site with reference to easily defined geographical points (GPS readings if possible)</b>						
On a mealiefield, approx 500m north of Hoopstad aerodrome – GPS position: S27°49,086', E025°55,192'; Elev = 4110 ft AMSL						
<b>Meteorological Information</b>	Wind: 050° @ 07 knots ; Temperature: 29°C; CAVOK					
<b>Number of people on board</b>	1+0	<b>No. of people injured</b>	0	<b>No. of people killed</b>	1

## AIRCRAFT ACCIDENT REPORT

**Name of Owner/Operator** : Value Port Transport CC.  
**Manufacturer** : Beech Aircraft Corporation  
**Model** : Baron E5

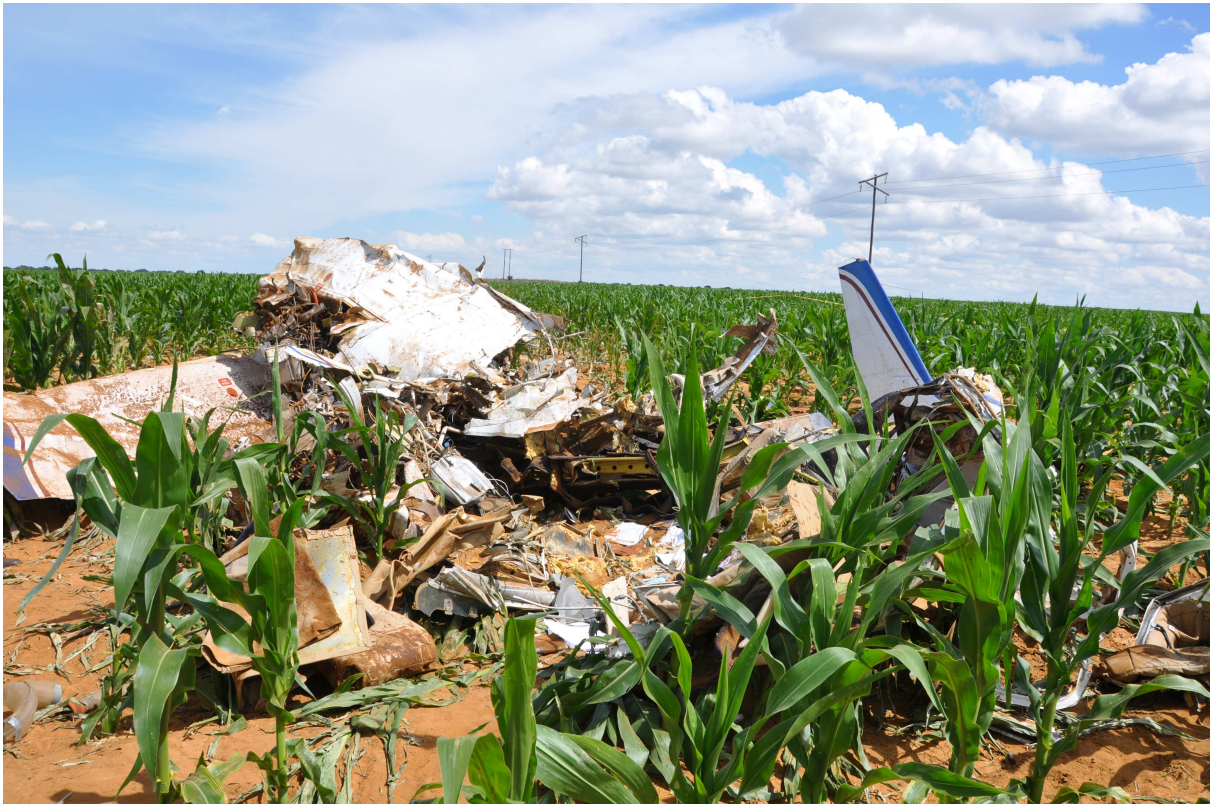
1.3.1. The aircraft was destroyed during the accident sequence.

Photo 1: Showing damage to aircraft

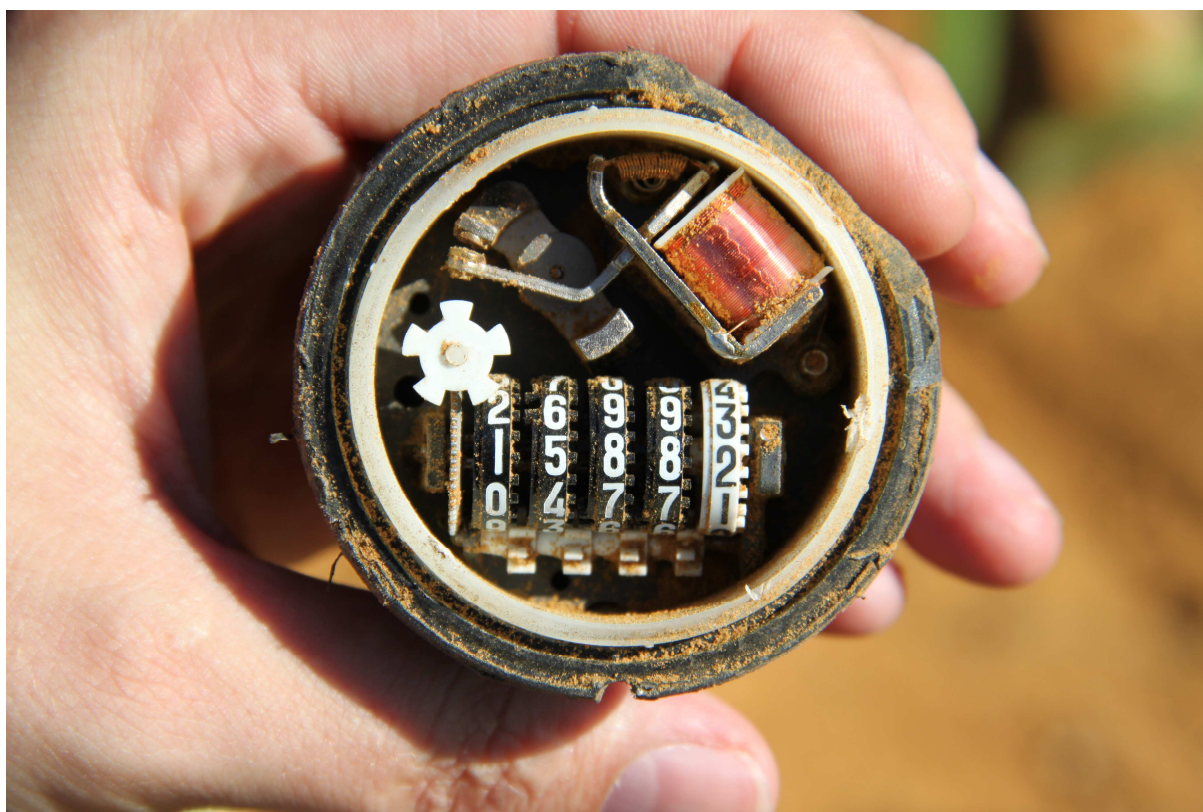
**Note:** The hours as shown in the tables above are estimates drawn from available information in relation to the Hobbs meter readings. According to the available records of the aircraft's flight folio (log book), on 20 February 2010 before the flight from FATP to FAHP, the Hobbs meter reading was 1587.2 hours. The Hobbs meter reading was also recorded to be 1516.0 hours during the last MPI on 24 July 2009. The Hobbs meter was found reading 1588.2 hours on the accident site (see photo 2 below).

Photo 2: Hobbs meter reading as found on accident site

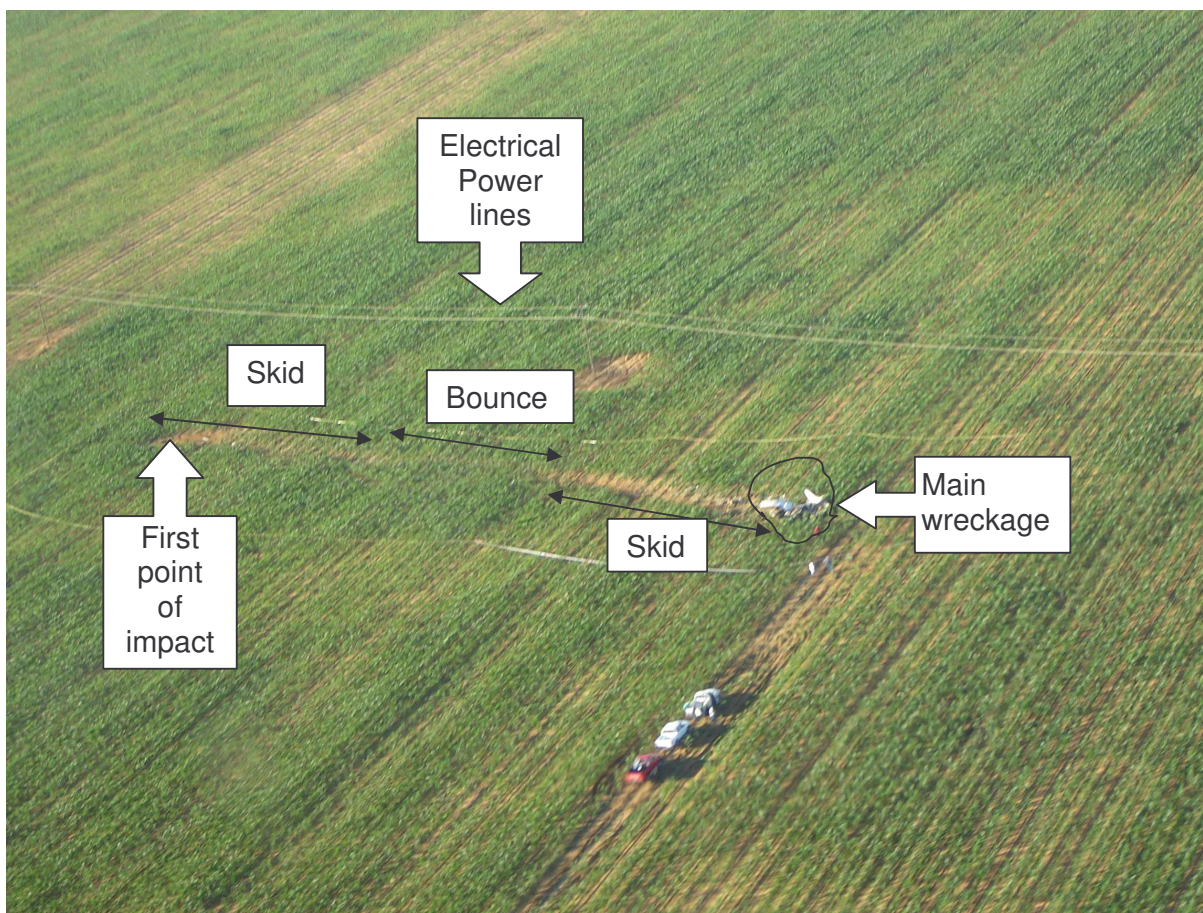
1.12.1. The aircraft was seen losing height after it was corrected from what looked like a wing over. It subsequently impacted the ground at an approximate 20 degrees nose down, left wing low attitude.

1.12.2. After the aircraft impacted the ground, it skidded for approximately 43 meters, then it bounced for approximately 25 meters and skidded approximately a further 38 meters, before it came to rest approximately 106 meters from the first point of impact. Evidence of fuel spillage was observed approximately 8 meters from the first point of impact.

1.12.3. Except for the propellers which were found approximately 17 and 44 meters from the main wreckage respectively, the debris were semi-localised to the accident site, most of which was found within 50 meter radius to the main wreckage.

Photo 3: Showing impact marks and main wreckage.
