AIRCRAFT ACCIDENT REPORT AND EXECUTIVE SUMMARY

Reference:	CA18/2/3/8770	
Aircraft Registration	ZU-KKW	Date of Accident	13 March 2010		Time of Accident	1525Z
Type of Aircraft	Quick R (microlight)		Type of Operation		Private	
Pilot-in-command Licence Type		Microlight	Age	58	Licence Valid	Yes
Pilot-in-command Flying Experience		Total Flying Hours	719,0		Hours on Type	23,0
Last point of departure		Rietfontein private airstrip				
Next point of intended landing		Rietfontein private airstrip				
Location of the accident site with reference to easily defined geographical points (GPS readings if possible)						
Aeroden private airstrip, Magaliesberg, North West Province						
Meteorological Information		Surface wind: S/W at 20 kt; Visibility: CAVOK				
Number of people on board	1 + 1	No. of people injured	0	No. of people killed	0	
Synopsis						
<p>On 13 March 2010, the pilot, accompanied by a passenger, took off from Rietfontein private airstrip on a private flight with the intention of returning to Rietfontein. During the flight, the weather conditions became unfavourable, and the pilot elected to execute a precautionary landing at Aeroden private airstrip. Just before touchdown, wind s

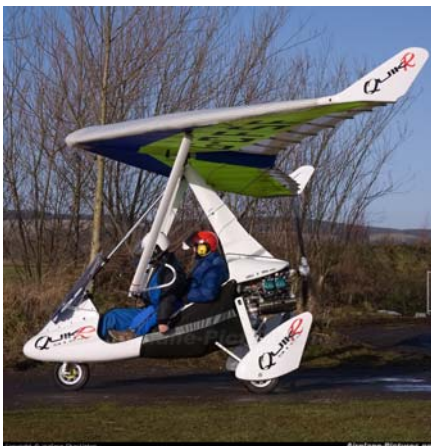
1.3.1 The nose gear and right wing were substantially damaged.

1.12.1 The microlight approached the airfield from the north in a landing configuration. Just before touchdown, wind shear caused the right wing and nose to drop. The nosewheel hit the ground hard, and the aircraft veered to the right of the runway.

Figure 1. The Quick R microlight.
