AIRCRAFT ACCIDENT REPORT AND EXECUTIVE SUMMARY

Reference:	C A18/2/3/8769	
Aircraft Registration	ZU-BUH	Date of Accident	13 March 2010		Time of Accident	0630Z
Type of Aircraft	Windlass Trike		Type of Operation		Private	
Pilot-in-command Licence Type		Microlight	Age	52	Licence Valid	Yes
Pilot-in-command Flying Experience		Total Flying Hours	129,83		Hours on Type	19,5
Last point of departure		Microland Aerodrome (FABA)				
Next point of intended landing		Microland Aerodrome (FABA)				
Location of the accident site with reference to easily defined geographical points (GPS readings if possible)						
Microland Aerodrome at GPS coordinates S25° 58' 628" E028° 23' 335"						
Meteorological Information						
Number of people on board	1 + 1	No. of people injured	1	No. of people killed	0	
Synopsis						
<p>The pilot, accompanied by a passenger, took off from Microland aerodrome (FABA) on a pleasure flight. The microlight failed to gain sufficient altitude after takeoff, and the pilot turned to the left of the runway to avoid power cables ahead. During the turn, the airspeed decayed and the aircraft stalled and crashed.</p> <p>The pilot sustained serious injuries while the passenger was unhu

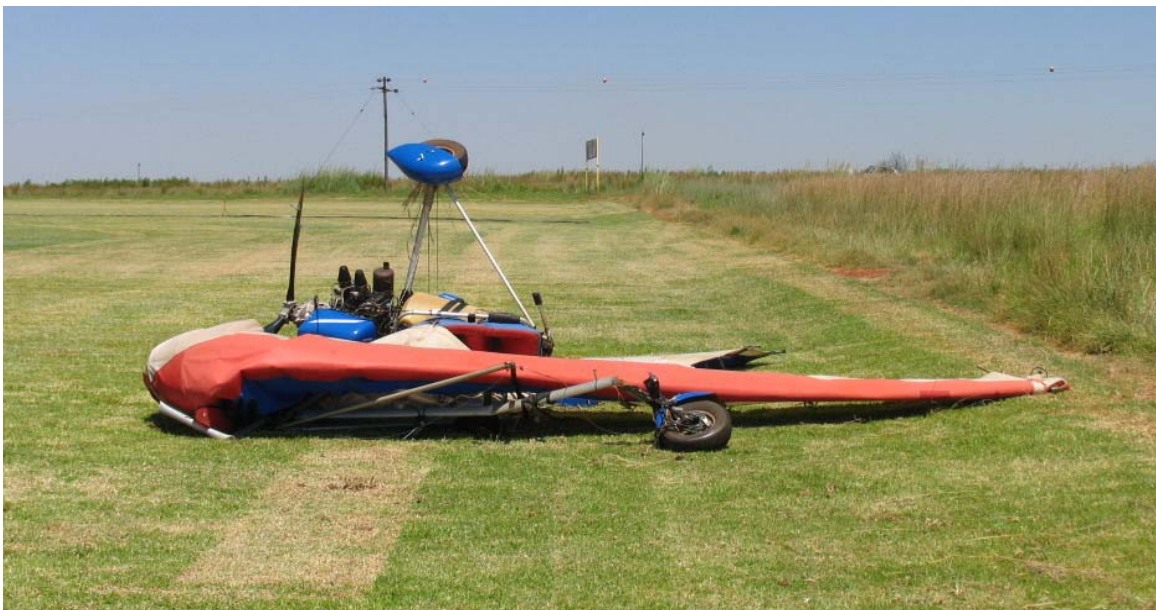
1.3.1 The aircraft sustained substantial damage to the wing and propeller, and the profile tube collapsed on impact.

Figure 1. Wreckage of the aircraft.

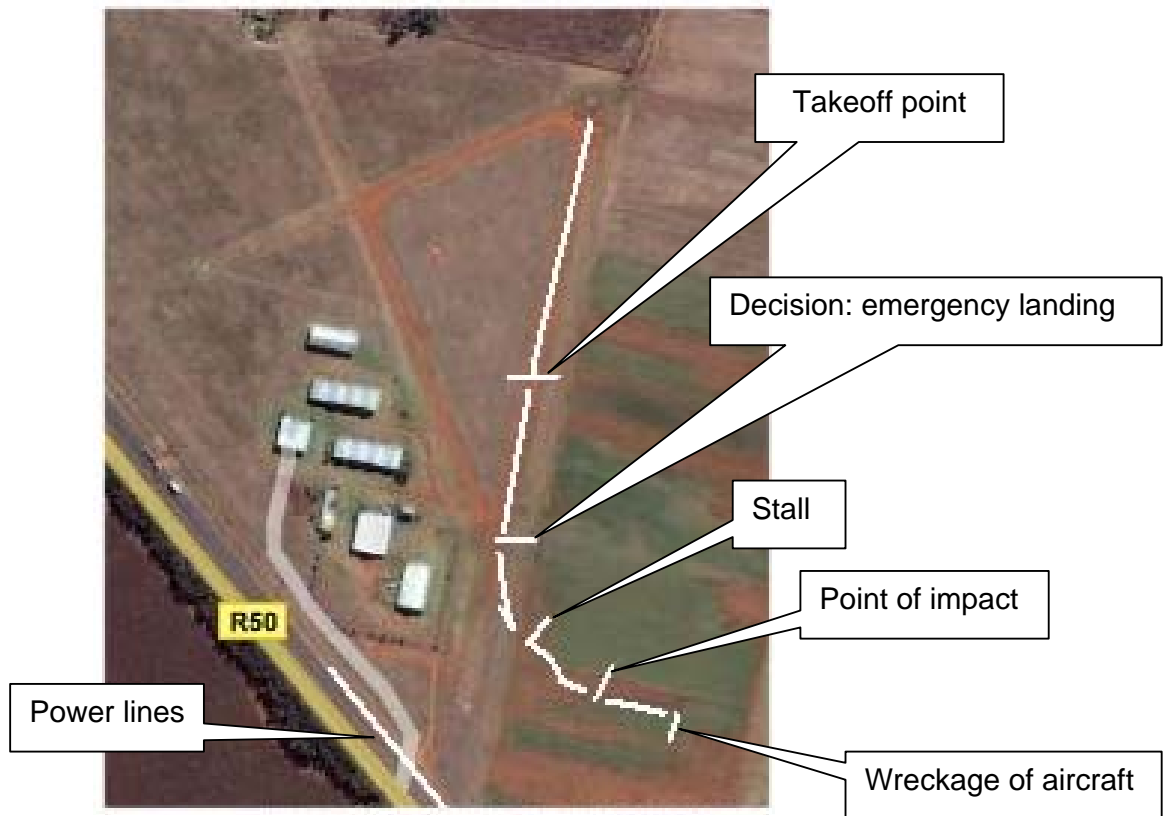
1.12.1 The pilot took off but the aircraft failed to gain altitude. He turned to the left of the runway as there were power lines ahead, approximately 200 m from the end of the runway. The speed decayed and the left wing hit the ground and collapsed, enfolding the cart. The aircraft then rolled over onto its right side. The instrument pod became separated from the microlight as a result of the impact.

Figure 2. The airport and sequence of events.

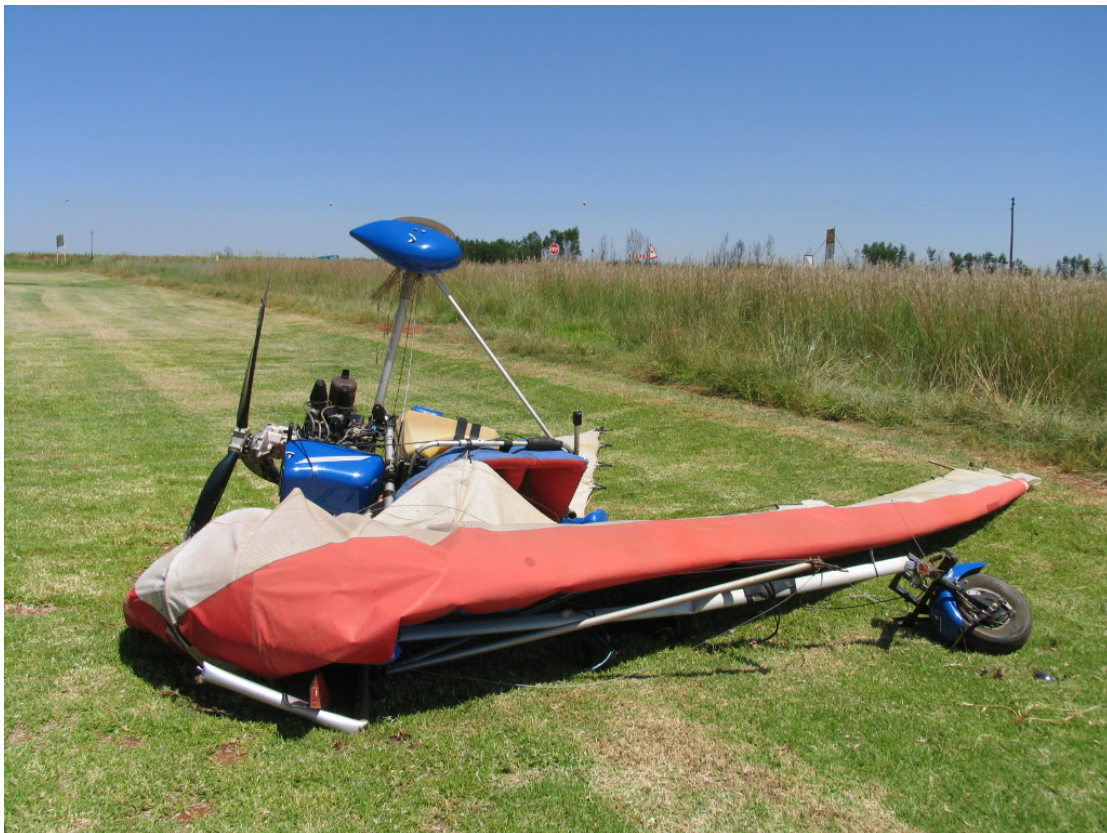
Figure 3. Another view of the damaged microlight.
