AIR ACCIDENT INVESTIGATION

ACCIDENT REPORT

PIPER PA 28-235 REGISTRATION 5Y-BGG

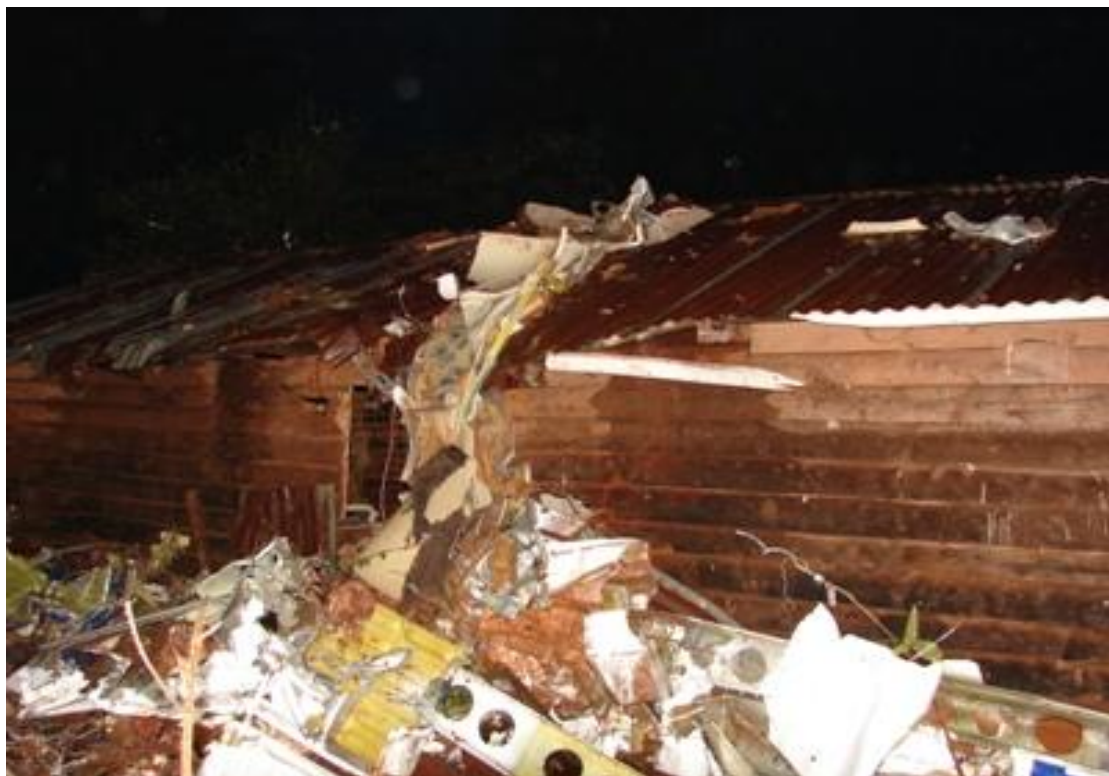
As shown in the wreckage photo above, the aircraft was completely destroyed on impact to the ground before the wreckage and debris scattered, much of which were restrained by the wooden house structure. There were some debris on the iron sheet roof of the house while some were found scattered within the compound within a radius distance of 40m from the point of impact with the ground.

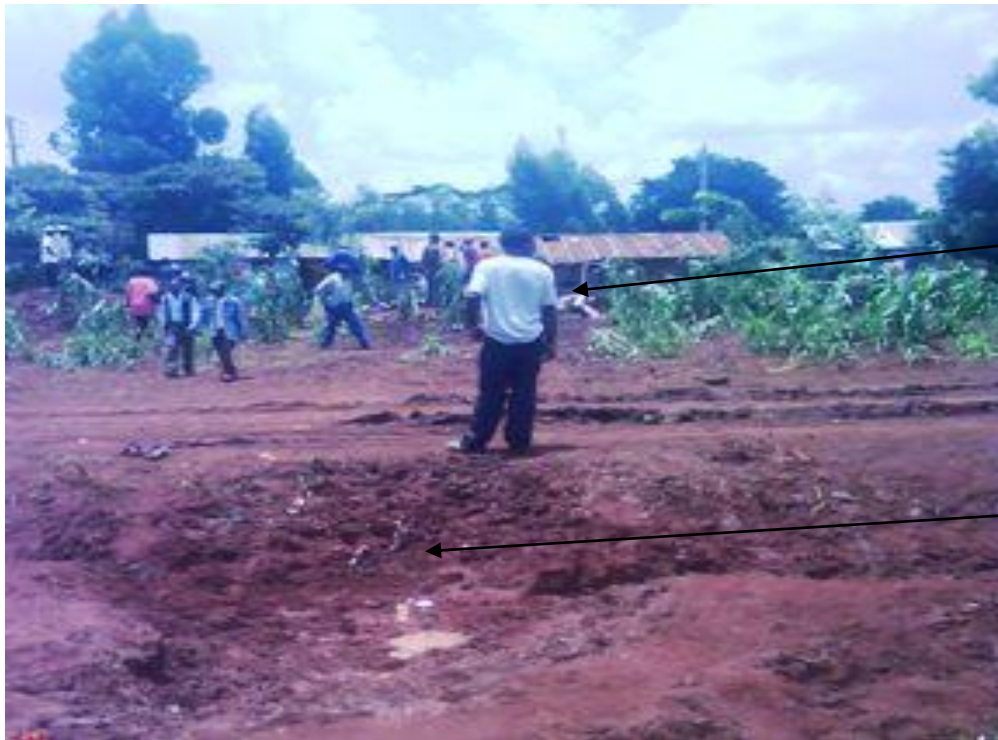
Photo showing point of impact with the ground

Wreckage position

Impact spot

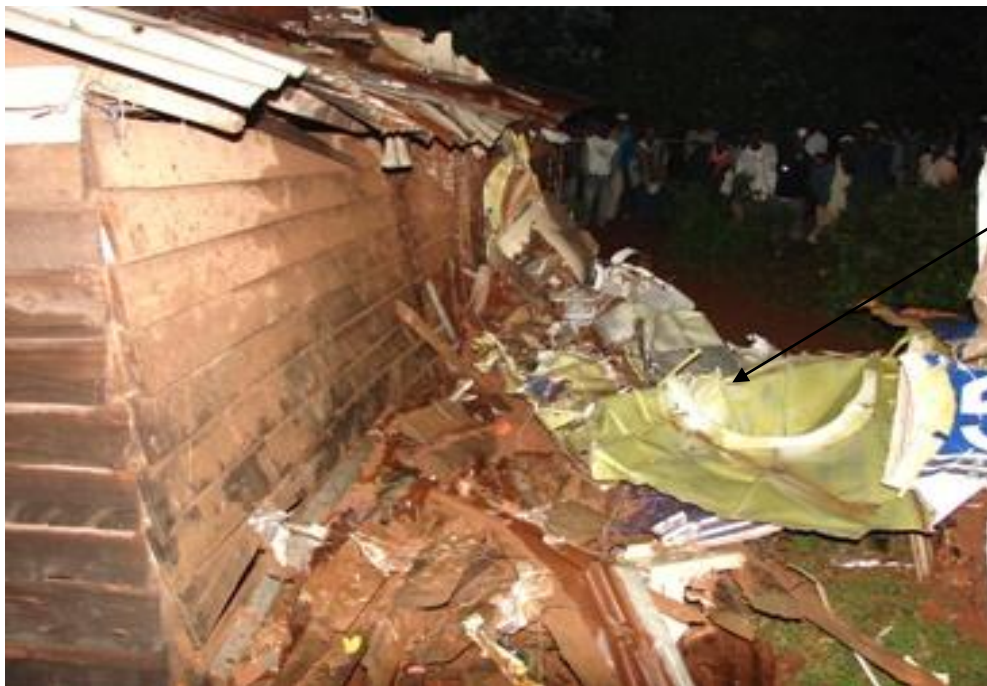
Photo showing wreckage from the left side of the wooden house.

wreckage
