AIRCRAFT ACCIDENT REPORT AND EXECUTIVE SUMMARY

Reference:	CA18/2/3/8777	
Aircraft Registration	ZS-SCS	Date of accident	10 April 2010		Time of Accident	0730Z
Type of Aircraft	Robinson R22 Beta		Type of Operation		Training	
Pilot-in-command Licence Type		Commercial	Age	25	Licence Valid	Yes
Pilot-in-command Flying Experience		Total Flying Hours	2015.6		Hours on Type	870
Last point of departure		Cape Town international aerodrome - FACT (Western Cape province).				
Next point of intended landing		Cape Town international aerodrome - FACT (Western Cape province).				
Location of the accident site with reference to easily defined geographical points (GPS readings if possible)						
At the helipad at GPS position determined as S33° 59. 07' E18° 36.13'. Elevation 151 Feet AMSL.						
Meteorological Information		Clear skies: Visibility 10 km.				
Number of people on board	1 + 1	No. of people injured	0	No. of people killed	0	
Synopsis						
<p>The certified flight instructor accompanied by a student pilot embarked on a training flight under Visual Flight Rules (VFR) from Cape Town international aerodrome (FACT) with the intention to return to the same aerodrome. The helicopter was refuelled b

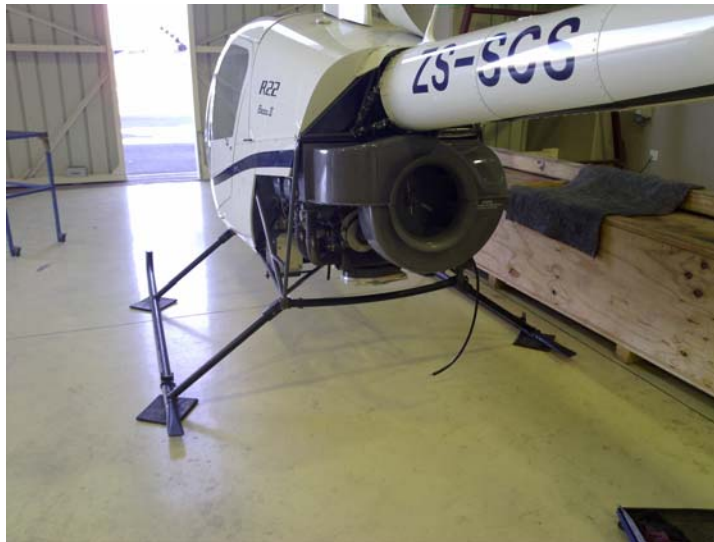
NB: The forward flex plate on the gearbox sheared off. The drive shaft ripped open both main and auxiliary fuel tanks, pulling all the wires off and out of loom and off the frame. The aft flex plate on the free wheel bent, but did not break. The clutch was fully engaged and was bent to one side. Both V-belts climbed off the pulleys and sheared. The sheave alignment rod was bent and the rod end pulled off the bearing. The aft cross tube was bent from hard landing. Below is the helicopter after it was recovered to the facility.

Figure 1: View of the helicopter in the hanger after recovery

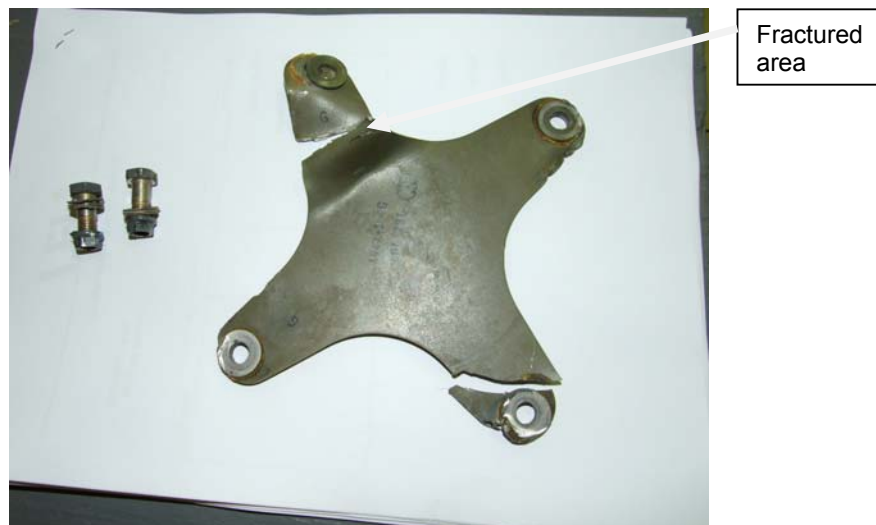
1.16.1 With the assistance of maintenance personnel, the helicopter was recovered to the hangar, where it was inspected for any possible mechanical failure or malfunction that could have contributed to the accident. During the inspection, it was noted that the crack initiated under the bonded washers and extended outwards until it failed in fatigue resulting in the following.

Figure 2: Fractured forward flex plate

- 2.4 It was evident that fatigue cracking in the forward flex plate started at the bolt hole and propagated under the washers of the bolted joint towards the edge of the flex plate. It was also evident from the fracture surface features that crack growth had occurred over a number of flights prior to the accident flight. The reliability of a general visual inspection (for example, pre-flight inspections) is affected by lighting, the ability to get close to the component (proximity), and dirt and dust from the operating environment. Reliable detection of a specific defect would require a directed detailed inspection.

- 4.1.1 In consultation with the Federal Aviation Administration of the USA, review the need for the defining of a service life of the forward flex plates as installed on Robinson R22 series helicopters;
- 4.1.2 In consultation with the Federal Aviation Administration of the USA, review the need for the defining of an inspection interval of the forward flex plates as installed on Robinson R22 series helicopters.

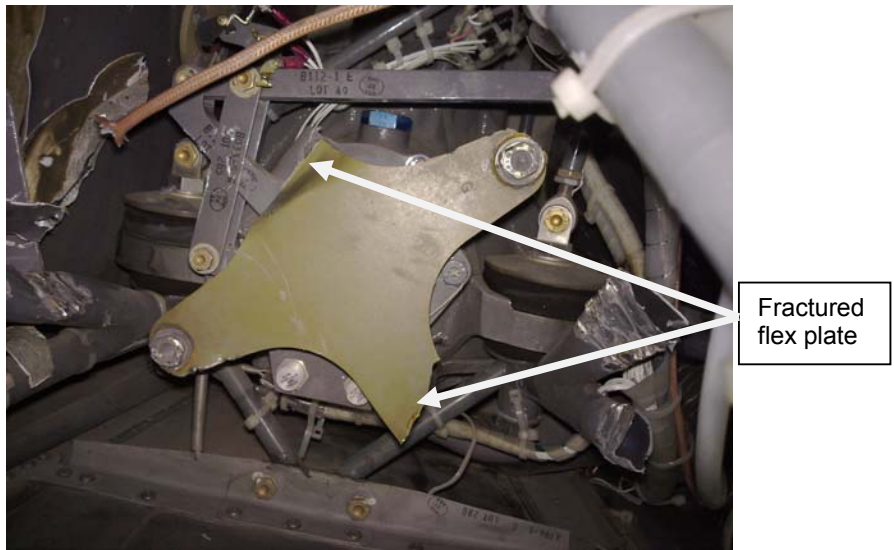
Figure 3: View of failed forward flex plate (both sides)

- ❖ Expert metallurgical examination revealed that the forward flex plate failed in fatigue on takeoff, resulting in extensive damage.

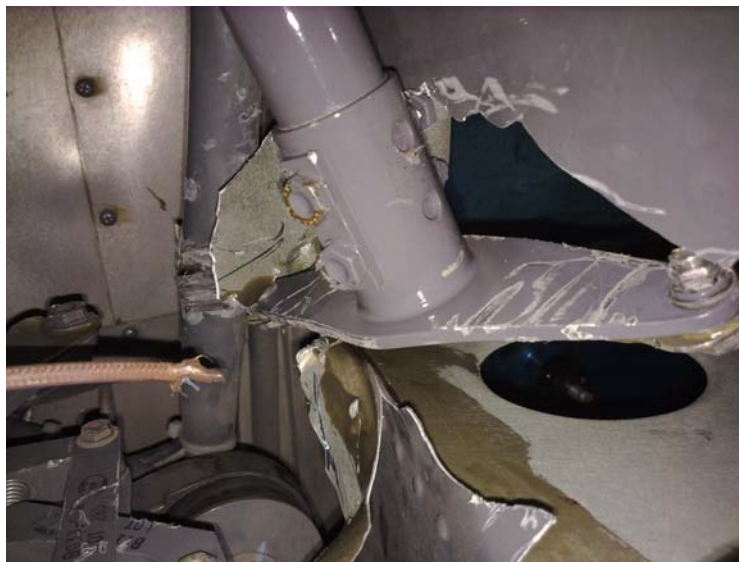
- ❖ The forward flex plate on the gearbox sheared off.
- ❖ The drive shaft then ripped open both main and auxiliary fuel tanks, pulling all the wires off and out of loom and off the frame.
- ❖ The aft flex plate on the free wheel bent, but did not break.
- ❖ The clutch was fully engaged and was bent to one side. Both V-belts had climbed off the pulleys and sheared.
- ❖ The sheave alignment rod was bent and the rod end had been pulled off the bearing.
- ❖ The aft cross tube was bent from the hard landing.

Figure 4: View of a destroyed forward yoke in main tank

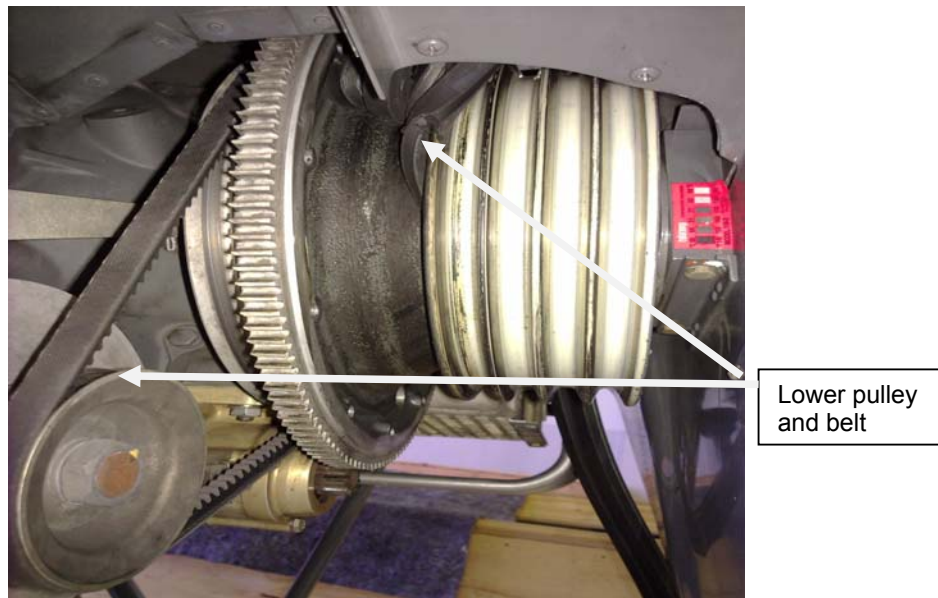
Figure 5: View of the lower pulley and belt

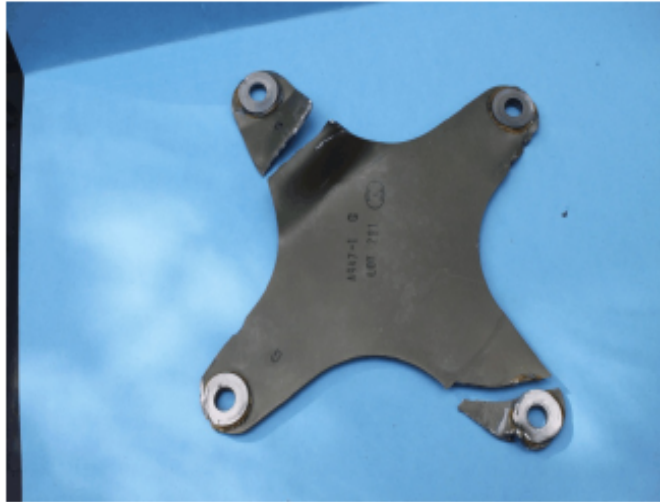
The plate bore identification markings, one presumed to be a part number, A947-1G and a lot number, lot 281. Also present was an inspection identification RHC 6 USA. These are reproduced in figure 1.

Figure 1. The flex plate as received, showing failure location and identification markings.

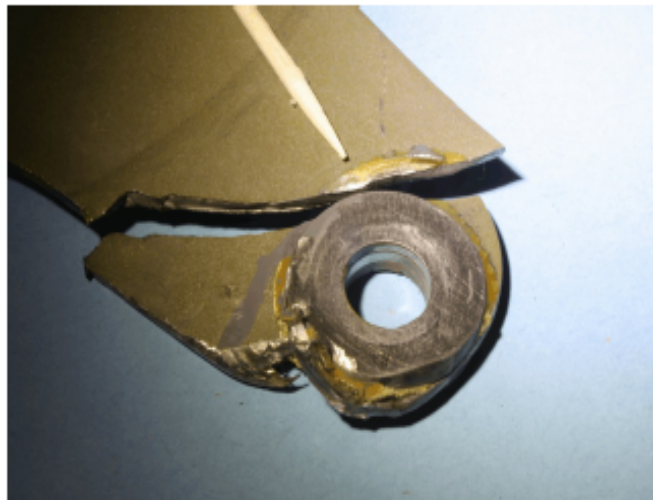
The plate had fractured adjacent to one of the four fixing holes, figure 2, with the fracture surface showing clear indications and features typical of fatigue, figure 3. Close examination showed that the origin of the fracture was a small thumb-nail shaped crack, figure 4, initiating underneath the reinforcing washer. The surface of this initial crack was discoloured, indicating that it had been present for a significant period of time. The opposite fixing hole had torn away with this second fracture exhibiting features indicating ductile overload, figure 5.

Figure 2. Location of the fracture adjacent to fixing hole.

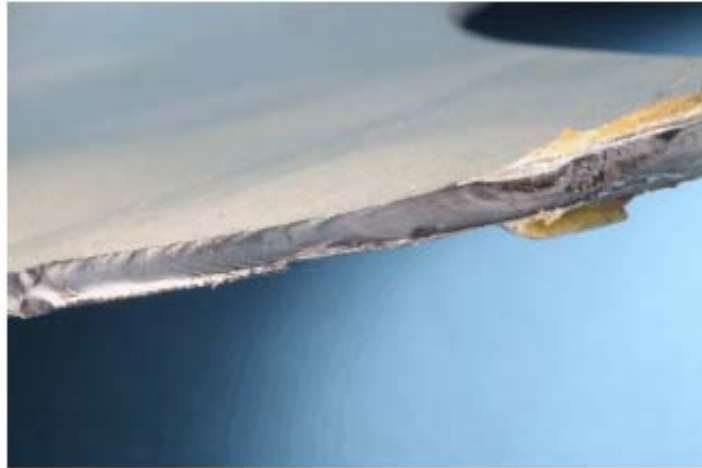
The flex plate has clearly failed in fatigue, with the failure initiating beneath the reinforcing

washer at one fixing hole, where detection would be difficult. The discolouration of this initial crack indicates that it had been in existence for a significant period, and had, in that condition, been relatively benign. It is probable that a relatively minor overload situation had caused the crack to commence growth, eventually reaching a critical length where catastrophic failure ensued. The opposite fixing hole then, being unable to withstand the additional load and mis-alignment, tore away in the resulting ductile overload mechanism.

Figure 3. The fracture surface, showing typical fatigue features.

It is recommended that this component, rather than being subjected to a complex and time-consuming and therefore costly inspection at regular intervals, for which no manufacturer's recommended procedure appears to exist, should be replaced at intervals representing half the life to failure of this component, *i.e.*, at intervals of not more than 500 service hours. It is further recommended that each component should be identified with a unique serial number and replacement recorded in the aircraft maintenance records.

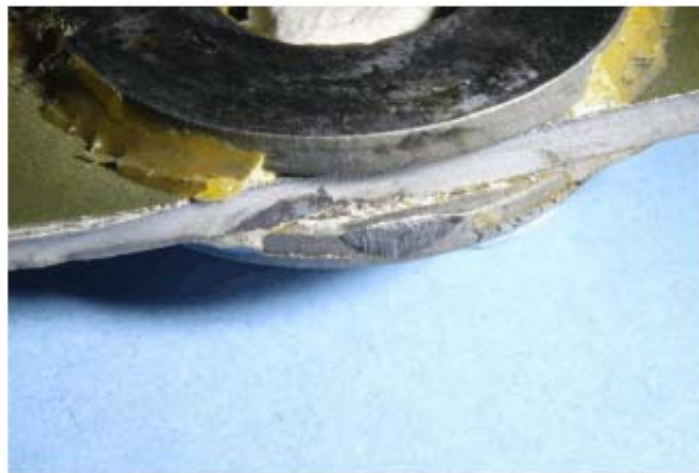
Figure 4. Thumb-nail feature, indicating initiation site, concealed beneath reinforcing washer.

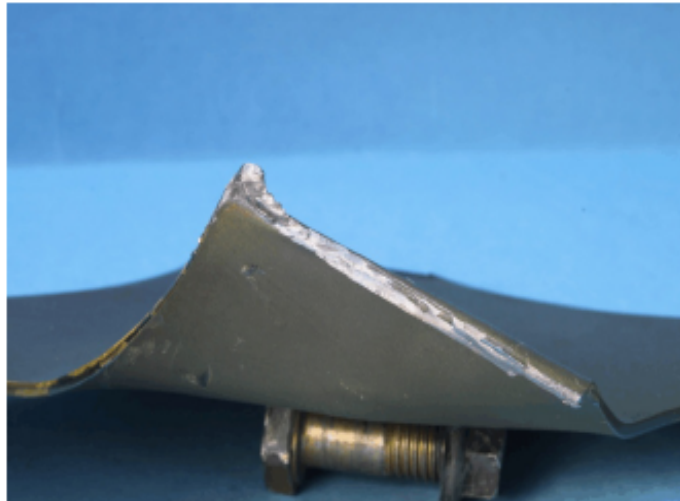
Figure 5. The opposing side fracture, showing only ductile overload features.

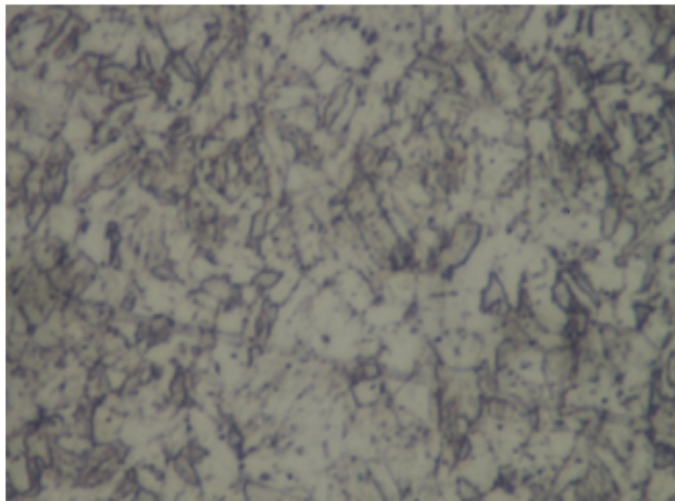
A section was cut from the plate and embedded in thermo-setting resin before being mechanically polished to a 1 μm finish using diamond abrasive. After etching in acid ferric chloride, a fine-grained structure of fine carbides in a martensitic matrix was observed, figure 6.

Figure 6. Microstructure of fine carbides in martensite. Etched acid ferric chloride, Approx. x 400.
