AIRCRAFT ACCIDENT REPORT AND EXECUTIVE SUMMARY

Reference:	CA18/2/3/8779	
Aircraft Registration	ZU-BMX	Date of Accident	12 April 2010		Time of Accident	1300Z
Type of Aircraft	KIS TR-1		Type of Operation	Private		
Pilot-in-command Licence Type		Private	Age	57	Licence Valid	No
Pilot-in-command Flying Experience		Total Flying Hours	399,5		Hours on Type	Unknown
Last point of departure		Petit Aerodrome (FARA)				
Next point of intended landing		Petit Aerodrome (FARA)				
Location of the accident site with reference to easily defined geographical points (GPS readings if possible)						
Petit Aerodrome (FARA) at the GPS coordinates S26° 05' 169" E028° 23' 436"						
Meteorological Information		Surface wind: light and variable; Temperature: 25°C; Visibility: > 10 km				
Number of people on board	1 + 0	No. of people injured	0	No. of people killed	1	
Synopsis						
<p>A witness assisted the pilot to move the aircraft, from which the engine cowling had been temporarily removed, from the hangar at Petit aerodrome. The pilot then taxied the aircraft on runway 21 to check the engine parameters, and afterwards taxied back at speed. The aeroplane lifted from the ground and stalled, and the left wi

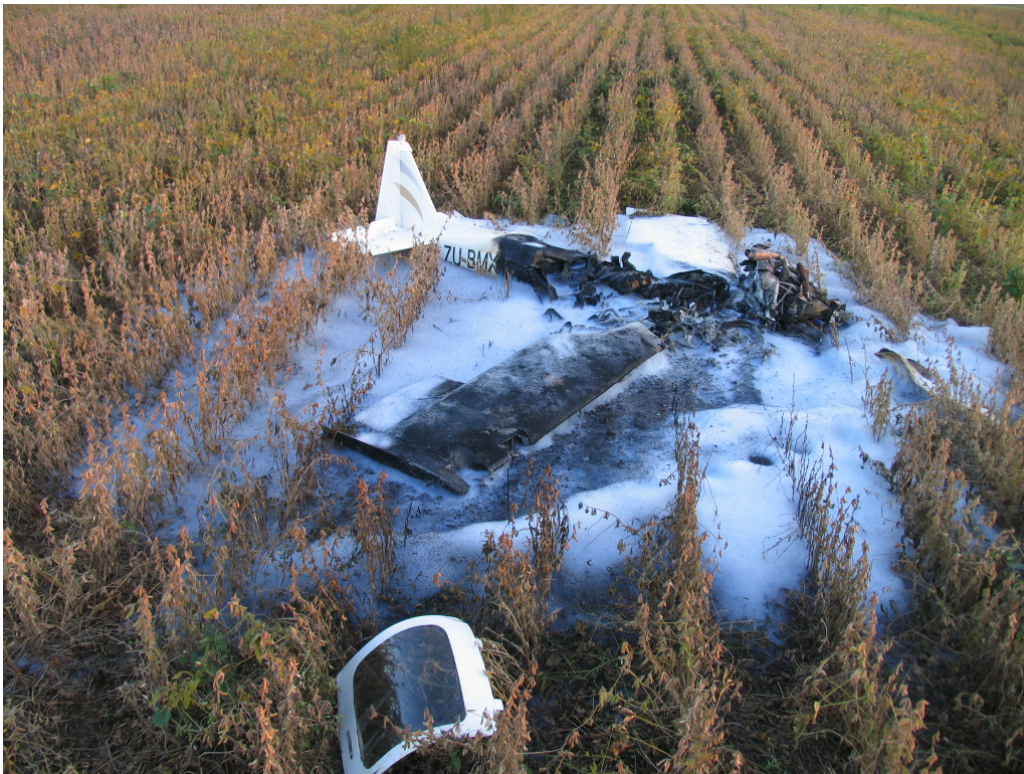
1.3.1 The aircraft was destroyed.

Figure 1. The wreckage of ZU-BMX.

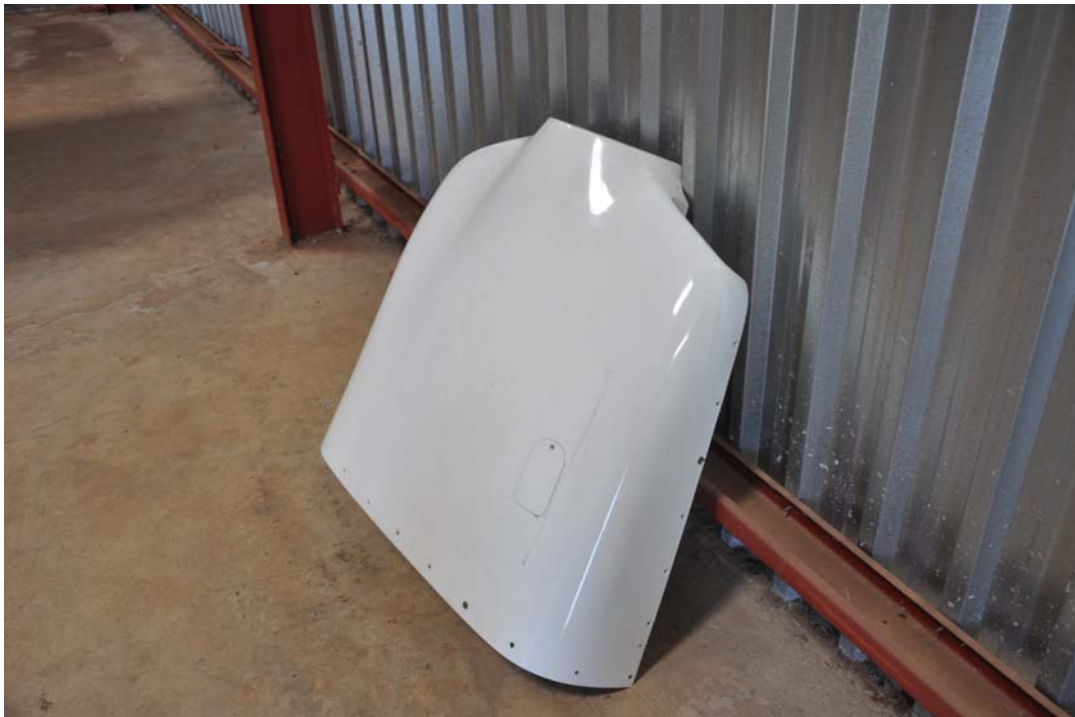
Figure 3. The engine cowling, which was removed before the ground-runs.

- 2.2 The fact that the top engine cowling was not fitted probably disturbed the airflow and caused increased drag, resulting in a stall with an extreme bank to the left. The aircraft was close to the ground at the time, and the left wing struck the ground. The pilot had very limited time to recover from the stall due to the insufficient height available.

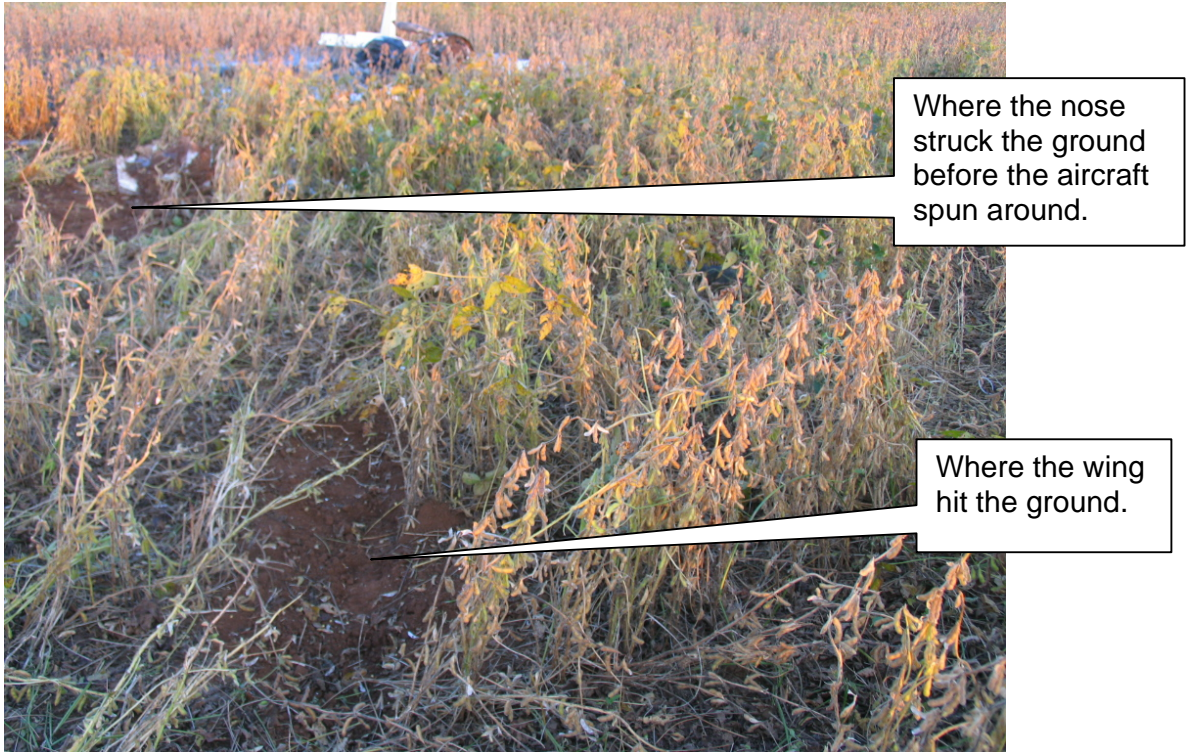
1.12.1 The aircraft was taxiing on runway 21 at Petit aerodrome. The aircraft suddenly became airborne, drifted to the left of the runway and the left wing struck the ground, followed by the nose. The aeroplane spun around approximately 90° and skidded for about 10 m before coming to a halt. Post-impact fire broke out, destroying the aircraft.

Figure 4. Points of impact.

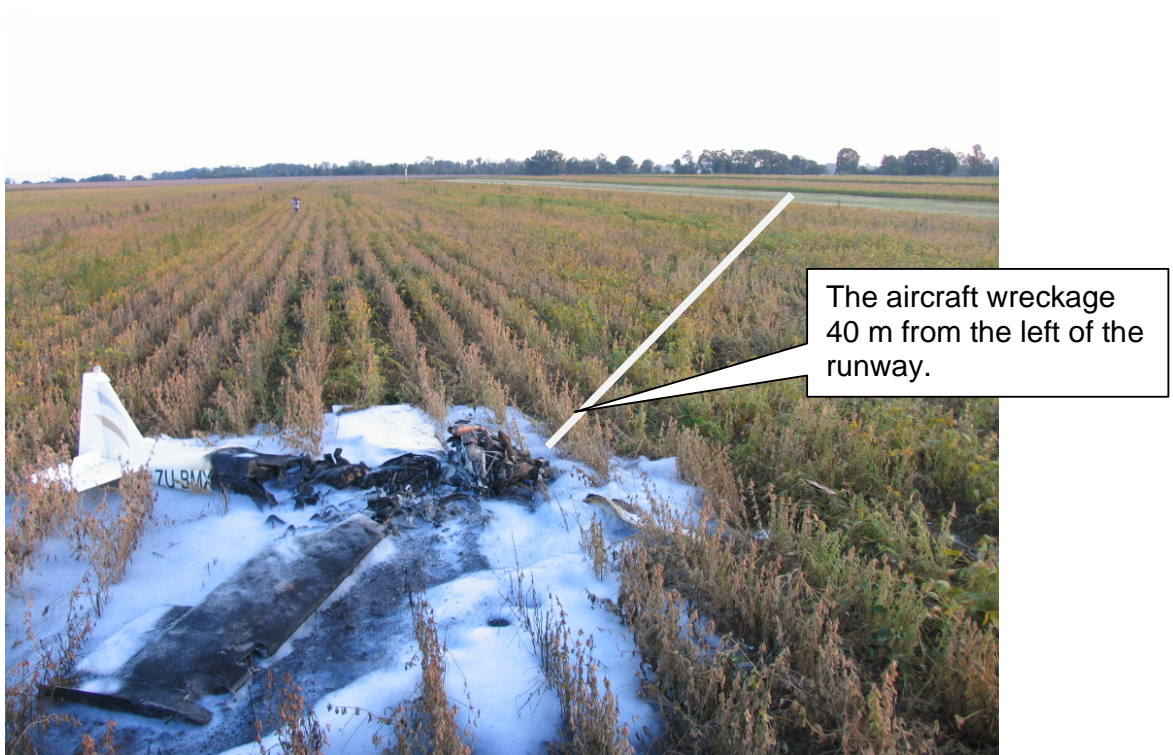
1.12.2 The distance from the runway to the wreckage was approximately 40 m. The aircraft came to rest about 7,5m from the first point of impact.

Figure 5. The position of the wreckage relative to the runway.
