AIRCRAFT ACCIDENT REPORT AND EXECUTIVE SUMMARY

Reference:	CA18/2/3/8780	
Aircraft Registration	ZS-ROV	Date of Accident	14 April 2010		Time of Accident	0547Z
Type of Aircraft	Robinson R22 (Helicopter)		Type of Operation	Private		
Pilot-in-command Licence Type	Private Pilot		Age	30	Licence Valid	Yes
Pilot-in-command Flying Experience	Total Flying Hours	72,5		Hours on Type	68,7	
Last point of departure	Rand Airport (FAGM) Gauteng					
Next point of intended landing	Rand Airport (FAGM) Gauteng					
Location of the accident site with reference to easily defined geographical points (GPS readings if possible)						
Open grass field NEAR Panorama Aerodrome (GPS position S 26°19'45" E028°03'54")						
Meteorological Information	Wind direction: 330°TN; Wind speed: 4 knots; Visibility 400 m; Temperature 17 °C; Dew point 15 °C; Cloud cover: NSC; Cloud base: NSC.					
Number of people on board	1+0	No. of people injured	0	No. of people killed	1	
Synopsis

Name of Owner/Operator : Gypsey Empire Properties (PTY) LTD
Manufacturer : Robinson Helicopter Company
Model : R22 Beta
Nationality : Nigerian
Registration Marks : ZS-ROV
Place : Alberton
Date : 14 April 2010
Time : 0547Z

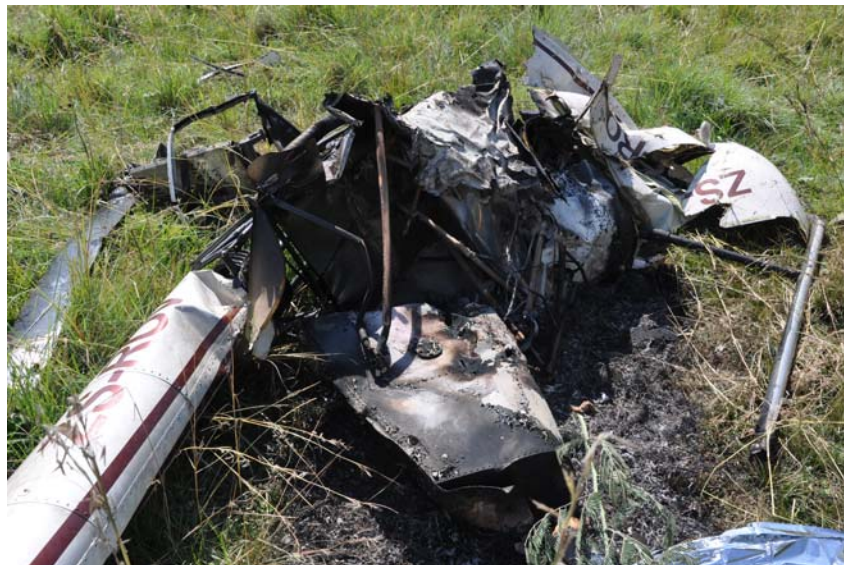
- 1.3.1 The helicopter was destroyed. **(See Figure 1.)**

Figure 1: Wreckage of the destroyed helicopter.

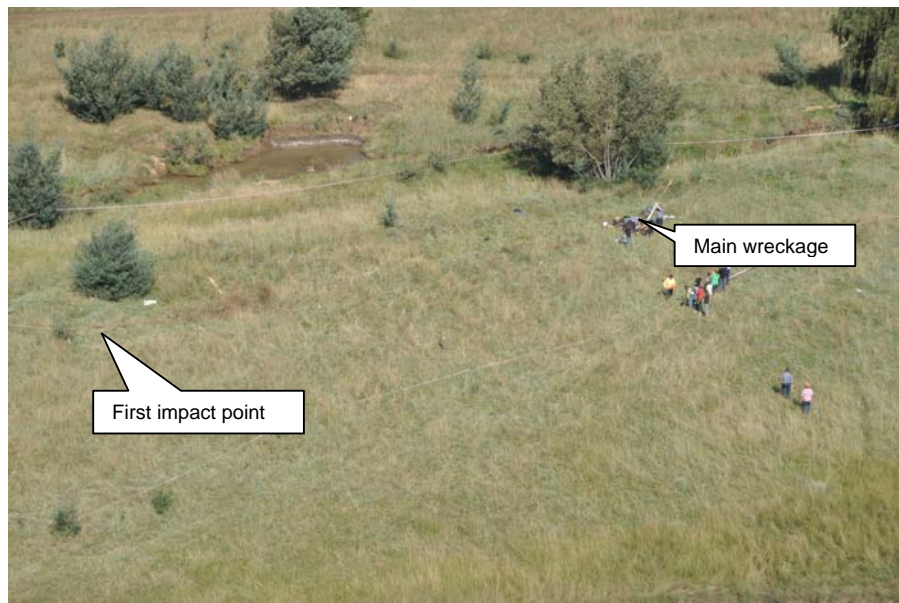
Figure 2: Area of Impact

The wreckage was located in a straight line in an open grass field. The debris path extended on a course of approximately 195 degrees magnetic and terminated approximately 10 metres beyond the main wreckage. The angle of freshly broken branches from a small tree next to the initial point of impact was measured and indicated that the helicopter had hit the ground at an angle of approximately 45 degrees. All of the helicopter's major components were located at the accident site, with most of the debris within a 50-metre radius from the initial impact point.

The initial point of impact (IPI) was noted by the presence of a depression of approximately 250 mm wide by 1 metre long by 200 mm deep in the firm, grass-covered dirt terrain. A piece of the right-hand skid gear was found outside the depression.

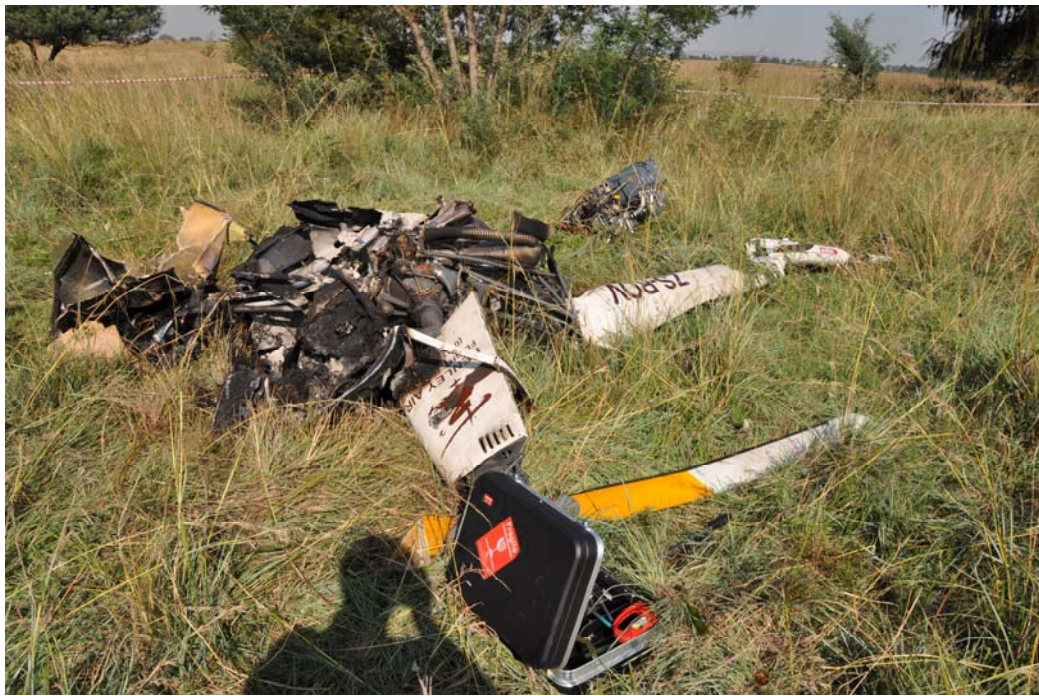
Figure 3: Wreckage of helicopter

The fuselage was destroyed by the impact and was subsequently consumed by the post-impact fire. Evidence on the ground indicated the fuel tank ruptured on impact and caused a fuel spillage of approximately 10 metres in length.

The tail boom structure was found attached to the main fuselage, but severed about midway by the main rotor blades.

One of the main rotor blades had separated from the main rotor mast and was found in the vicinity of the initial impact point. The other main rotor blade was still attached to the main rotor head hub assembly.

The engine was separated from the helicopter during the impact sequence. Evidence indicated that the engine hit the ground on two occasions between the impact point and the point where the engine came to rest, approximately 40 metres from the IPI. Substantial damage was caused to the engine and associated components.

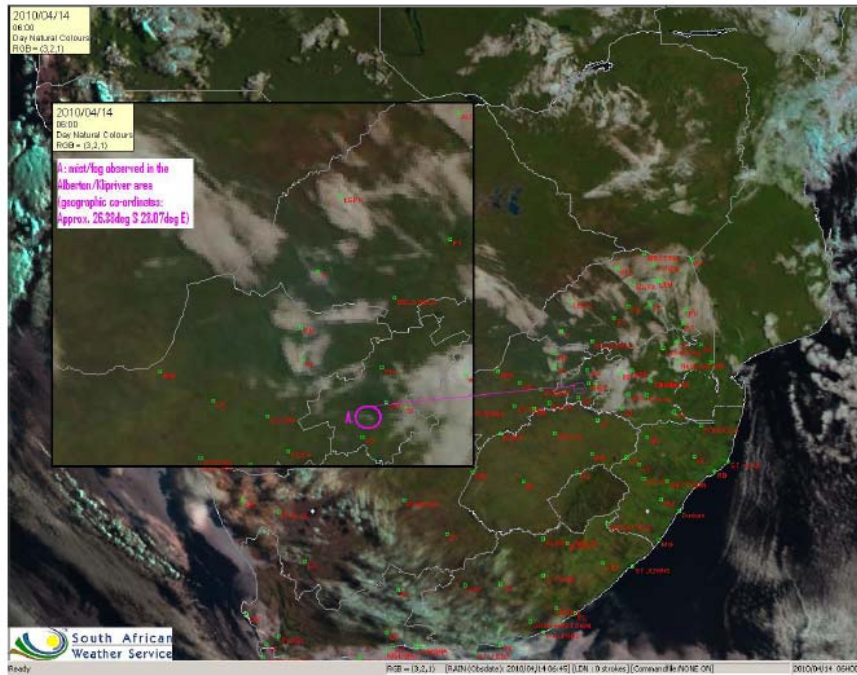
Attachment: D

The satellite image indicates mist and/or fog patches around the area of incident (See Attachment D).

Note: For visibility below 1000m fog should be reported and the satellite image (see Attachment D) does indicate the possibility of fog patches in the area of incident/accident. Thus the BR reported at Rand Airport could possibly be fog.

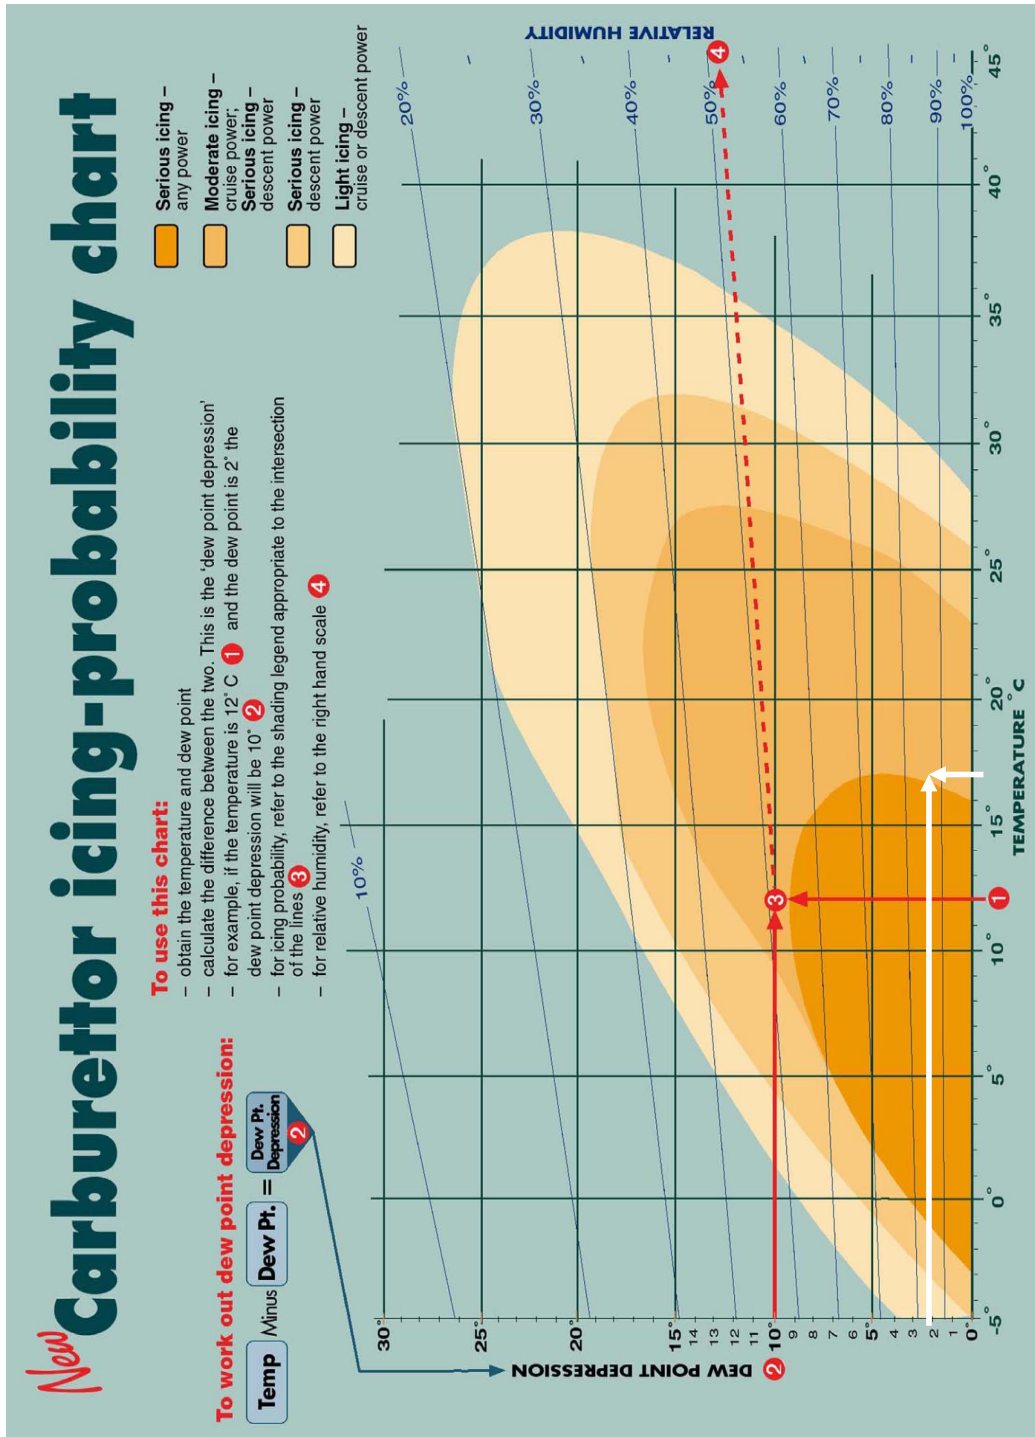
Carburettor icing-probability Chart

During the investigation at the accident site, the investigator-in-charge (IIC) could not find any anomalies that might have contributed to an engine or any other mechanical failure. However, when considering the meteorological conditions of the day – a dew point temperature of 15 °C and ambient temperature of 17 °C – there was a chance of moderate icing during cruise power and a chance of serious carburettor icing at descent power, as depicted on the carburettor icing probability chart. **(See Appendix C.)**

With a temperature of 17°C and a dew point of 15°C the dew point depression on the day of the accident was 2. The icing-probability falls in the area where the two white arrows met. This area indicate there was a possibility of Moderate icing during cruise power and Serious icing during descent power.
