## AIRCRAFT ACCIDENT REPORT AND EXECUTIVE SUMMARY

Reference:	CA18/2/3/8784	
<b>Aircraft Registration</b>	ZS-WXS	<b>Date of Accident</b>	15 May 2010		<b>Time of Accident</b>	0830Z
<b>Type of Aircraft</b>	Windlass trike		<b>Type of Operation</b>	Training		
<b>Pilot-in-command Licence Type</b>	Microlight		<b>Age</b>	45	<b>Licence Valid</b>	Yes
<b>Pilot-in-command Flying Experience</b>	Total Flying Hours	4477.9		Hours on Type	2254.8	
<b>Last point of departure</b>	Heidehof farm airstrip					
<b>Next point of intended landing</b>	Heidehof farm airstrip					
<b>Location of the accident site with reference to easily defined geographical points (GPS readings if possible)</b>						
Heidehof farm airstrip at Gansbaai in Hermanus in the Western Cape Province. GPS: S34°37.362' E019°29.757'						
<b>Meteorological Information</b>	CAVOK weather conditions were reported at the time of the accident.					
<b>Number of people on board</b>	1 + 1	<b>No. of people injured</b>	1	<b>No. of people killed</b>	1

**Name of Owner/Operator** : Albert A D & Marais H F Partnership  
**Manufacturer** : Solo Wings CC  
**Model** : Windlass Trike  
**Nationality** : South African  
**Registration Marks** : ZS-WXS

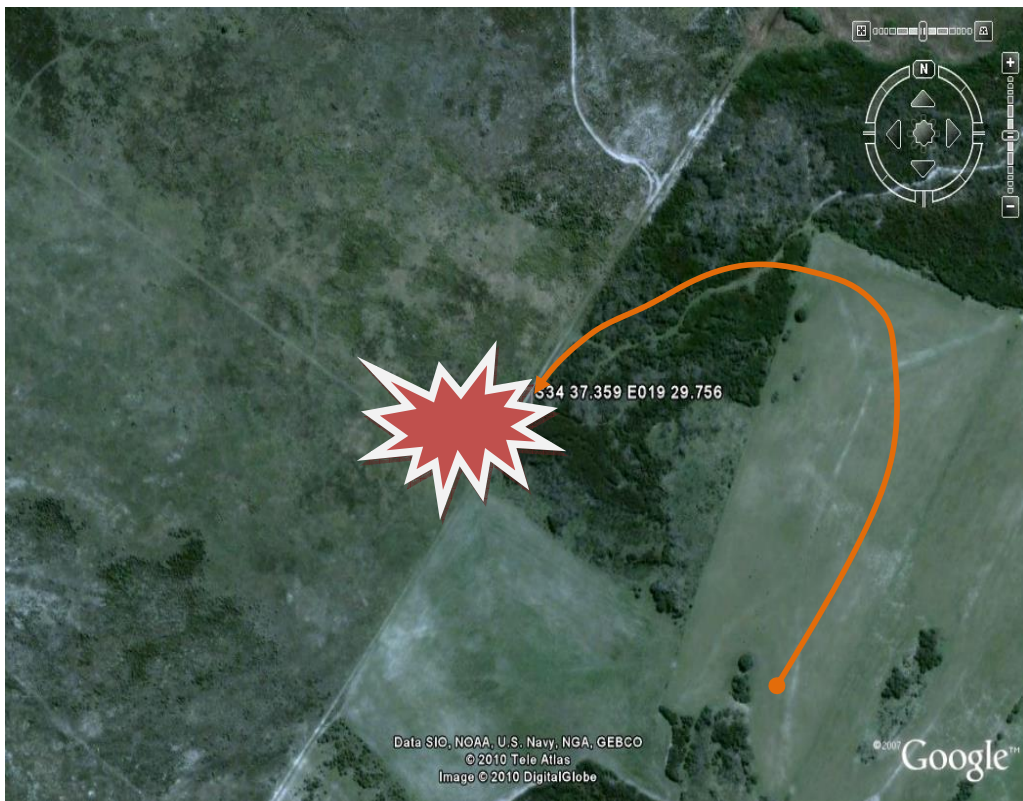
1.1.4 The student pilot immediately initiated a left turn towards the open field but did not have sufficient height and time and elected to land on a farm road next to the fence. During the flare the right-hand wing tip collided with a bush and the aircraft pitched nose down into the ground and the aircraft ground looped. The aircraft was destroyed during the impact sequence. The accident happened during daylight conditions.

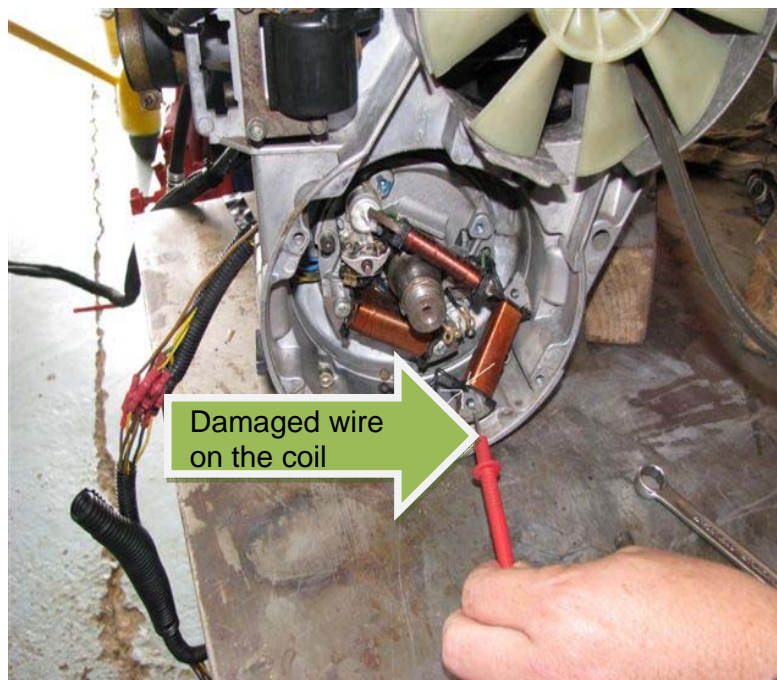
Damaged wire on the coil

1.16.3 No spark was noticed when cranking the engine. On removal of the coil, it was noticed that the earth wire on the ignition coil was not making a connection inside the coil. It was concluded that the single ignition coil failed in flight, causing the engine to stop.

- 2.6 No spark was noticed when cranking the engine. On removal of the coil, it was noticed that the earth wire on the ignition coil was not making a connection inside the coil. It was concluded that the single ignition coil failed in flight, causing the engine to stop.

- 3.2.1 Unsuccessful forced landing following an engine failure due to a damaged earth wire on the ignition coil

- 1.18.2 The instructor reported that he did not intervene because the student was in control of the aircraft at the time.
- 1.18.3 The aircraft engine manual (Engine problem isolation charts) states that if the engine suddenly stops after running: Check C.D. unit/coil and if defective replace with a new one.
- 1.18.4 The maintenance inspections do not require inspection of the coil.

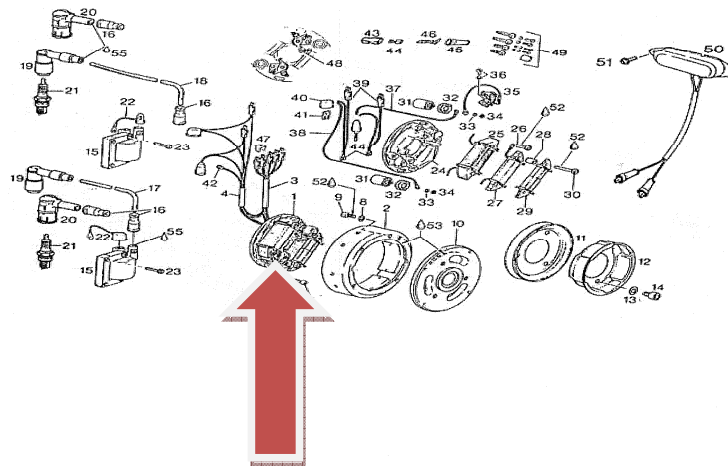
Schematic structure showing the electrical wiring of the engine
