AIRCRAFT ACCIDENT REPORT AND EXECUTIVE SUMMARY

Reference:	CA18/3/2/0786	
Aircraft Registration	ZU-MEG	Date of Accident	16 May 2010		Time of Accident	0930Z
Type of Aircraft	Jabiru J430		Type of Operation		Private	
Pilot-in-command Licence Type		Private	Age	43	Licence Valid	Yes
Pilot-in-command Flying Experience		Total Flying Hours	213,9		Hours on Type	213,9
Last point of departure		Pilanesberg Aerodrome (FAPN) – North West Province				
Next point of intended landing		KittyHawk Aerodrome (FAKT) – Gauteng Province				
Location of the accident site with reference to easily defined geographical points (GPS readings if possible)						
Approximately 150 m into the overshoot area at Kitty Hawk Aerodrome (FAKT)						
Meteorological Information		Wind direction: north-easterly; Windspeed: 15 kt; Cloud cover: 4/8; Cloud base: 6 500 ft; Visibility: good.				
Number of people on board	1 + 1	No. of people injured	0	No. of people killed	0	
Synopsis		<p>The pilot and passenger were engaged in a private flight under visual flight rules from Pilanesberg Aerodrome to Kitty Hawk Aerodrome. The pilot stated that at approximately 0930Z they flew overhead the runway at Kitty Hawk and she executed normal

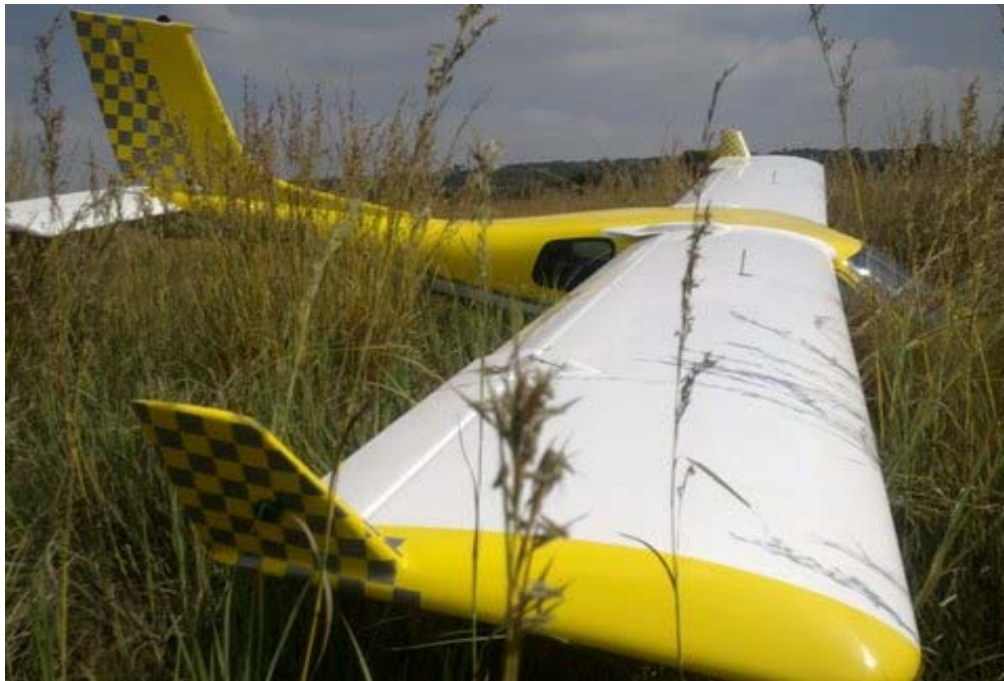
1.3.1 The aircraft sustained substantial damage.

Figure 1. The aircraft after coming to rest in the overshoot area.

1.12.2 The aircraft landed far down the runway, with the wheels touching down approximately 100 m from the threshold. The runway length remaining was approximately 710 m, which the pilot considered to be insufficient to bring the aircraft to a stop. The aircraft continued its landing roll over the end of the runway into an uneven overshoot area covered with long grass. Due to the roughness of the terrain, the landing gear failed and the aeroplane slid on its belly until it came to a stop approximately 150 m from the end of the runway. The landing gear, propeller blade tips and fuselage sustained damage.

3.2.1 The pilot landed too far down runway 01, which sloped downwards towards its end. The slope increased the rolling speed of the aircraft, preventing the brakes from bringing the aircraft to a stop in time.

3.2.2 Contributory cause: the pilot did not select full flaps prior to landing.
