AIRCRAFT ACCIDENT REPORT AND EXECUTIVE SUMMARY

Reference:	CA18/2/3/8798	
Aircraft Registration	ZU-EFG	Date of Accident	24 June 2010		Time of Accident	0830Z
Type of Aircraft	Ikarus C42		Type of Operation	Training		
Pilot-in-command Licence Type		Student pilot	Age	25	Licence Valid	No
Pilot-in-command Flying Experience		Total Flying Hours	19.5		Hours on Type	14.0
Last Point of Departure		Oudtshoorn Aerodrome (FAOH), Western Cape				
Next Point of Intended Landing		Oudtshoorn Aerodrome (FAOH), Western Cape				
Location of the Accident Site with Reference to Easily Defined Geographical Points (GPS readings if possible)						
Runway 22 at Oudtshoorn Aerodrome (GPS coordinates: S33°36'22" E022°11'22")						
Meteorological Information		Temperature 9°C, dew point 4°C, wind 250°TN at 4 kt, visibility >10 km, cloud cover Nil				
Number of People on Board	1 + 0	No. of People Injured	0	No. of People Killed	0	
Synopsis						
<p>On 24 June 2010 at 0830Z, an Ikarus C42 aeroplane with registration ZU-EFG, operated by an aviation training organisation and piloted by a student pilot, took off from Oudtshoorn Aerodrome (FAOH) with the intention to land back at FAOH. This was the student pilot's first

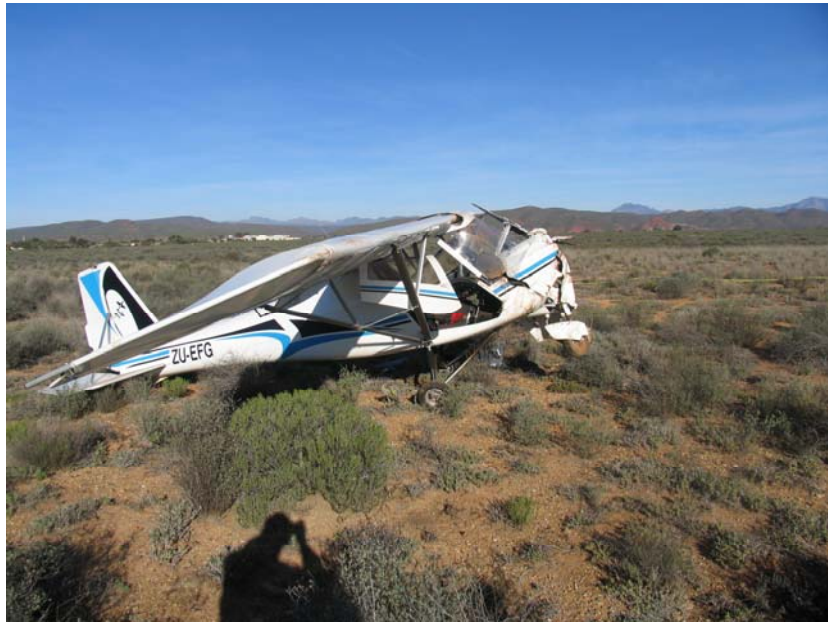
- 1.1.3 Approximately 400 m down the runway, at an indicated airspeed of approximately 45 kt, the aircraft lifted off with a higher-than-normal nose attitude. The pilot stated that the aircraft became airborne but the left wing immediately dropped. The left wing and propeller then impacted with the ground 44 m to the left of the centreline of runway 22.

1.3.1 The aircraft was destroyed during the sequence of the accident. (See Figure 1.)

Figure 1: Damage caused to the aircraft

The first impact impression was caused when the left wing tip impacted the ground approximately 44 m to the left of the centreline of runway 22. The second impact mark was the impression of the propeller approximately 52 m to the left of the centreline of runway 22. The third and final impression was when the aircraft came to rest approximately 60 m to the left of the centreline of runway 22 facing in a direction of 280°M.

- 3.2.1 Incorrect go-around technique placed the aircraft behind the drag curve, which resulted in a stall and inevitable ground impact.

- 4.1 It is recommended the Airworthiness Department within the SACAA investigate the possibility of requiring a stall warning system on all aircraft to be used for initial pilot training to warn inexperienced pilots of a stall condition.
