## AIRCRAFT ACCIDENT REPORT AND EXECUTIVE SUMMARY

Reference:	CA18/2/3/8805	
<b>Aircraft Registration</b>	ZS-NLY	<b>Date of Accident</b>	16 July 2010		<b>Time of Accident</b>	1715Z
<b>Type of Aircraft</b>	De Havilland Dash 8-300		<b>Type of Operation</b>	Domestic Scheduled Flight		
<b>Pilot-in-command Licence Type</b>		Airline Transport	<b>Age</b>	26	<b>Licence Valid</b>	Yes
<b>Pilot-in-command Flying Experience</b>		Total Flying Hours	4 575.4		Hours on Type	1 524.9
<b>Last point of departure</b>		O.R. Tambo International Aerodrome (FAJS)				
<b>Next point of intended landing</b>		Kimberley Aerodrome (FAKM)				
<b>Location of the accident site with reference to easily defined geographical points (GPS readings if possible)</b>						
On runway 20 at FAKM (GPS position; South 28° 48.545' East 024° 45.868' elevation 3 910 feet AMSL)						
<b>Meteorological Information</b>		Surface wind; 310°/2kt, Temperature; 3°C, Visibility; +10 km				
<b>Number of people on board</b>	2+2+40	<b>No. of people injured</b>	0	<b>No. of people killed</b>	0

<b>Synopsis</b>						
<p>On 16 July 2010 at 1715Z flight SA1107, a de Havilland Dash 8 with registration ZS-NLY, collided with a wild animal (aardvark/

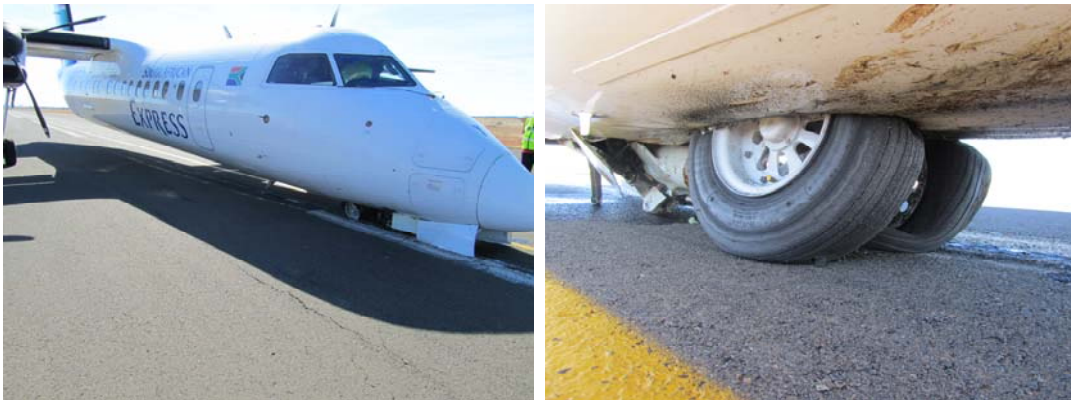
1.3.1 The aircraft sustained substantial damage to the nose landing gear and lower nose fuselage structure.

Figure 1. A view of the aircraft as it came to rest on the runway with the nose gear collapsed backwards.

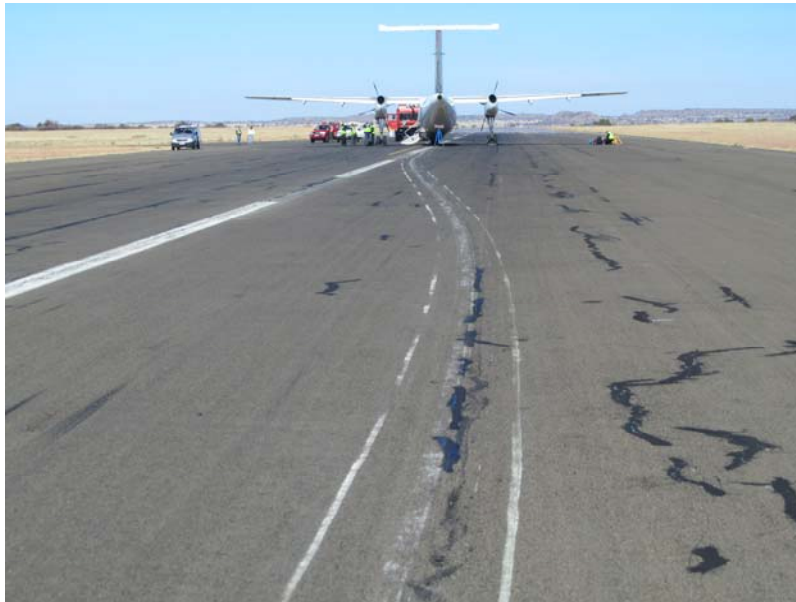
The pilot managed to keep the nose of the aircraft up for a further 479 m past the point of impact. Although both nose wheel tyres were found to be deflated, there was a clear blowout on the right nose wheel tyre some 400 m past the point where the nose gear had first made contact with the runway surface. Fourteen (14) m past the tyre blowout marking, both nose gear doors started making contact with the runway surface, followed by the nose gear strut assembly some 186 m further on. The aircraft came to a halt on the runway centre line 1 838 m past the threshold of runway 20.

**Figure 4.** A view of the nose gear strut assembly and the gear doors scraping on the runway.

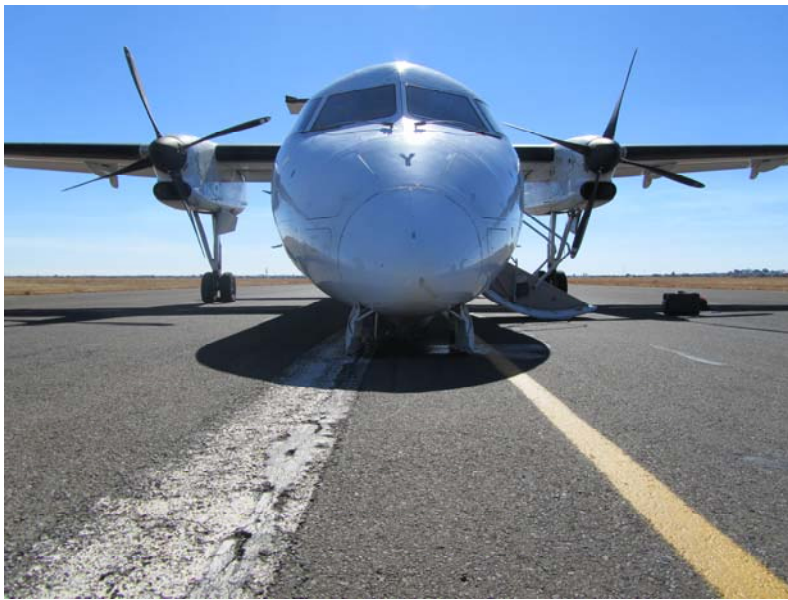
**Figure 5.** Final position of the aircraft as it came to rest on the runway centre line.

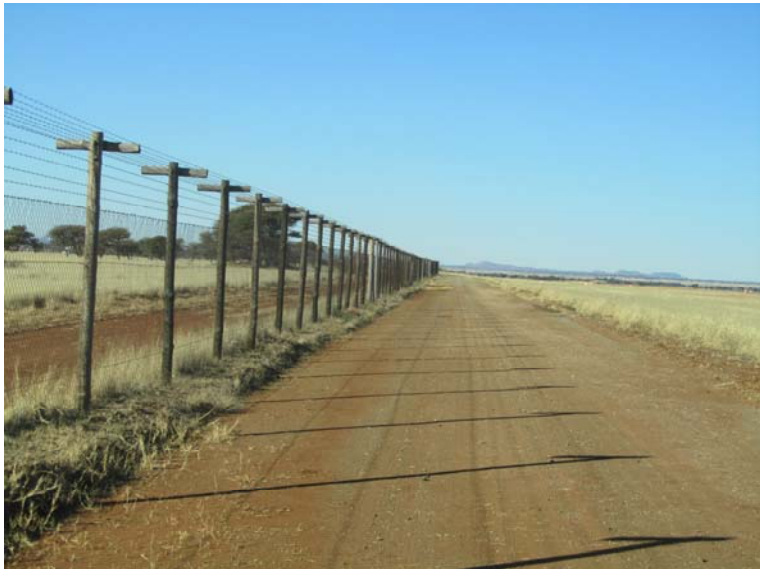
**Figure 6.** A general view of the aerodrome perimeter fence, consisting of wire meshing.

3.3.1 The aerodrome fence had been constructed without a proper foundation, which allowed animals to dig holes and trenches underneath the fence in order to gain access to the aerodrome property, thereby easily migrating from one side of the fence to the other.

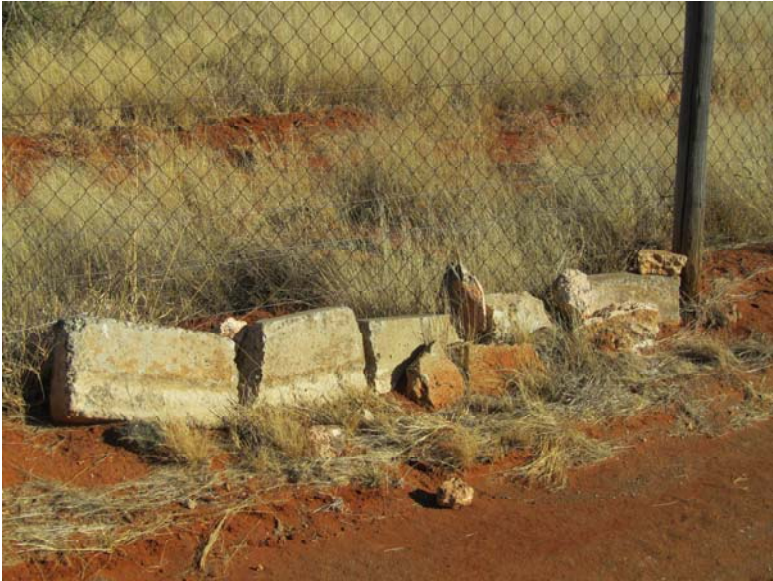
**Figure 7.** A section of the fence where concrete blocks were used to restrict animal access.

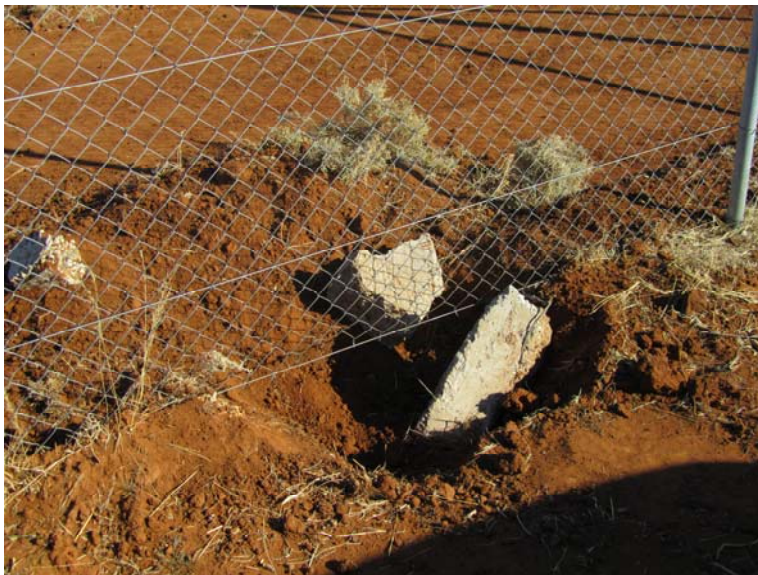
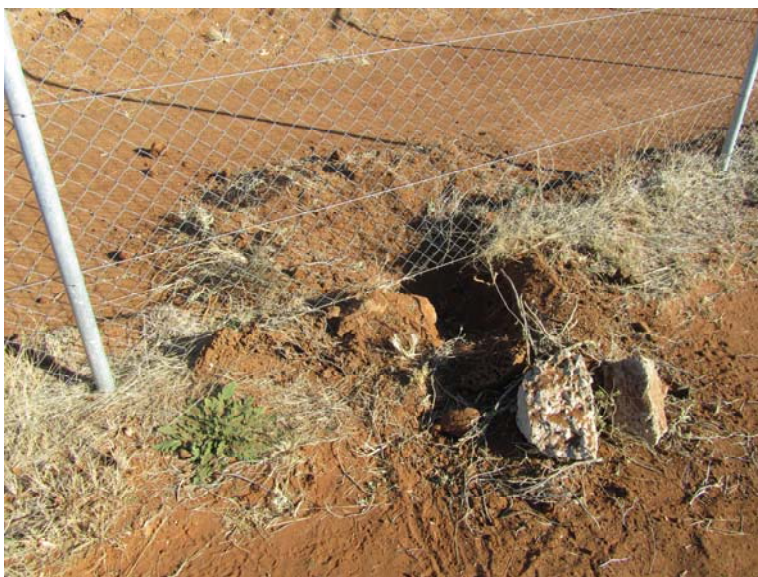
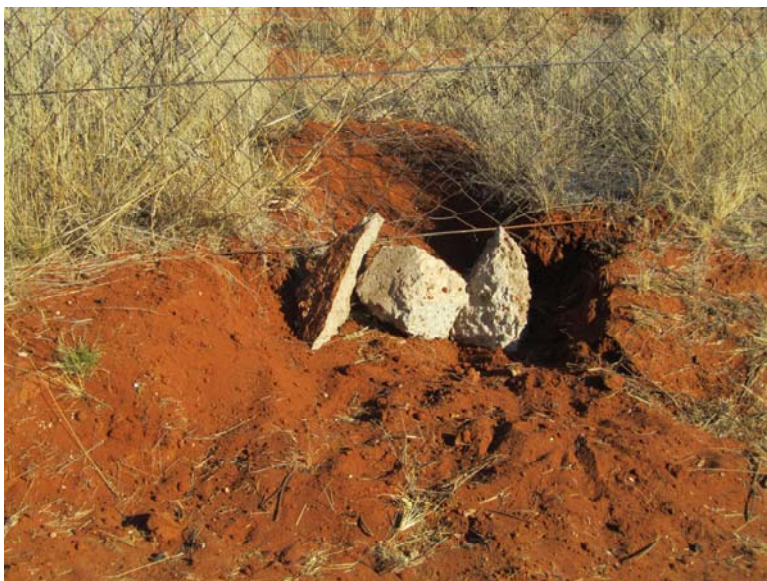
**Figure 8.** A substantial hole that was previously closed up and then dug open again.

**Figure 9.** A substantial hole that was previously closed up and then dug open again.

**Figure 10.** A substantial hole that was previously closed up and then dug open again.

3.1.20 A perimeter fence inspection the day after the accident revealed several holes, dug underneath the fence. Temporary repairs were found to have been performed on a number of these holes in order to close them, but they were found to be dug open again.

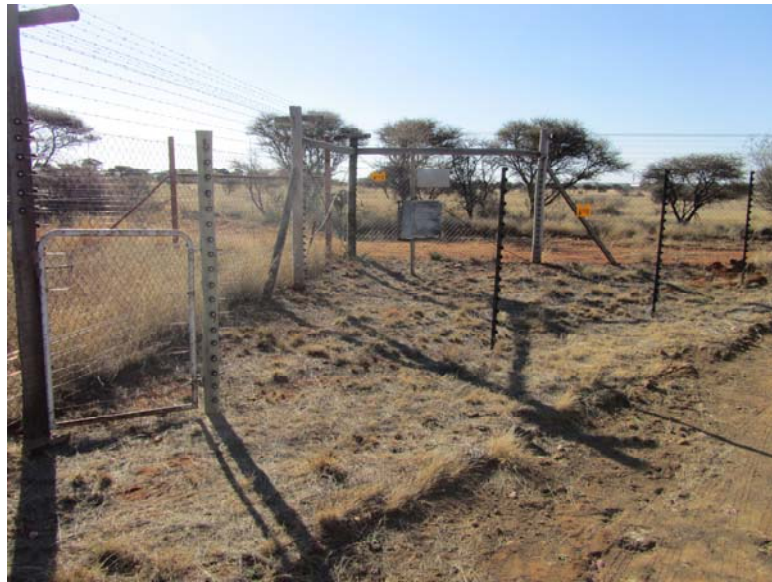
**Figure 11.** The solar panel was located in the designated area behind the electric fence.

3.1.21 A certain section of the perimeter fence used to be electrified, however it was found that the electrical supply to the fence had been disabled due to the fact that the solar panel that powered the fence was reportedly stolen on 22 June 2010.

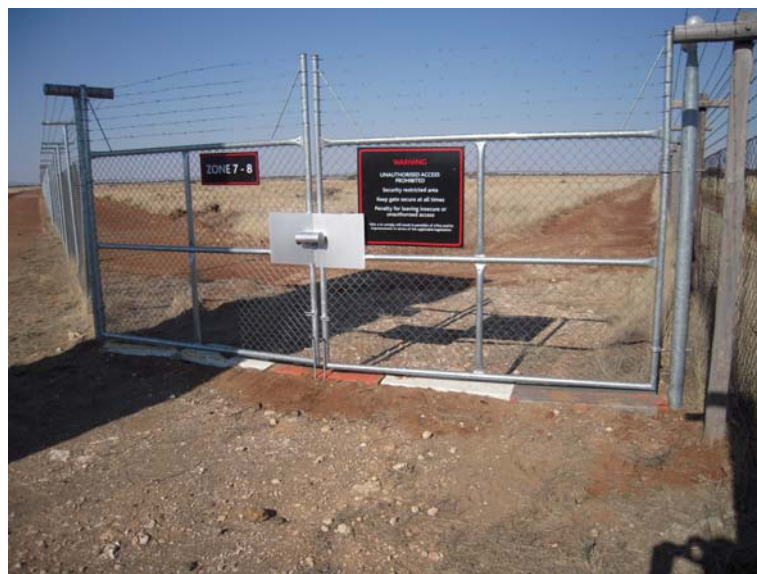
It was noted that one of the perimeter fence access gates had a solid platform that consisted of concrete blocks. This practice was however, isolated to this gate only. See photo below.

**Figure 12.** Access gate within the perimeter fence with solid concrete foundation.

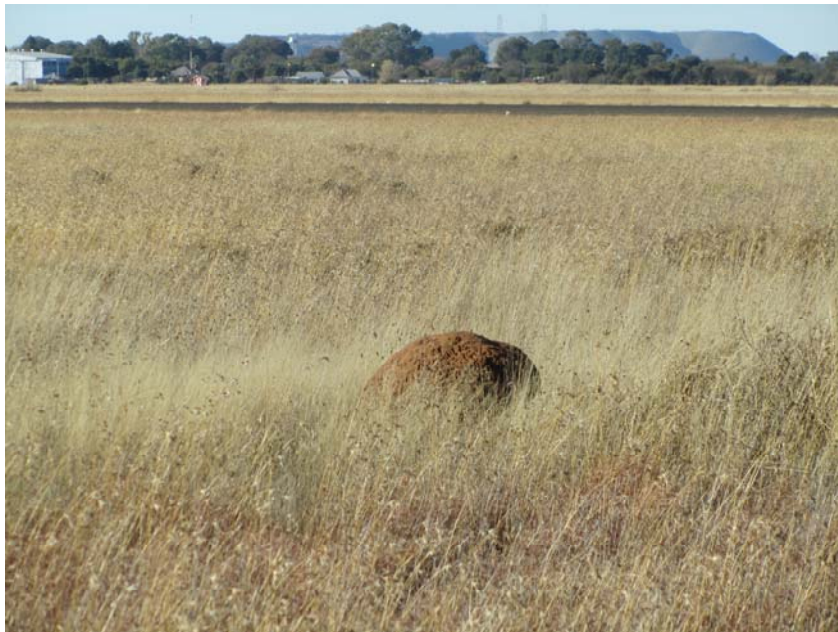
**Figure 13.** A general view of the aerodrome property with runway 02/20 in the background.

At the time of the accident, the grass on the aerodrome property between the runways was approximately 0.5 m in height. As a result most of the termite mounds were hardly visible, even if a person was in close proximity to them. This acted as ideal camouflage/shelter for wild animals and birds that might have roamed the aerodrome property.

3.1.22 The grass between the runways was found to be approximately 0.5 m in height, which allowed for good camouflage for certain species of wildlife on the aerodrome property.

Following the accident in question the aerodrome licence holder started with a process to burn the grass next to the runways and taxiways in order to identify the termite mound problem and initiate remedial action. The area depicted in the photo was burned a few days prior to the photo was taken, which was on 5 August 2010. The investigating team was informed that this was an ongoing process at the aerodrome in order to improve the visibility in the areas around the taxiways and runways, which would allow for better inspections with special emphasis on the sightings of birds and wildlife in close proximity to the runways and taxiways.

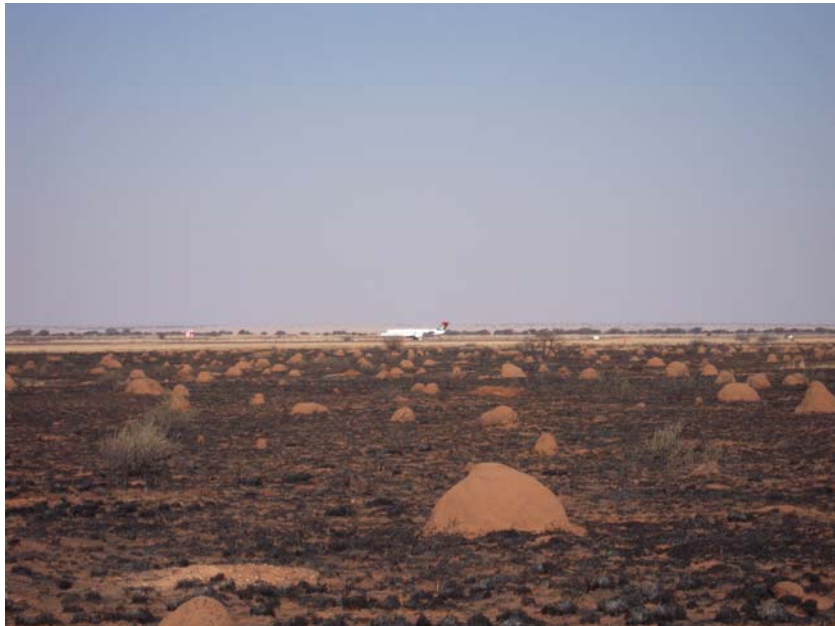
At the time the investigating team visited the aerodrome again, being 5 August 2010 several of the areas were still not subjected to any burning (still grass covered). It could however, be seen from the photo that there was indeed a serious termite mound population within the boundaries of the aerodrome property. It was noted during the visit in question that the aerodrome licence holder had indeed commence with a program whereby they had obtained the services of a contractor to start demolish these termite mounds by making use of earth moving equipment.

**Figure 14.** A view of the termite mounds located on the north-western side of the aerodrome.

- 4.2 That the aerodrome licence holder, in collaboration with Nature Conservation and the Endangered Wildlife Trust, engage on a proactive programme to manage the termite problem at FAKM.
- 4.3 That night operations at the aerodrome are restricted until the aerodrome licence holder has implemented a corrective action plan in accordance with the wildlife animal management programme.
- 4.4 During the investigation it was noted that the approved Aerodrome Operations Manual on record with the SACAA was last updated on 29 March 2007. It is recommended that an updated/amended copy of the Aerodrome Operations Manual be placed on record with the regulating authority.

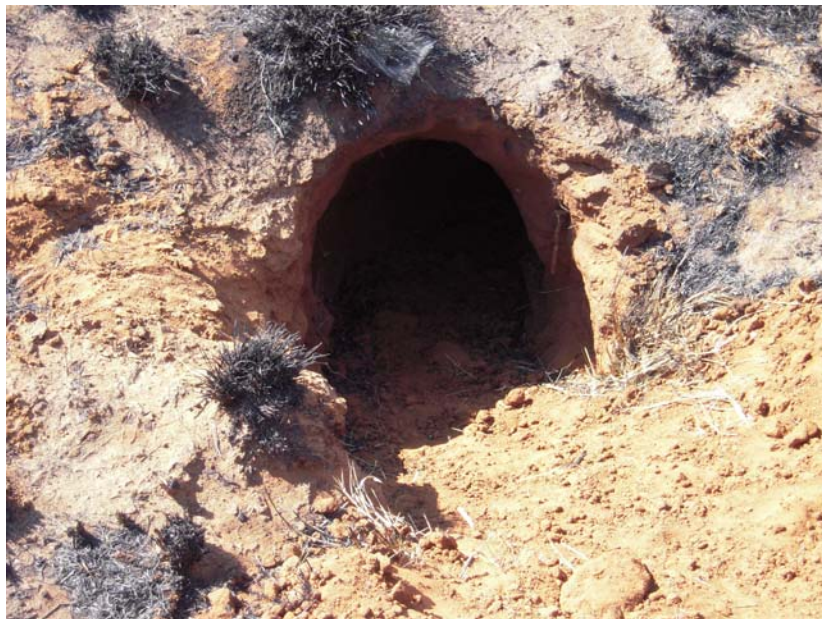
During the inspection of the aerodrome property, many animal holes/shelters of different sizes were observed. Most of the holes appeared to be new/recent and active in nature. These holes provided ideal shelter for several animal species, including the aardvark.

**Figure 15.** The photo displays one of many animal holes/shelters on the aerodrome property.

3.1.24 Several animal holes were found on the aerodrome property, which provided shelter for many different species of animals, including the aardvark.
