AIRCRAFT ACCIDENT REPORT AND EXECUTIVE SUMMARY

Reference:	CA18/2/3/8808	
Aircraft Registration	ZS-RXV	Date of Accident	22 July 2010		Time of Accident	0945Z	
Type of Aircraft	Robinson R22 Beta II		Type of Operation		Training		
Pilot-in-command Licence Type		Commercial	Age	27	Licence Valid	Yes	
Pilot-in-command Flying Experience		Total Flying Hours	560.9		Hours on Type	250.0	
Last Point of Departure		Rand Aerodrome (FAGM)					
Next Point of Intended Landing		Rand Aerodrome (FAGM)					
Location of the Accident Site with Reference to Easily Defined Geographical Points (GPS readings if possible)							
Approximately 300 m from south of the threshold of Runway 29 at GPS coordinates: S26°14.636' E028°09.415' , Elevation: 5466 AGL							
Meteorological Information		CAVOK weather conditions were reported at the time of the accident. Surface wind: 070/07 knots; Temperature: 16°C; Dew point: 08°C; QNH: 1032.					
Number of People on Board	1 + 1	No. of People Injured	1	No. of People Killed	0

Name of Owner/Operator : Starlite Aviation (PTY) LTD
Manufacturer : Robinson Helicopter Company
Model : R22 BETA II
Nationality : South African
Registration Marks : ZS-RXV
Place : Rand Aerodrome (FAGM)
D

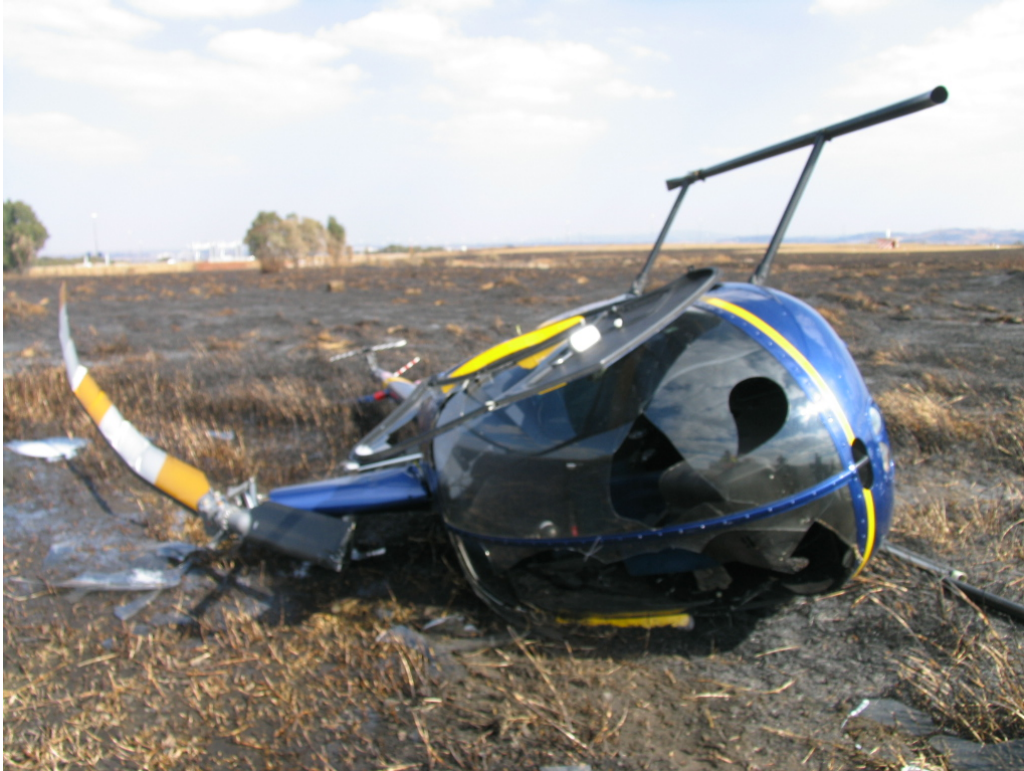
1.3.1 The aircraft sustained substantial damage on the right-hand side of the fuselage, right-hand skid, main and tail rotor blades, tail boom and windshield.

Figure 1: Damage to the aircraft

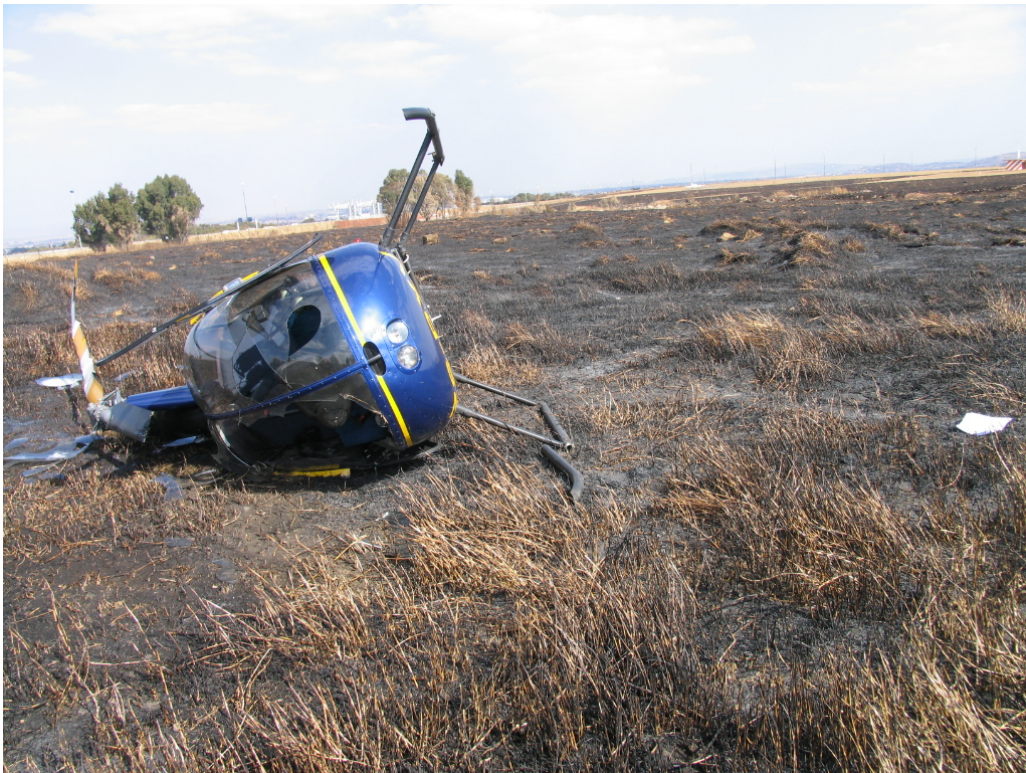
Figure 2: The wreckage after it rolled over

1.12.2 The wind change resulted in a sudden yaw to the left during which the right skid impacted and dug into the ground. The helicopter rolled onto its right-hand.

1.12.3 The aircraft sustained damage on the right-hand side of the fuselage, right-hand skid, main and tail rotor blades, tail boom and wind shield.

- 3.2.1 The student pilot lost control of the aircraft after experiencing a sudden change in wind direction, which resulted in yaw to the left and the right-hand skid impacting the ground.
- 3.2.2 Contributing factors:
 - Lack of supervision by the instructor
