AIRCRAFT ACCIDENT REPORT AND EXECUTIVE SUMMARY

Reference:	CA18/2/3/8810	
Aircraft Registration	ZU-ESB	Date of Accident	24 July 2010		Time of Accident	1030Z
Type of Aircraft	A-22L Foxbat		Type of Operation	Private		
Pilot-in-command Licence Type	NPL		Age	17	Licence Valid	Yes
Pilot-in-command Flying Experience	Total Flying Hours		47,2		Hours on Type	47,2
Last point of departure	Light Flight aerodrome near Cato Ridge, KwaZulu-Natal					
Next point of intended landing	Light Flight aerodrome near Cato Ridge, KwaZulu-Natal					
Location of the accident site with reference to easily defined geographical points (GPS readings if possible)						
On a sugarcane field in the Wartburg area. GPS position: S 29° 26.185' E 030° 33.684'						
Meteorological Information	The weather was fine. Temp: 22°C; Wind: calm					
Number of people on board	1 + 1	No. of people injured	0	No. of people killed	2	
Synopsis						
<p>According to available information, the pilot was issued with a valid National Pilot's Licence by Recreation Aviation Administration South Africa (RAASA) on 14 July 2010 after passing his flight test on 8 July 2010. He received his pilot's licence by courier post on the morning of 24 Jul

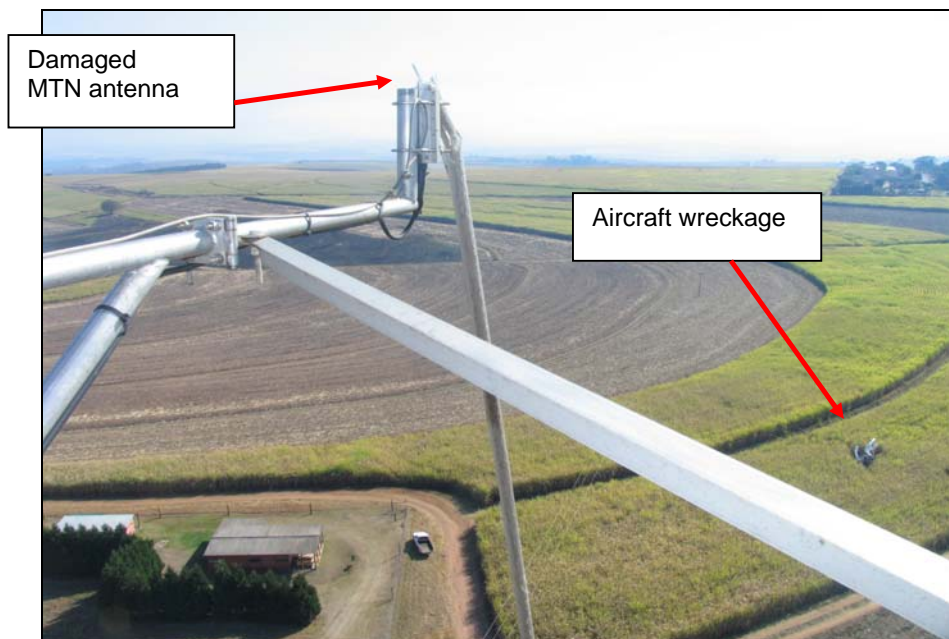
Figure 2. The impact damage to the MTN antenna.

1.4.1 The omni antenna at the top of the MTN cellular mast was damaged.

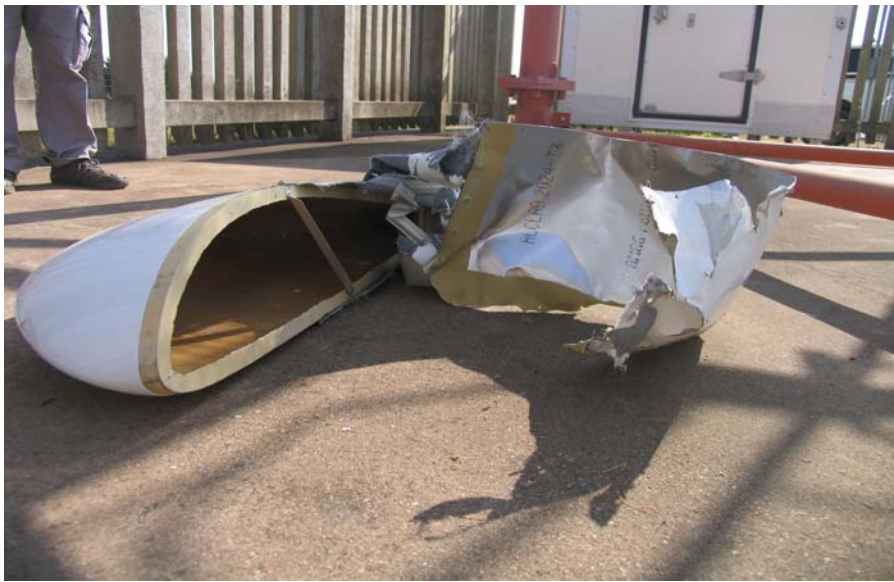
Figure 3. The right wingtip and part of the outer wing.

1.12.1 The aircraft was flying overhead the Church property in the Wartburg area in a northerly direction when the right wing struck the 54 m-high cellular phone mast. The antenna on top of the cellular phone mast structure extended a further 5 m. The right wing tip broke off on impact, the wing folded backwards and the aircraft spiralled clockwise into a sugarcane field approximately 100 m away.

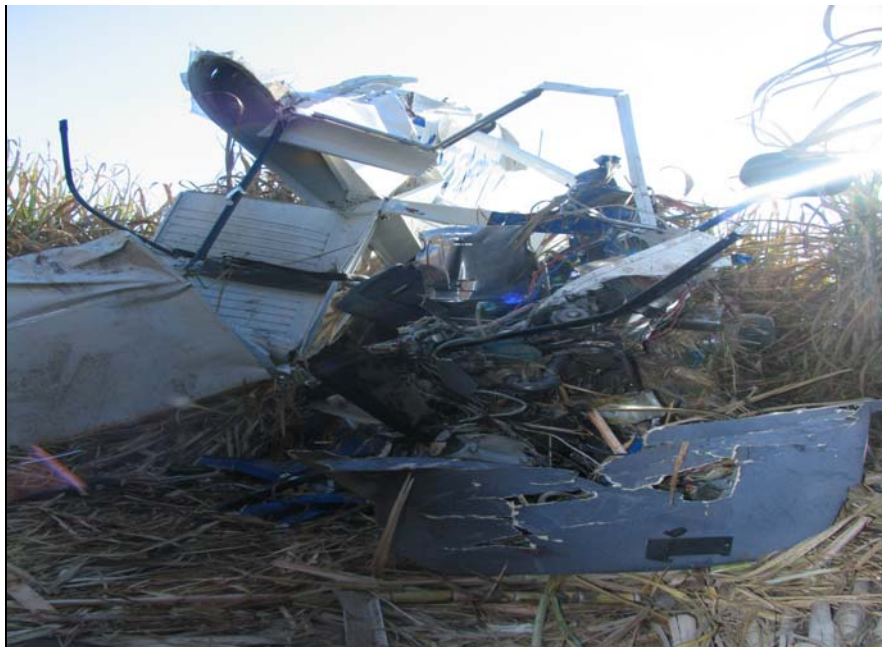
Figure 4. The main wreckage in a sugarcane field.

1.3.1 The aircraft was destroyed during the impact sequence

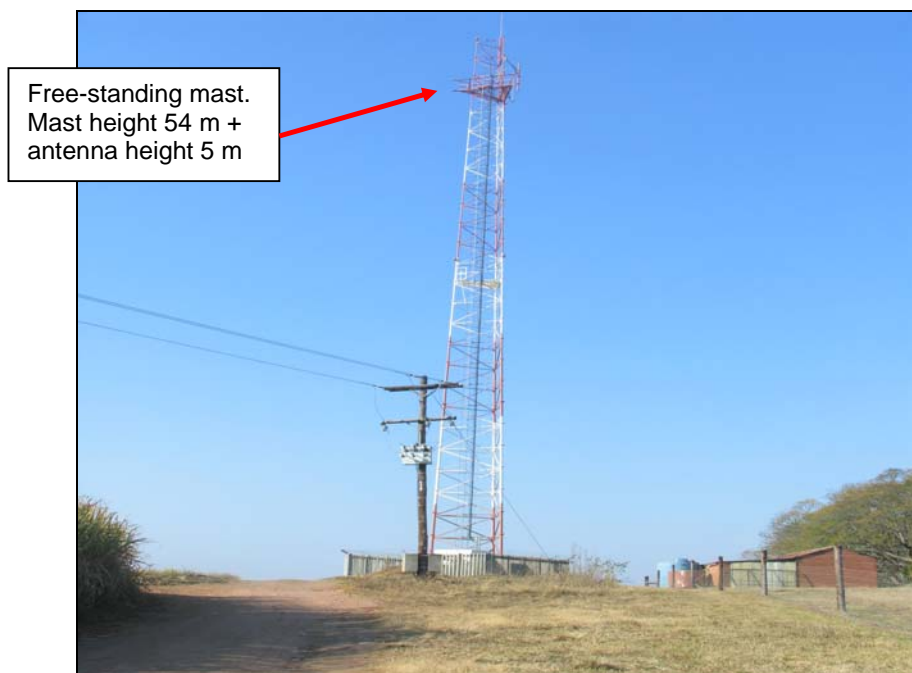
Figure 5. The MTN cellular radio mast

- i. The cellular phone mast site at Kingshill Church (Wartburg) is 1 140 m (3 740 ft) AMSL.
- ii. The freestanding mast height is 54 m.
- iii. The height of the antenna above the mast is 5 m.
- iv. The height to the top of the mast is thus 59 m.
- v. The height to the top of the mast is 1 199 m (3 933 ft) AMSL at the mast site.
- vi. Red aviation lights are located at the top of the mast (54 m above the ground)
- vii. Red aviation lights are also located midway on both sides of the mast 27 m above the ground.
- viii. It is certified that there is no landing strip / aerodrome within 8 km from the site.

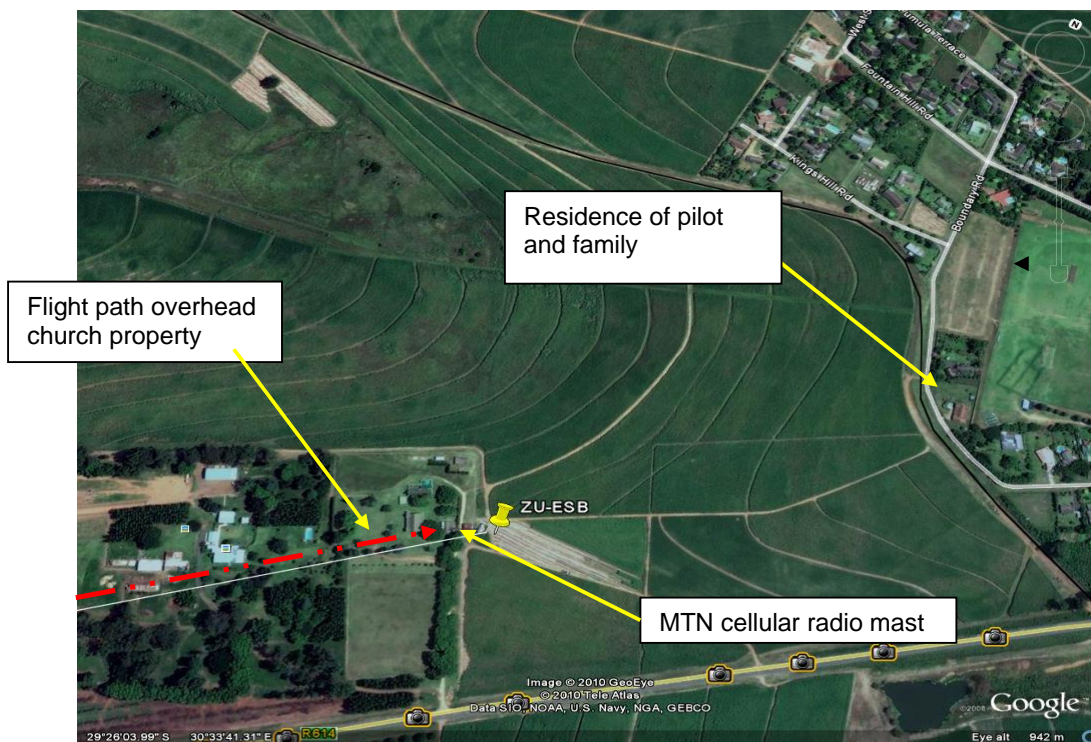
Figure 6. The aircraft's flight path and direction.

- 2.1 While flying low above the ground and in a north easterly direction towards the sun, the pilot misjudged the distance and height of the cellular phone mast structure and collided with the antenna 54 m above ground level.
- 2.2 The pilot's attention was diverted by people on the ground and he failed to observe the MTN structure.
