<b>AIRCRAFT ACCIDENT REPORT AND EXECUTIVE SUMMARY</b>
---

Reference:	CA18/2/3/8815	
<b>Aircraft Registration</b>	ZS-RRM	<b>Date of Accident</b>	29 July 2010		<b>Time of Accident</b>	1000Z
<b>Type of Aircraft</b>	Robinson R22 Beta (Helicopter)		<b>Type Operation</b>	Hire an Fly		
<b>Pilot-in-command Licence Type</b>	Private Pilot		<b>Age</b>	47	<b>Licence Valid</b>	Yes
<b>Pilot-in-command Flying Experience</b>	Total Flying Hours		381,3		Hours on Type	89,4
<b>Last point of departure</b>	Rand Aerodrome (FAGM), Gauteng Province					
<b>Next point of intended landing</b>	Rand Aerodrome (FAGM), Gauteng Province					
<b>Location of the accident site with reference to easily defined geographical points (GPS readings if possible)</b>						
5 nautical miles south of Panorama at GPS co-ordinates S26°23.680 E028°03.429						
<b>Meteorological Information</b>	Wind direction: light/variable; Temperature: 19°C; Visibility: good.					
<b>Number of people on board</b>	1 + 0	<b>No. of people injured</b>	0	<b>No. of people killed</b>	0

## AIRCRAFT ACCIDENT REPORT

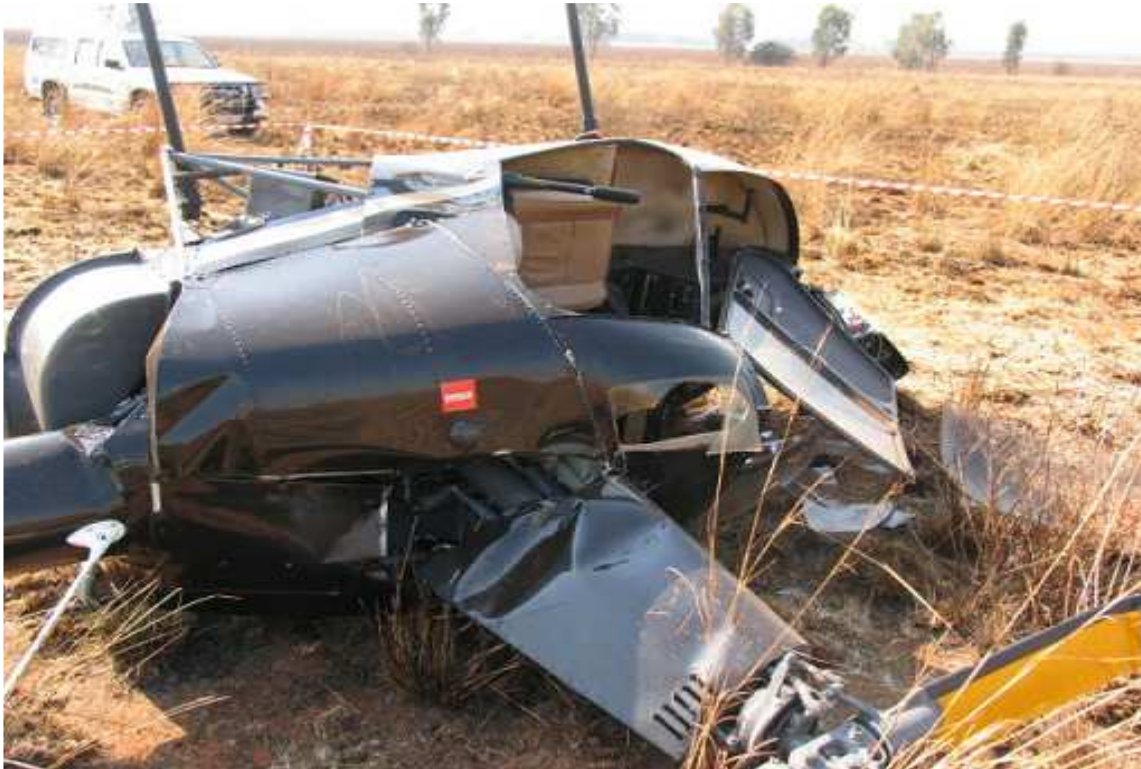
1.3.1 The helicopter was extensively damaged.

Figure 1. View of the wreckage on level ground.

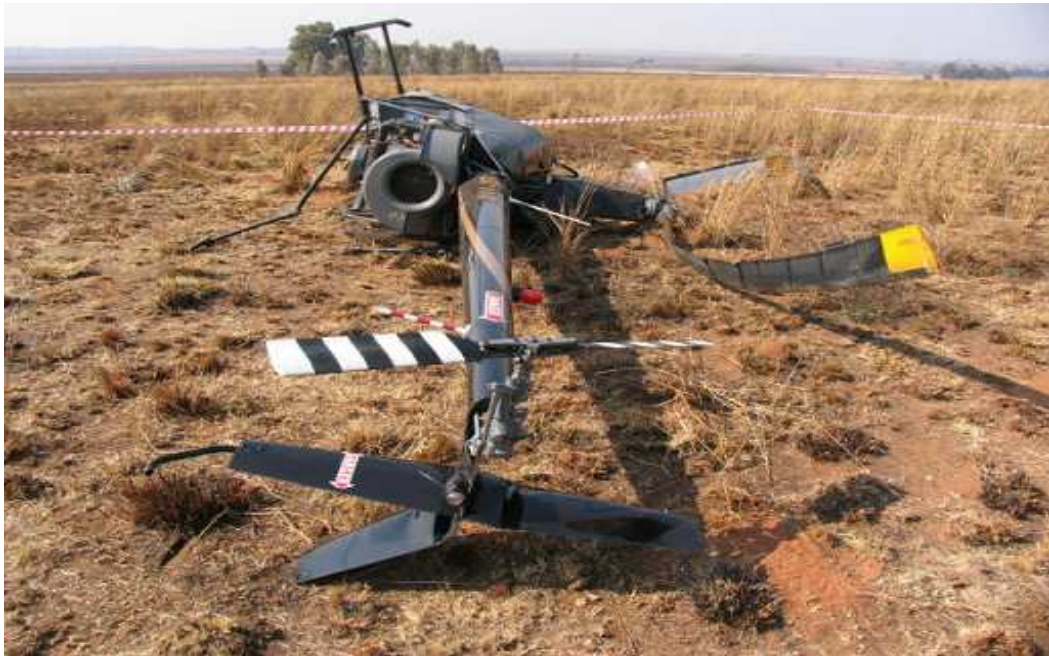
1.12.1 The helicopter was in a hover and banked to the right. The right skid struck the ground and the helicopter dynamically rolled over onto its right side. The main rotor blades struck the ground and the aircraft sustained substantial damage during the impact sequence.

**Figure 2: Helicopter viewed at rear section**

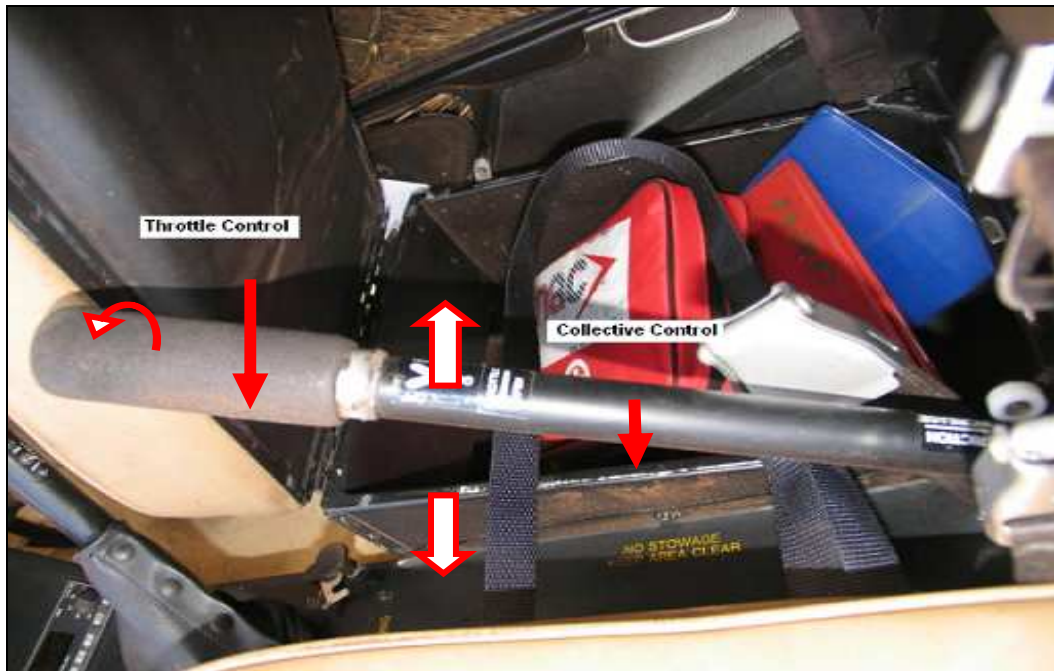
**Figure 3.** The collective pitch lever and throttle control lever.

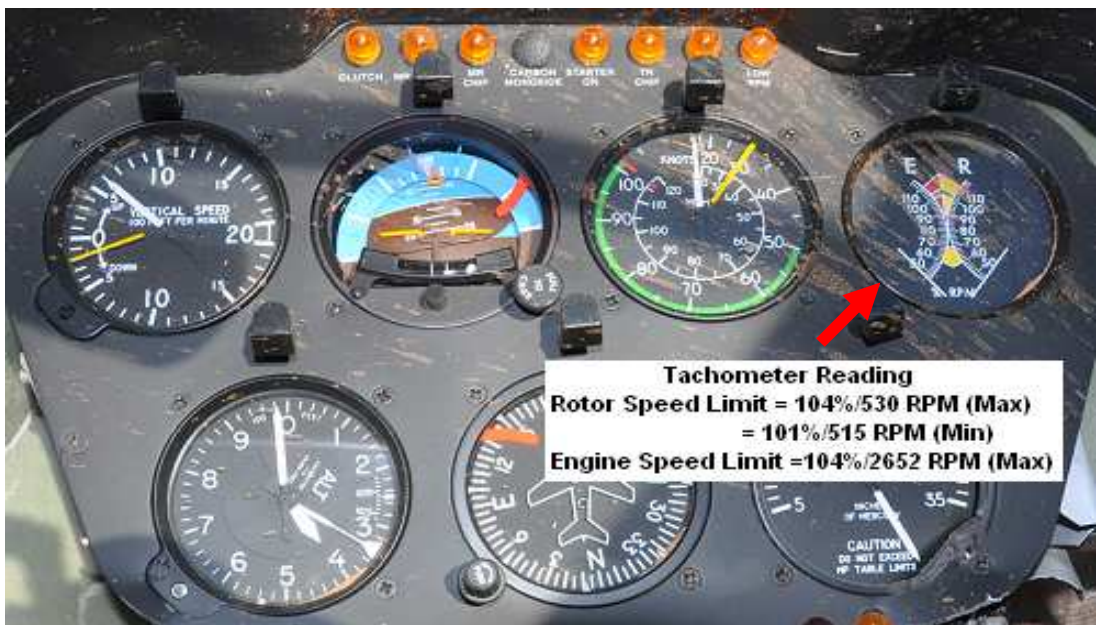
**Figure 4.** The instrument panel of ZS-RRM, showing the tachometer measuring rotor and engine RPM.

- 2.3 The rotor and engine RPM responded instantly, as indicated by the needles entering the yellow or red arcs on the tachometer. The pilot tried to recover when he saw what was happening but this recovery did not take place instantaneously.

- 2.5 According to the pilot, he was surprised by the responsiveness of the rotor and engine RPM indication on the tachometer. The pointers were increasing from the green arc, which means that the rotor and engine RPM indication was too aggressive. Under normal circumstances, the governor should have controlled the RPM. The responsiveness of the tachometer indication showed that the governor was either switched off or malfunctioning.

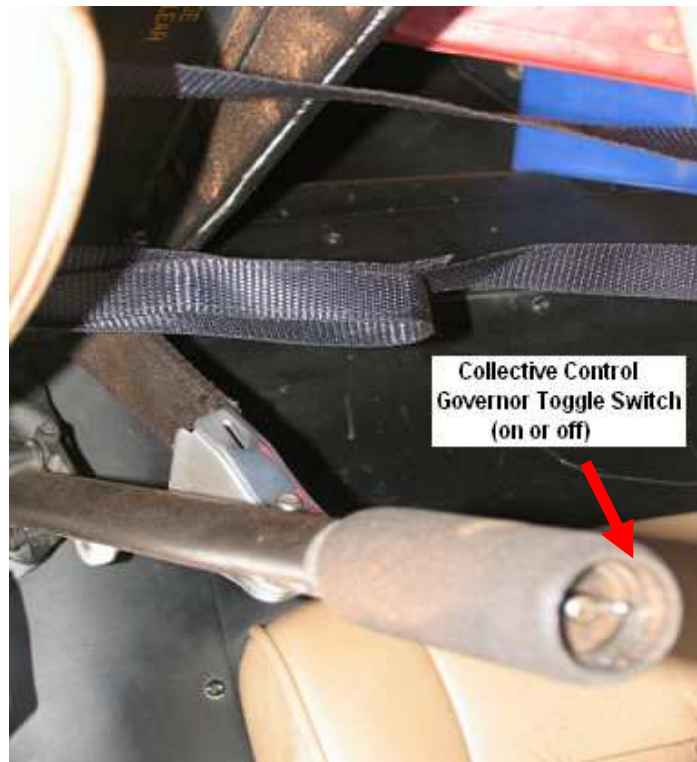
**Figure 5.** The position of the governor toggle switch.

- 3.1.13 The governor system is designed to assist in controlling RPM, hence preventing the responsiveness observed on the tachometer. The pilot obviously switched the governor off and attempted to fly with the governor off. The resultant lag and increased response of the throttle movement obviously caused the pilot to freeze and he employed the incorrect recovery technique.

1.18.2 The corrective action by the pilot would have been to manually control the RPM first and then engage the governor, once stabilised. The onset of, and subsequent uncontrolled RPM profile obviously alarmed the pilot and lead to the unfortunate incident
