# Air Accident Investigation Sector

Nose Gear Tire Tread  
Separation on Takeoff

AAIS Case N° AIFN/0012/2010

Operator: Emirates  
Type: Boeing 777  
Registration: A6-EWC  
Location: Dubai International Airport, U.A.E.  
Date of Occurrence: 08 August 2010

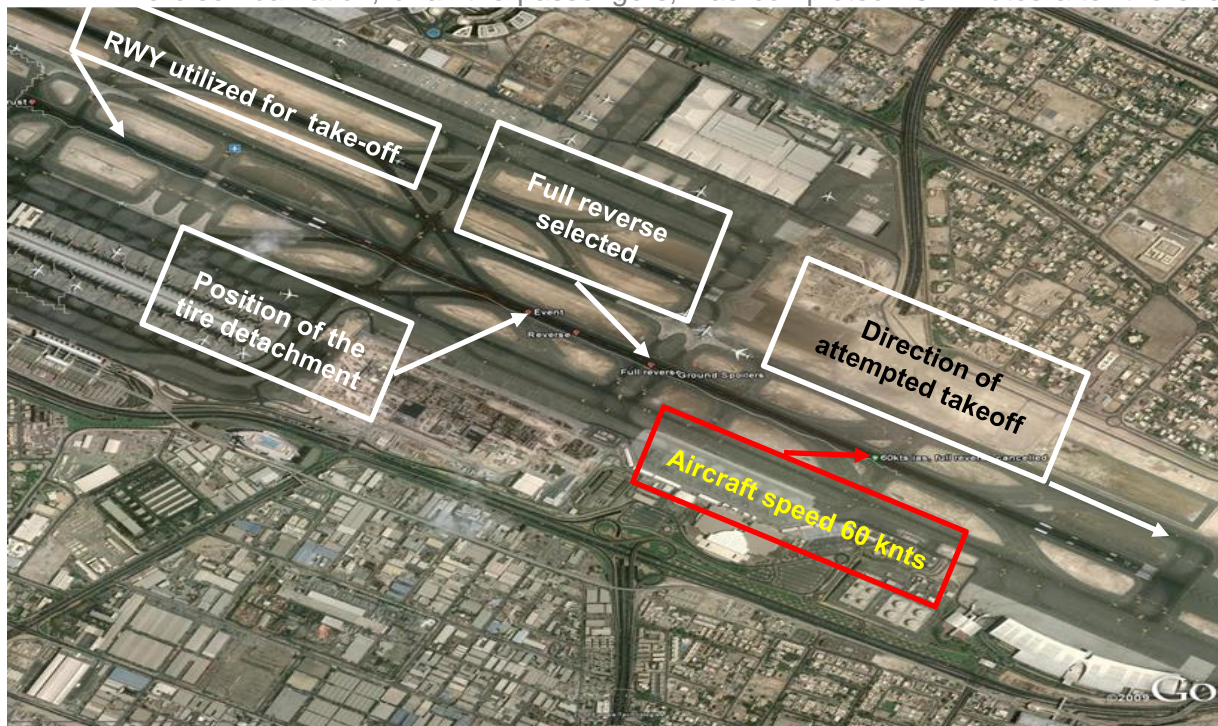
Figure 1. The event.

On 08 August 2010, at 05:57 UTC, a Boeing 777-200LR aircraft registration A6-EWC, operating Emirates flight number EK211 from Dubai International, United Arab Emirates to Houston, United States of America, commenced its take-off roll from the full length of runway 12R, at Dubai International Airport, UAE, with the Commander as pilot flying (PF). The aircraft was 5,767 kilograms below the maximum certified take-off mass and had a correctly calculated decision speed ( $V_1$ ) of 178 knots. At a speed of approximately 170 knots, the crew heard a loud bang and saw tire debris flying up in front of the aircraft, followed by significant vibration from the nose gear.

The PF rejected the take-off prior to  $V_1$  and during the rejected take-off the Aircraft speed did not exceed  $V_1$ . The aircraft was stopped on the centerline of the runway, with ample paved surface remaining. ATC was notified and the airport fire service attended. The commander alerted the cabin crewmembers. Due to the high energy rejected take-off (RTO) an Engine Indication and Crew Alerting System (EICAS) warning for 'brake temperature' activated and the main gear tires deflated. The crew did not attempt to move the aircraft. They started the APU, and shut down the engines. The fire service reported smoke coming from the main gear area and cooled the brakes with water. The commander made a public address to the passengers, explaining that the take-off had been rejected due to a tire failure and that everyone would disembark via steps.

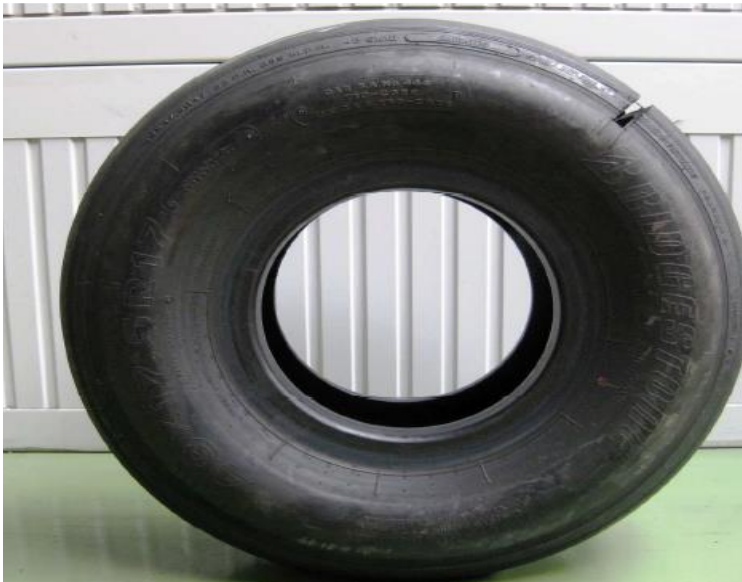
Figure 2. The failed tire outboard sidewall.

The failed tire was inspected in a laboratory and the tire outboard sidewall was found to be in a normal condition (see figure 2).

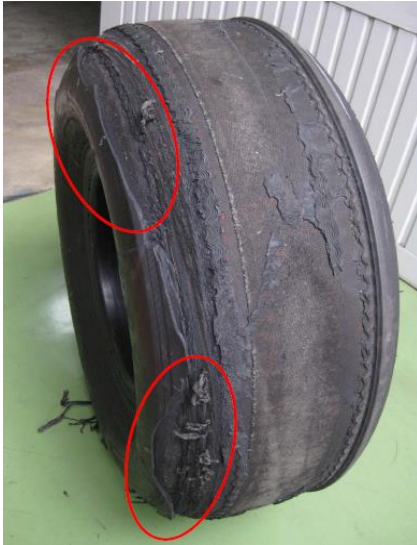
**Figure 3.** Inboard sidewall.

The inboard tire sidewall exhibited signs of seven large bulges in the upper sidewall/shoulder area (see figure 3).

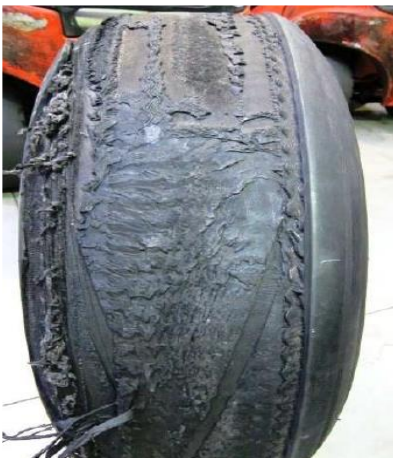
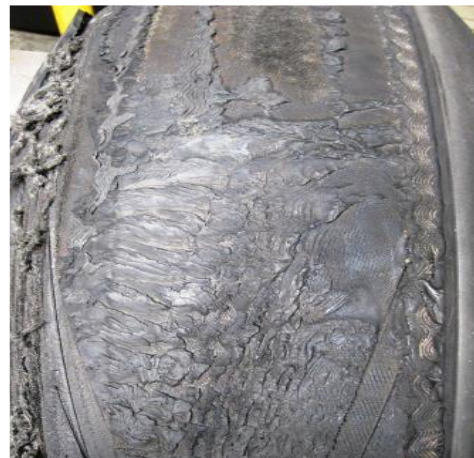
The tread crown had fully detached from the casing, except for the outboard shoulder rib, which remained firmly attached to the casing.

The separation surface was located at the top surface of the first belt ply and the original under-tread rubber (see figures 4 & 5).

The detachment pattern indicates good adhesion.

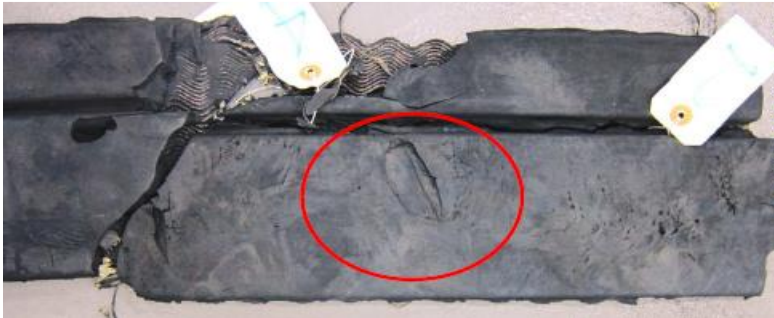
**Figure 6.** Indentation on the center rib.

Approximately 50% of the detached tread pieces were recovered. Closer examination of the detached tread pieces highlighted the presence of a large notch, measuring 46mm x 17mm in the surface of the tread center rib rubber (see red circle in figure 6).

Following an analysis of the right hand nose wheel tire debris, and the tire inspection report, it is evident that there was an imprint of an object that the failed tire had most probably passed over. The presence of this object, which the tire imprint showed did not have sharp edges or corners, was most likely, the initiating cause of the event. The object was not recovered. Therefore, it was not possible to determine where or when the tire ran over the object. But as the failed casing of the tire had marks of heat, one could argue of how many seconds it takes to generate the heat that was caused by the friction of the casing.

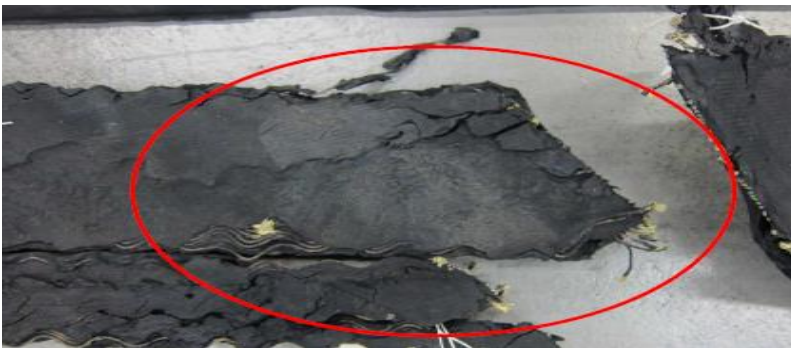
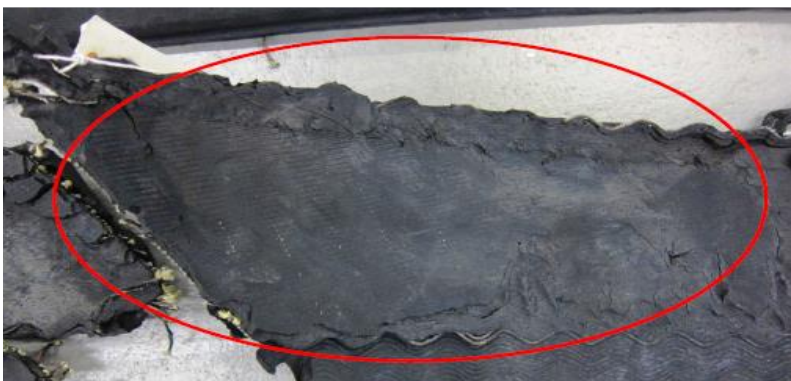
On the corresponding surface underneath the large notch, a clear sign of separation was evidenced by the smooth aspect and blue coloration of the rubber resulting from heat build-up due to internal friction (see figures 7 & 8 in red circles).

The investigation indicated that the casing plies showed no indication of separation or anomaly within the casing structure. The laboratory report concluded that the cause for the tire tread separation was an impact with a blunt foreign object.

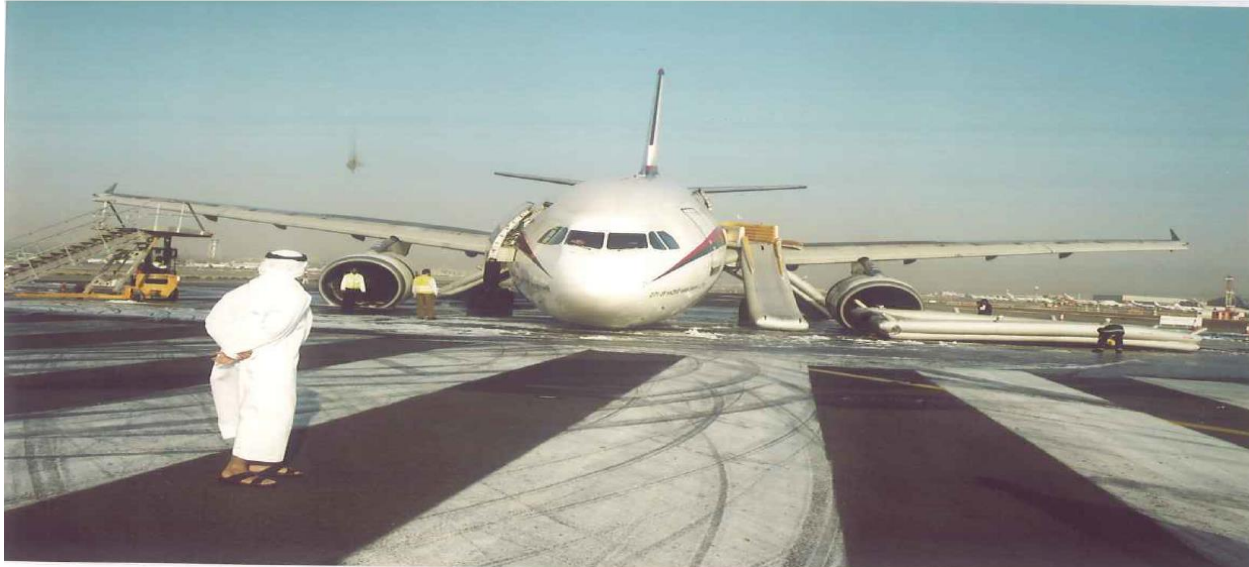
**Figure 12.** The A-310, following the Collapse of the Nose Landing Gear, after hitting an FOD on the take-off runway.

An Airbus A-310, registration S2-ADE, owned and operated by Bangladesh Biman Corporation Ltd, operating on a scheduled passenger flight from London United Kingdom to Dacca Bangladesh, with a stopover at Dubai International airport at 12 March 2007. During its take off from Dubai International runway 12L, passed  $V_1$ , the Commander rejected take-off after the crew heard a loud bang associated with considerable airframe shudder and vibration, later attributed to the collapse of the nose landing gear. The accident aircraft was kept under control and brought to a stop within the runway surface, left of the runway centerline.

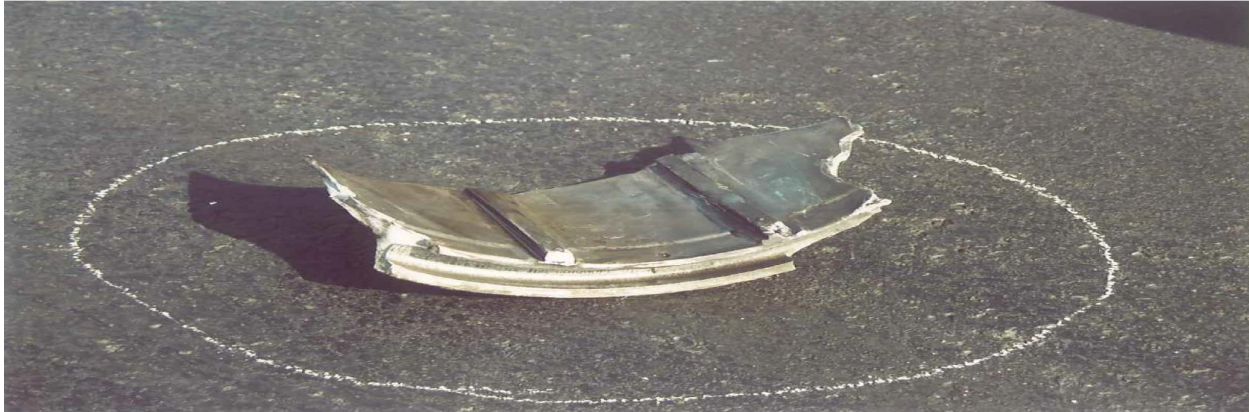
**Figure 13.** The Piece of the Wheel Rim, which was the cause of the Nose Landing Gear Collapse.

The cause of the accident was identified by the GCAA Air Accident Investigation team, as the collapse of the nose wheel landing gear, when it impacted a half wheel rim, which was broken off during the take-off roll of a previous aircraft (see below figure).
