AIRCRAFT ACCIDENT REPORT AND EXECUTIVE SUMMARY

Reference:	CA18/2/3/8829	
Aircraft Registration	ZU-FEZ	Date of Accident	03 September 2010		Time of Accident	1130Z
Type of Aircraft	Sportsman GS 2		Type of Operation		Private	
Pilot-in-command Licence Type		Private Pilot	Age	48	Licence Valid	Yes
Pilot-in-command Flying Experience		Total Flying Hours	292.4		Hours on Type	24.1
Last point of departure		Knysna				
Next point of intended landing		Plettenberg Bay				
Location of the accident site with reference to easily defined geographical points (GPS readings if possible)						
Private airstrip at Jakalskraal district - Plettenberg Bay.						
Meteorological Information		Surface Wind: Southerly, Wind Speed: 3 - 5kts; Temperature: 24°C, Visibility: Good				
Number of people on board	1 + 0	No. of people injured	0	No. of people killed	0	
Synopsis						
<p>During approach for landing the pilot pulled back on the control stick to initiate flaring in order to touch down on the runway. The pilot realised that the control stick was not moving back as required, but had somehow got stuck. His observation at the time was that the aircraft was experiencing a control lock condition. The result was that

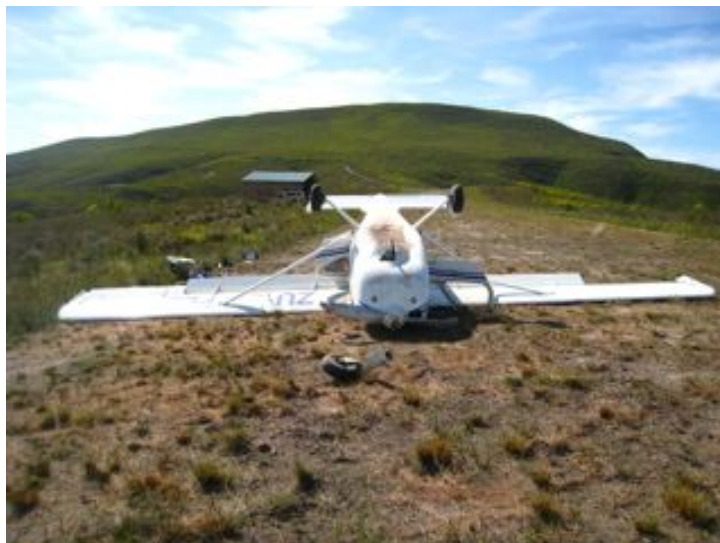
Figure 1, showing damage sustained in the accident.

1.12.2 During the investigation process, the damage observed was that the rear fuselage had cracked, the tail section (rudder) was crushed, the propeller blades were bent, the nose cone and windscreen were smashed, the nose landing gear was broken off and the right wing spar bent.

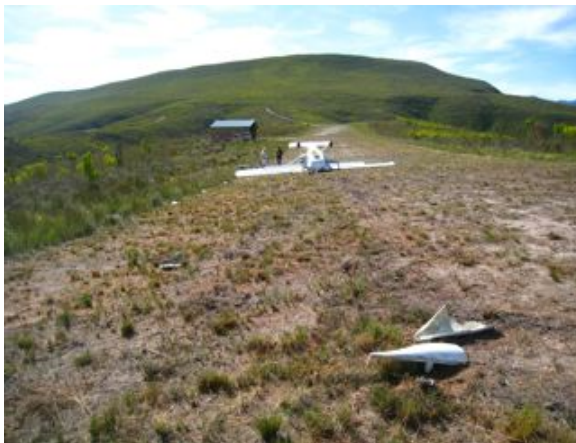
1.12.1 The aircraft was approaching the runway from a northerly direction. The runway length was determined to be approximately 500 metres long. It was a prepared ground runway on a hilly terrain that had a slight up-slope. The aircraft landed hard and bounced on the runway. While it was bouncing, the nose landing gear collapsed and broke off. At approximately 150 metres down the runway from the threshold, the aircraft flipped over. The aircraft sustained substantial damage in the ground impact sequence.

Figure 2 shows wreckage in direction of landing.

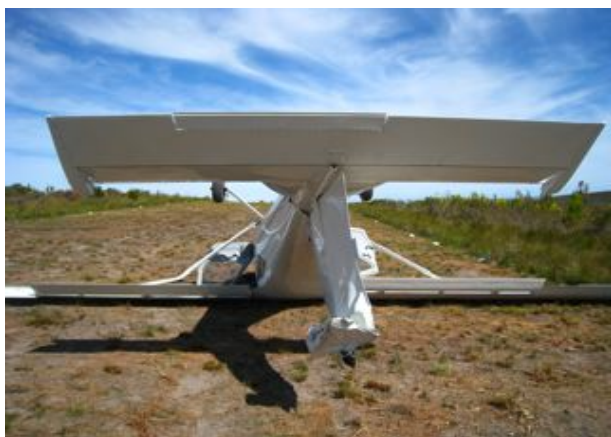
Figure 3 shows wreckage facing opposite direction of landing.

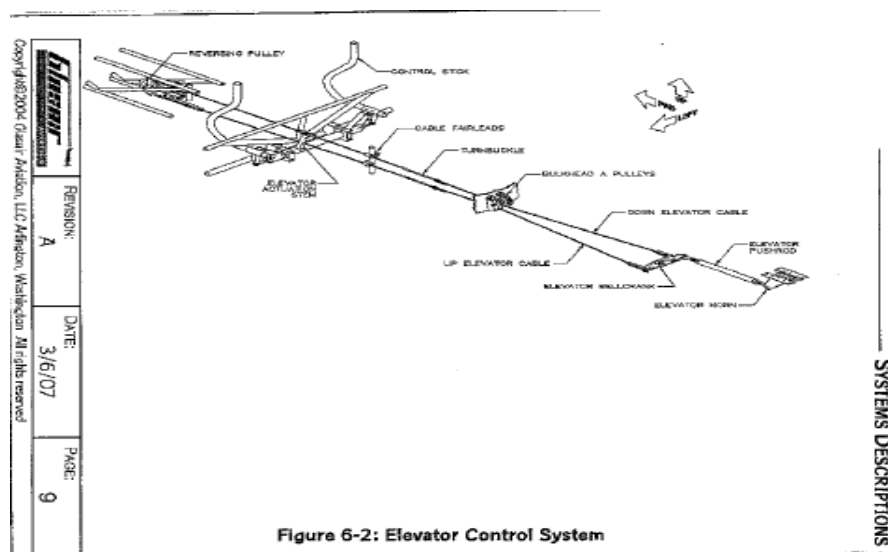
1.16.2 The primary control systems of the aircraft were inspected with the aim to determine the factors that contributed to the control lock condition. The evidence found indicated that only the elevator control system operation had been affected. The aft movement of the control stick to initiate a corresponding downward deflection reaction from the elevator control surface was found to be malfunctioning. The indication regarding the malfunctioning situation was that an obstruction had occurred between the passenger seat back (if folded forward) and the control stick. See below figure showing the elevator control system:

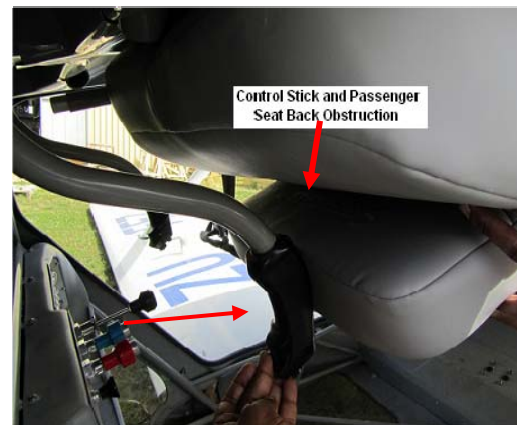
The passenger seat back was folded forward as it was during the flight. The control stick was pulled back against the top edge of the seat back. The indication was that the seat back was preventing the control stick from moving further back up to the travel stop. There was a difference in the forward and aft movement of the control stick. In order to measure the difference, the elevator control surface deflection “up/down” had to be measured.

Figure 4 shows obstruction caused by seat.

- 2.7 The passenger seat backrest was then folded forward to simulate the same scenario of the aircraft during the flight under discussion. Remarkably when the control stick was pulled back, it was discovered that an obstruction occurred between the passenger seat backrest and the control stick. The control stick was prevented by the passenger seat backrest to move fully back to its mechanical stop. The result was that the elevator flight control surface movement, up and down, was drastically affected by the obstruction. The elevator flight control surface movement was measured to determine the true impact. It was found that the elevator flight control surface up movement with the control stick pulled back firm against the top edge of the passenger seat backrest was measured to be approximately 13 degrees. The evidence found indicated that the elevator flight control surface movement was required to be up (23 degrees) and down (20 degrees). The “up” movement was thus reduced by 10 degrees, which may have influenced the performance of the aircraft.

- 3.1.8 The aircraft did not flare due to an obstruction caused between the front passenger seat backrest that was folded forward, and the control stick.

4.1 The SACAA, should immediately publish safety advisory information in the It is recommended that the Director of Civil Aviation (DCA) through the relevant department within form of the following: Service Bulletin, Airworthiness Directive, Service Letters etc. with the aim of notifying the GS-2 Sportsman type aircraft owners and operators of the indicated safety concerns involving the obstruction between the control stick and passenger seat back as mentioned in the report.

4.4 It is recommended that the State of Design and Manufacturer address the control stick and seat back obstruction design issues identified in the report with the aircraft manufacturer.

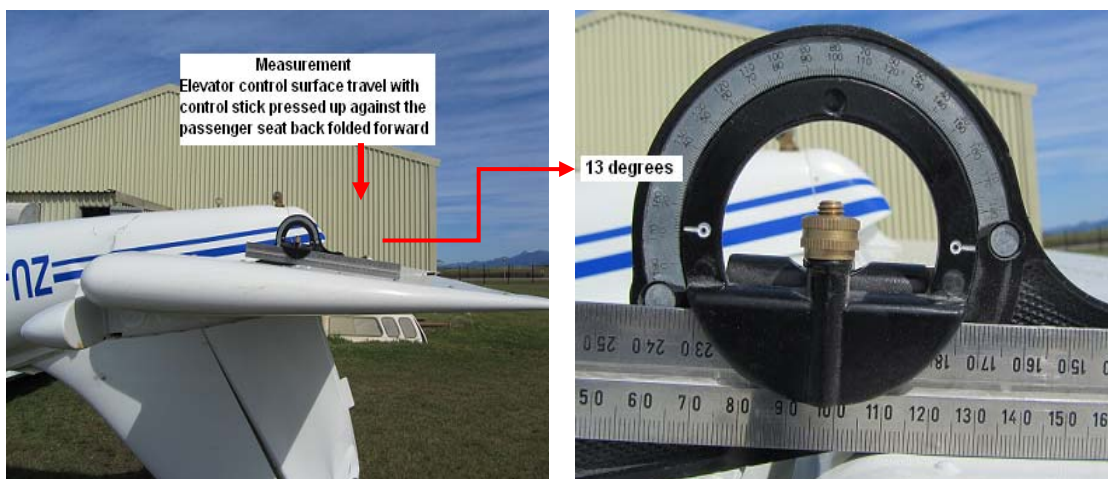
- (i) Elevator Travels: According to the Pilot Operating Manual (POH) the maximum elevator control surface travel distance is - up (23 degrees) and down (20 degrees) with an allowance of ± 1 degree in either direction. Based on the evidence of the information, the forward and aft movement of the control stick compared to the elevator control surface up and down was measured to determine if it was in compliance with the measurements included in the POH. The evidence found indicated that the elevator control surface moved - up ± 13 degrees and down 20 degrees. There was a difference of approximately 10 degrees in the “up” movement which was caused by the obstruction between the control stick and passenger seat back.

Figure shows flight control surfaces being measured.

- 3.1.12 The obstruction between the seat back rest and control stick affected the travel movement of the elevator flight control surface. The elevator flight control surface travel was measured and it was determined that the effect was a reduction in maximum "up" travel from the required 23 degrees to 13 degrees. Furthermore any change in the seat back rest position or the seat back rails moving forward would reduce the elevator travel even more drastically.

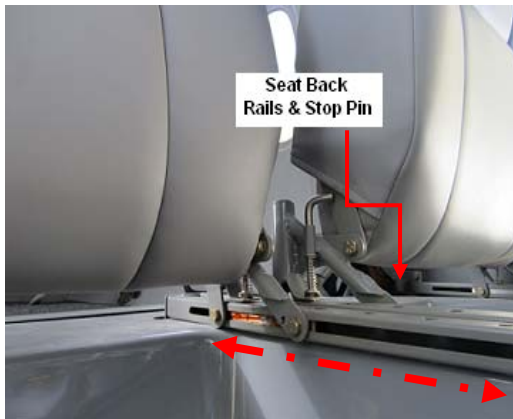
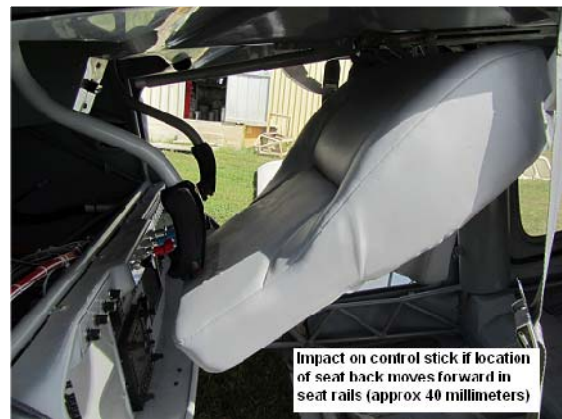
- (i) The distance between the seat back pivot point and locking pin was determined to be approximately 30 millimetres.
- (ii) The Seat Rail has eight holes wherein the locking pin is secured to stop it from inadvertently moving forward or rearward. The holes are approximately 40 millimetres in distance away from each other.

- (iii) If the seat back is pushed backwards to its furthest point on the seat rail and folded forward, the distance from the pivot point to the top of the seat back will be approximately 540 millimetres.
- (iv) Every time the seat back is moved one hole forward, the distance from the pivot point to the top of the seat back increases by approximately 40 millimetres, which is calculated to be the following: (x2-580,x3-620,x4-660,x5-700,x6-740,x7-780 and x8-820). The increase in the distance of the seat back being moved forward is equal to the obstruction presented between the seat uprest and the control.
- (v) The pilot and passenger seat backs are also not fitted with a latch device that would keep it from folding forward inadvertently during flight.

- 3.1.11 Both the pilot and passenger seats back rests were inspected during the investigation. There was evidence found indicating that the seat back rests were obstructing the backward movement of the control stick. It was also found that the seat backs did not have any latching device to keep them from inadvertently folding forward during flight and causing a similar problem.
