AIRCRAFT ACCIDENT REPORT AND EXECUTIVE SUMMARY

Reference:	CA18/2/3/8838	
Aircraft Registration	ZS-REU	Date of Accident	22 September 2010		Time of Accident	0800Z	
Type of Aircraft	Schweizer 269C-1		Type of Operation		Private		
Pilot-in-command Licence Type		Private (helicopter)	Age	23	Licence Valid	Yes	
Pilot-in-command Flying Experience		Total Flying Hours	115.5		Hours on Type	2.1	
Last Point of Departure		Kob Inn Beach Resort, Eastern Cape					
Next Point of Intended Landing		Port Alfred, Eastern Cape					
Location of the Accident Site with Reference to Easily Defined Geographical Points (GPS readings if possible)							
Kob Inn Beach Resort, Eastern Cape (GPS co-ordinates: S32° 26.446' E028° 40.378')							
Meteorological Information		SA Weather Services Report: Scattered low cloud, strong surface winds and moderate to severe turbulence in the Kob Inn area					
Number of People on Board	1 + 1	No. of People Injured	0	No. of People Killed	0

AIRCRAFT ACCIDENT REPORT

Name of Owner/Operator : North Coast Chartering Services
Manufacturer : Schweizer Aircraft Corporation
Model : 269C-1
Nationality : South African
Registration Marks : ZS-REU
Place : Kob Inn Beach Resort Eastern Cape
D

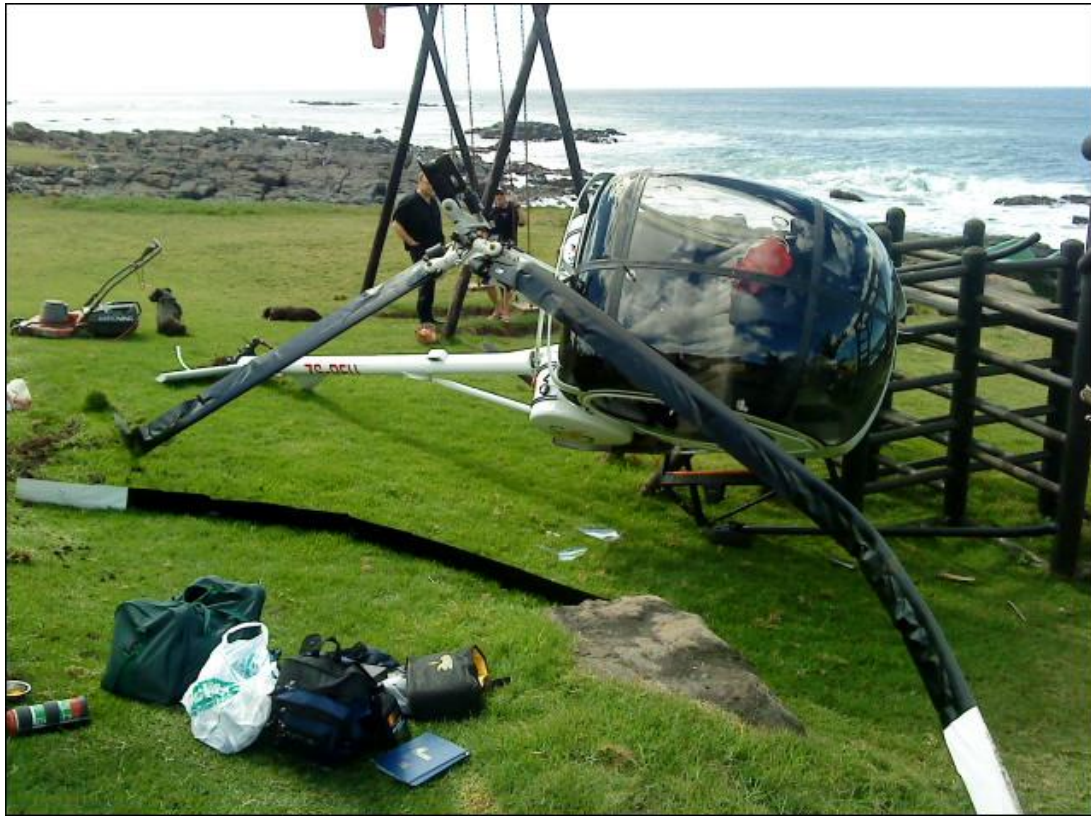
1.3.1 The helicopter sustained substantial damage to the main rotor blades, tail boom, tail rotor and skids.

Figure 1: The helicopter next to the jungle gym wooden construction

1.12.1 The helicopter collided with a jungle gym wooden construction, causing the helicopter to roll over onto its right-hand side. The main rotor blades, tail boom, tail rotor and skids subsequently sustained substantial damage during the impact sequence.

1.12.2 The jungle gym was slightly damaged.

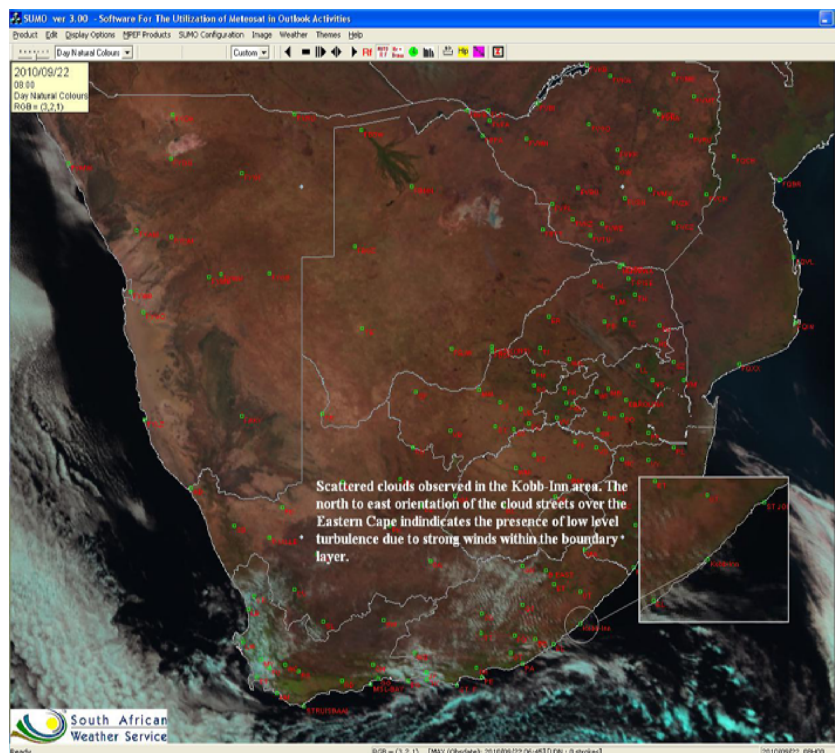
The analysis of the METAR together with the satellite image indicates the presence of scattered low clouds, strong surface winds and moderate to severe turbulence in the Kobb Inn area at about the time of the incident.

The satellite image (Figure 2) shows scattered to broken low-level clouds over the southern parts of the country due to the onshore flow caused by the frontal system. The presence of the cloud streets (with a north-south orientation) over the south-eastern parts of the country indicates the occurrence of low-level turbulence over these areas.

Figure 2: Satellite image at the accident site at Kobb Inn in the Eastern Cape

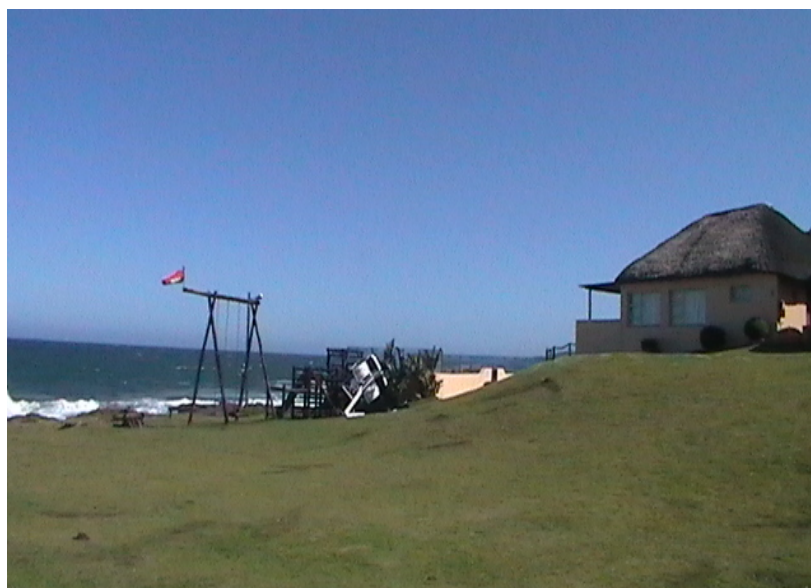
1.10.1 The helicopter landed and attempted to take off from Kob Inn Beach Resort in the Eastern Cape (GPS Co-ordinates: S32° 26.446' E028° 40.378'), at an elevation of 5ft above mean sea level (AMSL). A windsock is located at the beach resort.

Figure 2: The wreckage with windsock on swing frame.
