**Statens haverikommission**  
Swedish Accident Investigation Board

***Final report RL 2011:06e***

**Aircraft accident to SE-IDT  
at Älvsbyn/Högheden Airfield, BD County,  
on 1 October 2010**

Case L-130/10

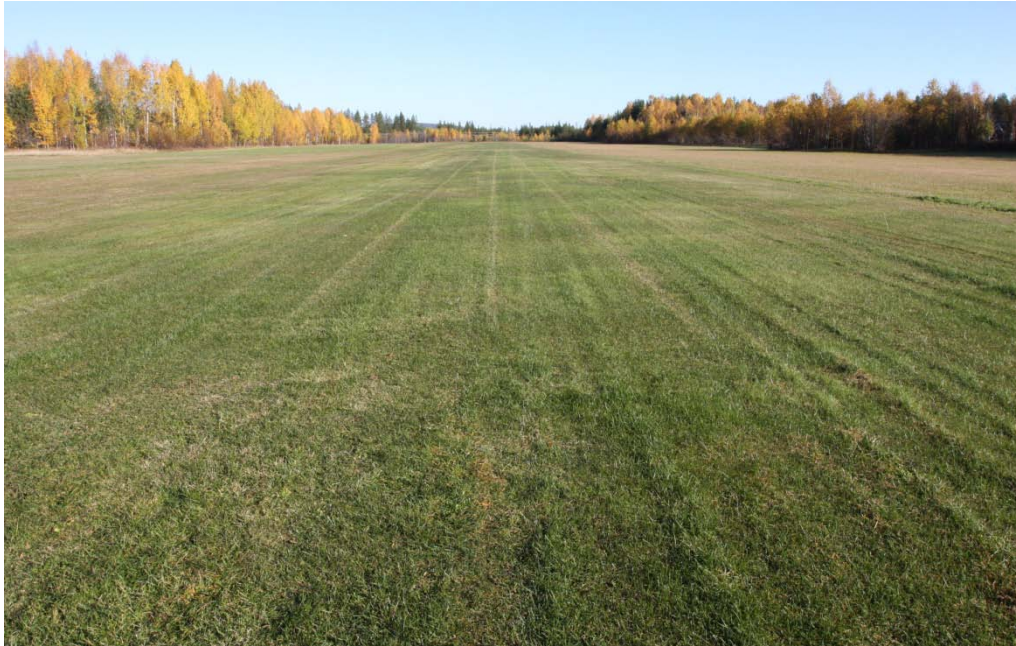
The image below shows that the tracks from the nose wheel and main wheels start along the same line. Because the nose wheel is 2.4 meters in front of the main wheels, it indicates that the aircraft landed with its nose wheel first.

Fig. 1 Tracks after touchdown. Photo Älvsbyn Police.

The marks on the ground after landing showed that the aircraft had landed with its nose wheel slightly before the main landing gear which shows that the speed was much higher than recommended.

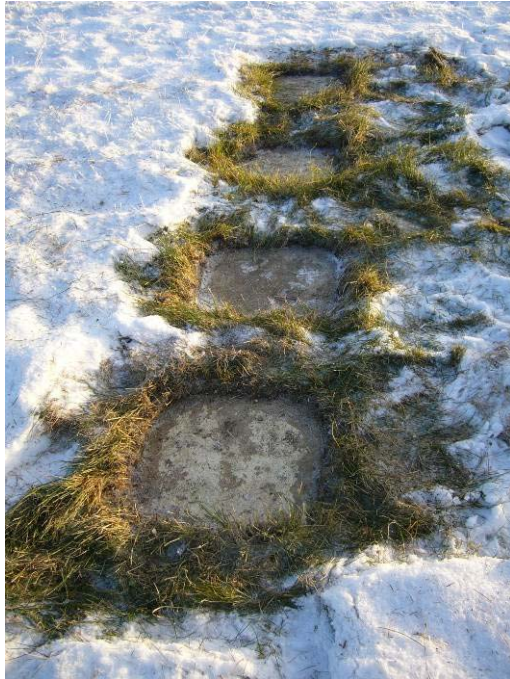
Both thresholds had been moved in at Älvsbyn Airfield. For the approach in question, the pilot used runway 04 whose threshold had been moved in by 90 metres. The threshold for runway 04 was equipped with day markings on the left side. The markings consisted of four slabs of approximately 40x40 cm. The slabs were painted in white paint that had almost completely peeled off which made them difficult to detect.

Fig. 5 Day marking threshold runway 04.

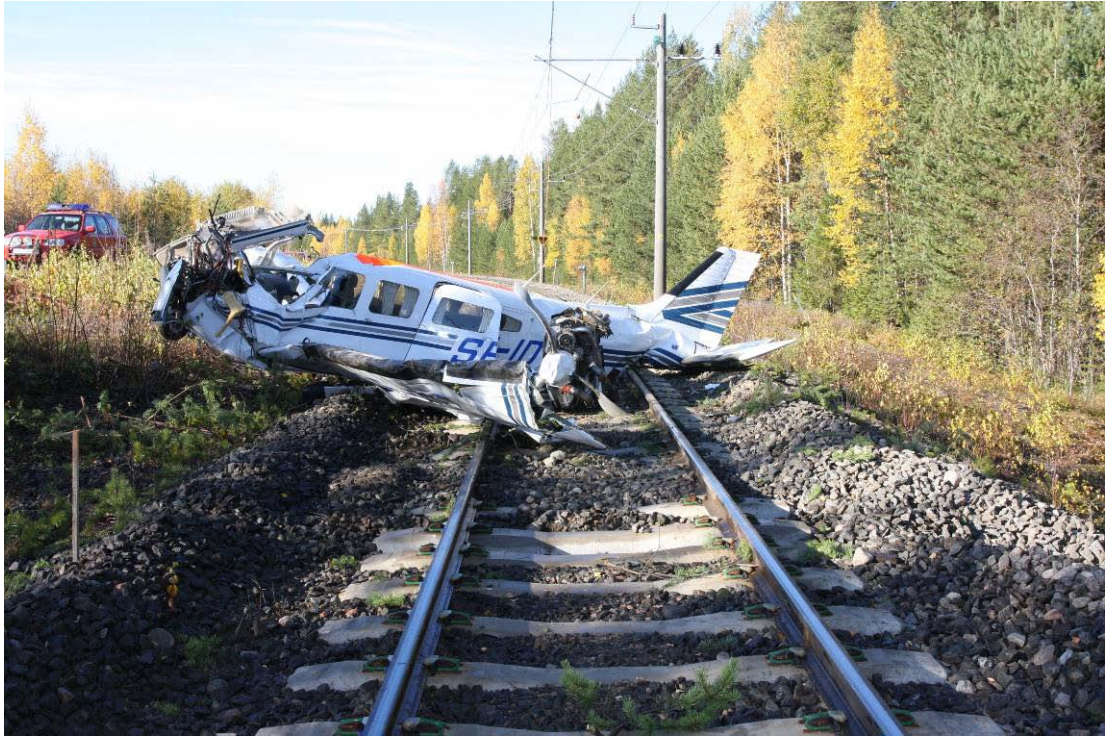
Fig. 6 The aircraft wreckage. Photo Älvsbyn Police.

The aircraft was substantially demolished. The engine and propeller had separated from the fuselage and lay at the aircraft's rear left side. The nose section had been bent upwards and backwards and the windscreen and the front of the cabin had been pushed in. Both the wings and the tail unit were severely deformed.

The instrument panel, whose top edge had rotated towards the pilot, was relatively intact. The pilot's steering yoke was broken on the right-hand side and the right steering yoke was resting against the front passenger seat. Both yokes were in their rearmost positions. The flap and the flap lever was fully extended. Gas, propeller and mixture controls were in their frontmost positions.

Nothing has emerged to suggest that the aircraft had any technical faults.

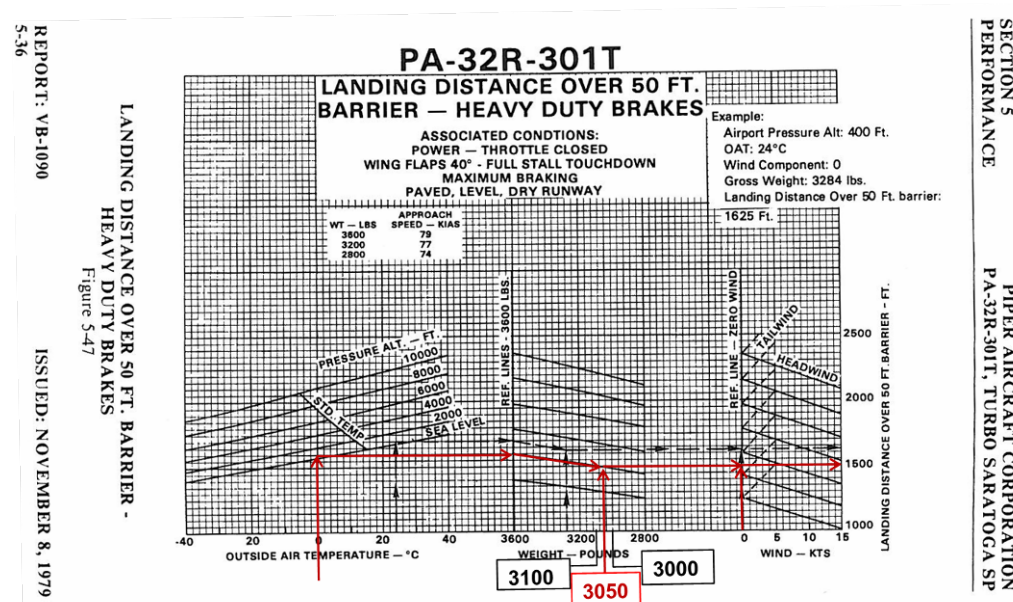
Since the condition of the runway surface was made up of a wet short-cropped grassy surface, the landing distance must be increased by at least 20 per cent. The corrected landing distance is therefore 548 m (457 x 1.20).

The condition of the runway surface causes an increase in the landing distance by 91 m (548-457=91 m). The required landing distance is therefore 784 m (548 x 1.43).

Fig. 8 Landing distance.

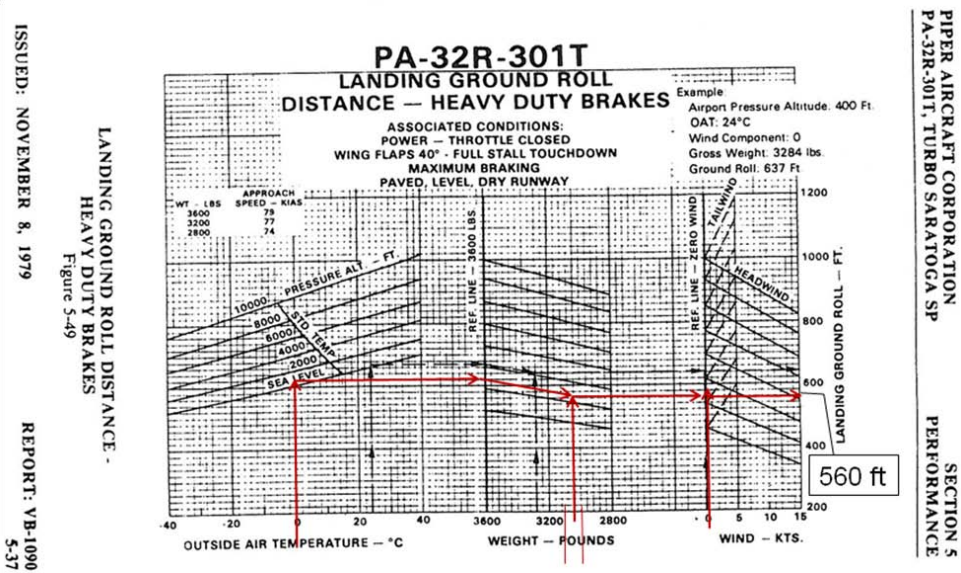
The SHK has similarly calculated landing run to 560 feet or 171 m (see fig. 9 below).

Fig. 9 Landing distance.

Landing run corrected due to the wet grass is 262 m (171 + 91).

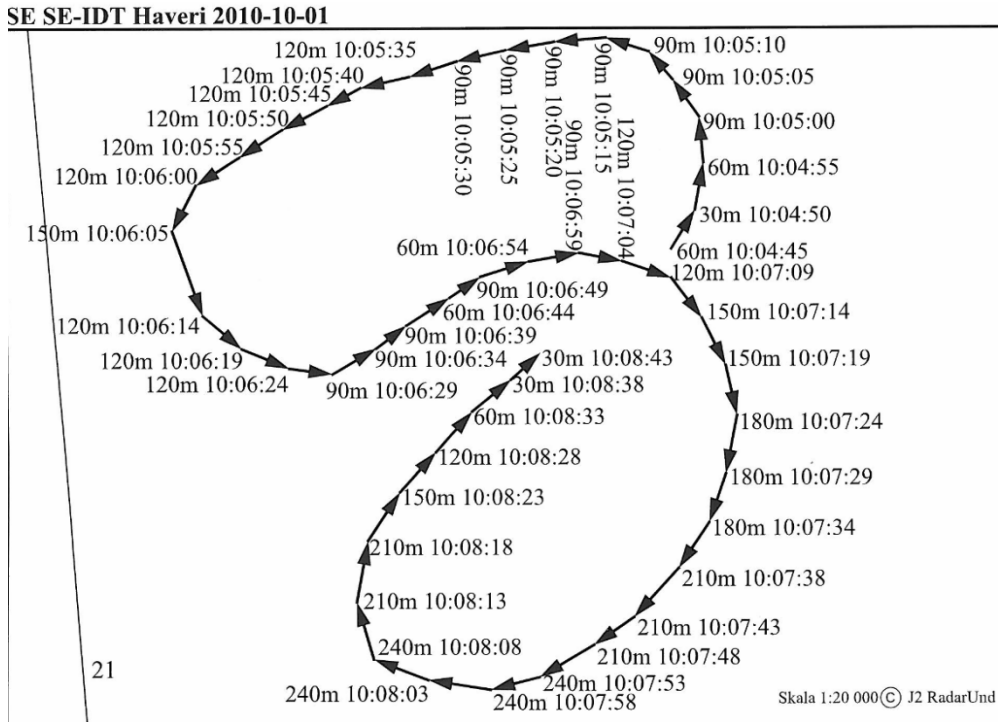
The radar information shows that the pilot made a final approach with a right-hand circuit.

Fig. 10 The approach to Älvsbyn Airfield.

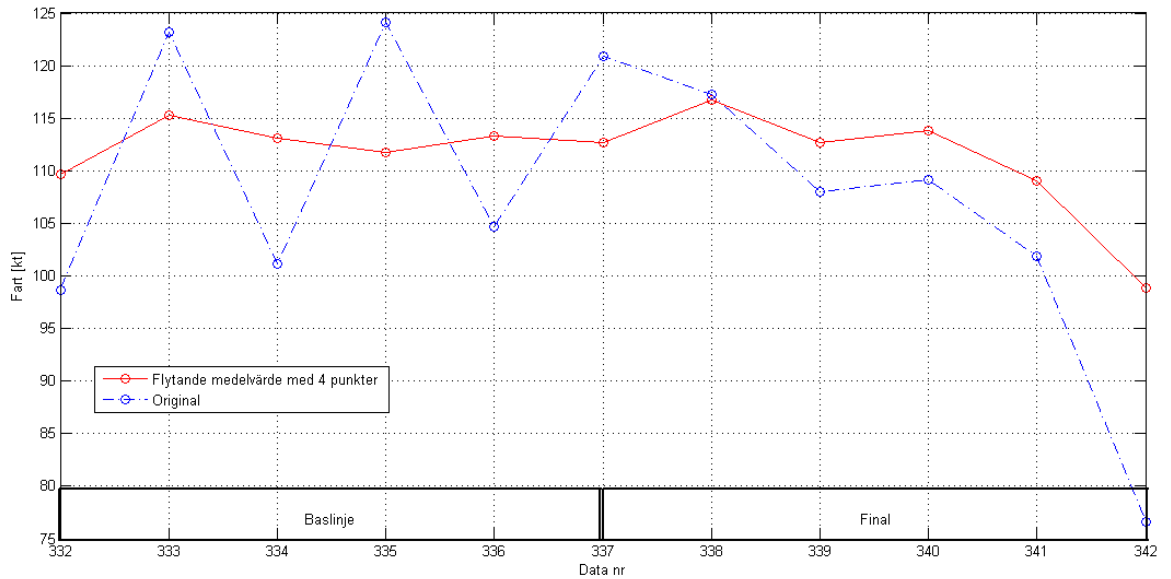
Speed data calculated after the radar points are not exact. SHK has therefore chosen to present the speed as a floating average of four points as shown in fig. 11.

Fig. 11 The graph shows the speed of the last points on the radar base line and final.

With the help of radar data, SHK has been able to establish that the speed was just over 110 knots at baseline and on the long final. For the final approach, the speed gradually decreased, but was much higher than the recommended final approach speed.

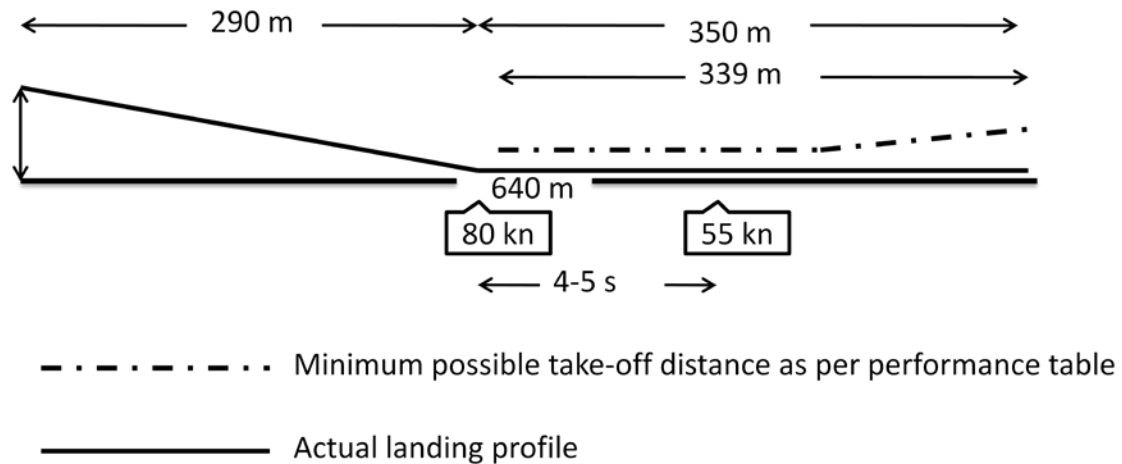
SHK has performed calculations of the actual landing profile as described below (see fig 12). In the calculations, it has been assumed that the touchdown speed was 80 kn.

Fig. 12 Go-around from touchdown at 80 knots.

Fig. 12 shows that the latest possible go-around point is at about 55 knots, and the time available for the go-around procedure which is 4-5 seconds.
