AIRCRAFT ACCIDENT REPORT AND EXECUTIVE SUMMARY

Reference:	CA18/2/3/8845	
Aircraft Registration	ZS-HTJ	Date of Accident	8 October 2010		Time of Accident	1245Z	
Type of Aircraft	Hughes 269C (Helicopter)		Type of Operation		Game darting operation		
Pilot-in-command Licence Type		Private Pilot	Age	47	Licence Valid	Yes	
Pilot-in-command Flying Experience		Total Flying Hours	1 594.8		Hours on Type	1 568.1	
Last point of departure		Farm Eulalie in the Marken district (Limpopo Province)					
Next point of intended landing		Farm Eulalie in the Marken district (Limpopo Province)					
Location of the accident site with reference to easily defined geographical points (GPS readings if possible)							
Farm Eulalie in the Marken district (GPS position; South 23° 25.229' East 028° 17.137', elevation 3 100 feet)							
Meteorological Information		Surface wind; 040°/4kts, Temperature; 34°C, Visibility; + 10 km					
Number of people on board	1 + 1	No. of people injured	1 + 1	No. of people killed	0

AIRCRAFT ACCIDENT REPORT

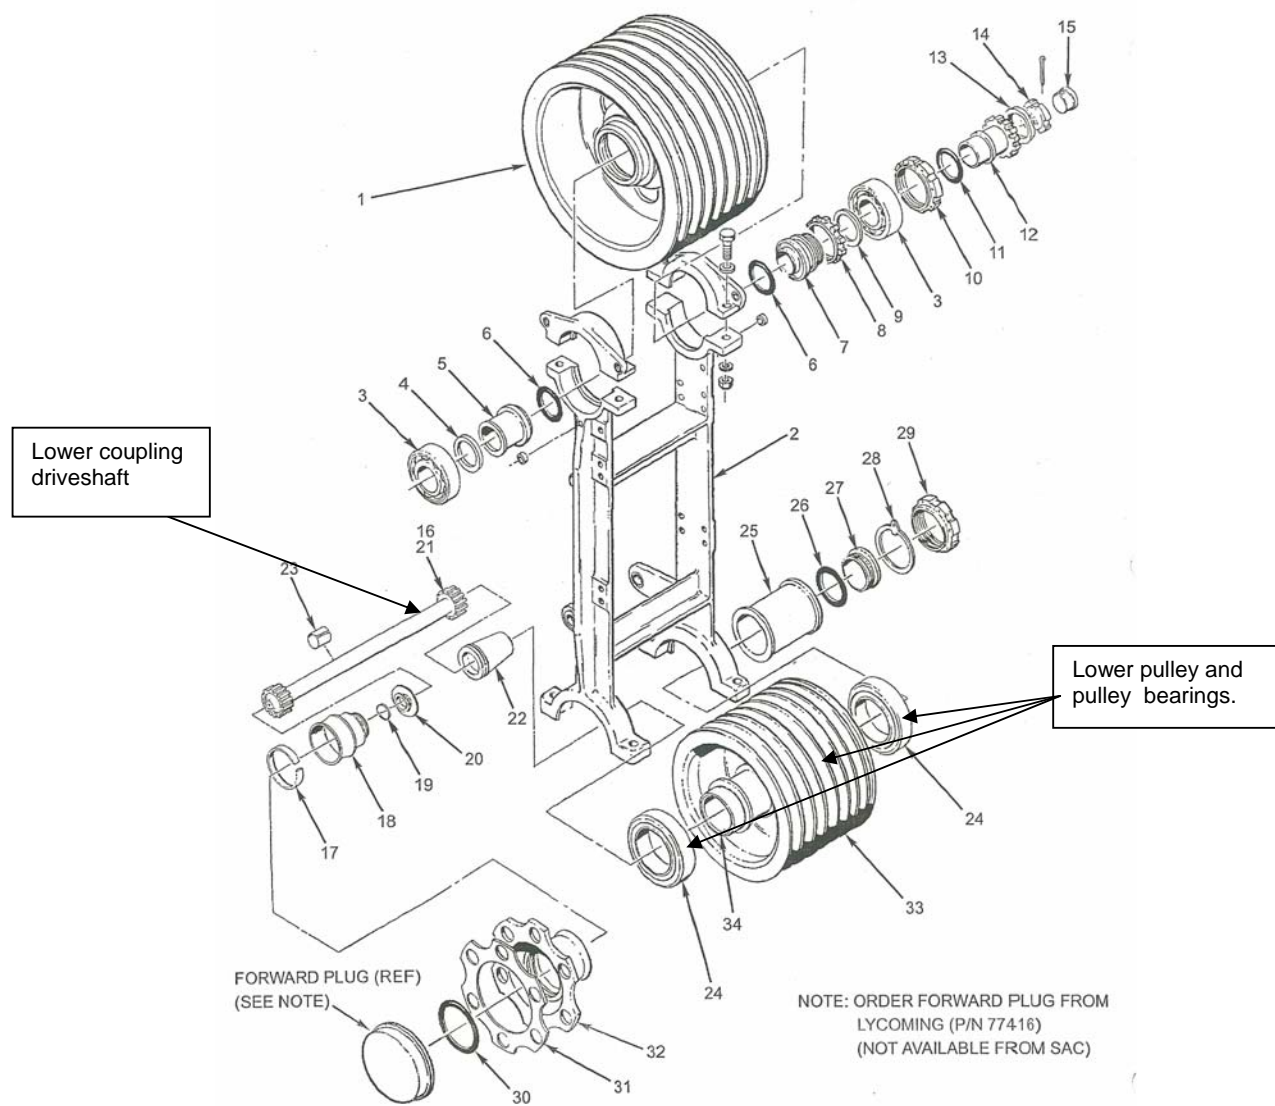
Diagram 1. Lower and upper transmission drive pulley assemblies.

During the post-field investigation it was found that the lower coupling driveshaft, part number 269A5559-3, serial number S1206 had failed. The lower coupling driveshaft on this helicopter was replaced with a new unit on 21 June 2001 at 3 593.0 airframe hours. The driveshaft, which has a life limit of 6 000 hours, had been in service for 1 442.8 hours at the time of the accident/failure. The failed component (lower coupling driveshaft) can be seen on the diagram on the next page, indicated by an arrow projected from the text box.

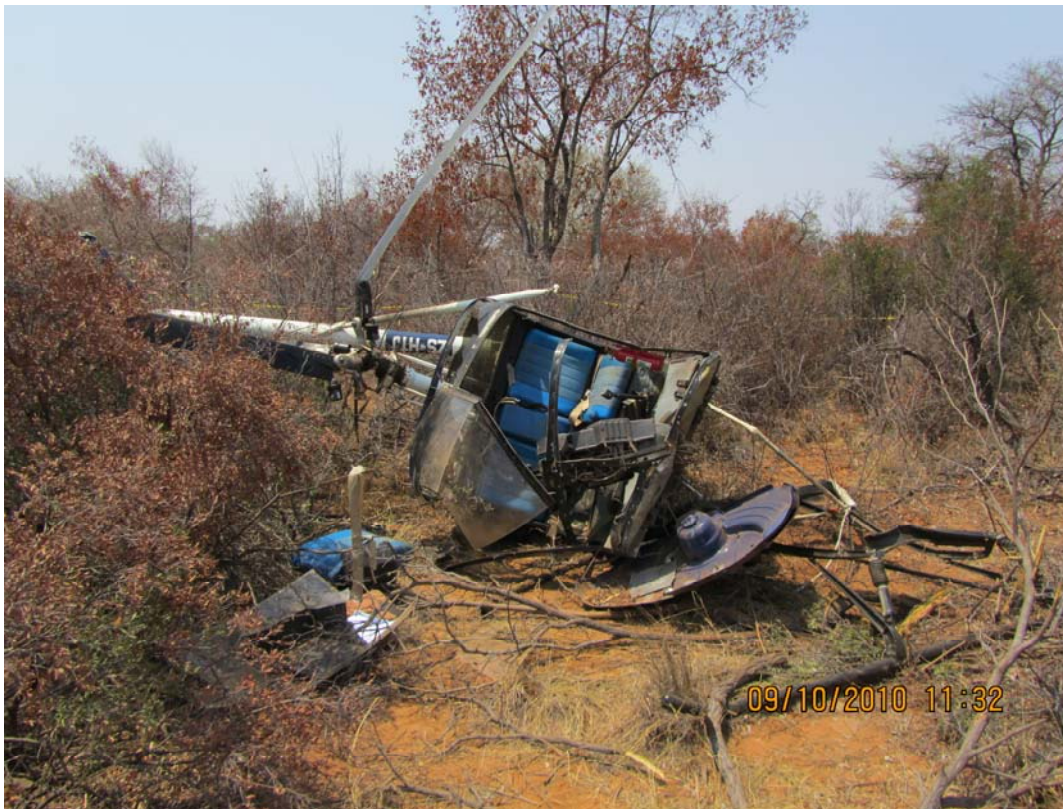
1.12.1 The helicopter impacted with dense bush-type of terrain on a heading of 010°M. The helicopter landed hard in an upright position on its skid gear, which subsequently collapsed. The airframe structure subsequently separated from the skid gear and rolled over to the right-hand side. According to the ground impact markings, there was very little to no forward movement during the impact sequence. The markings were substantially disrupted by persons who assisted the two occupants that were on board the helicopter, following the accident.

Figure 1. A view of the main wreckage as it came to rest following impact.

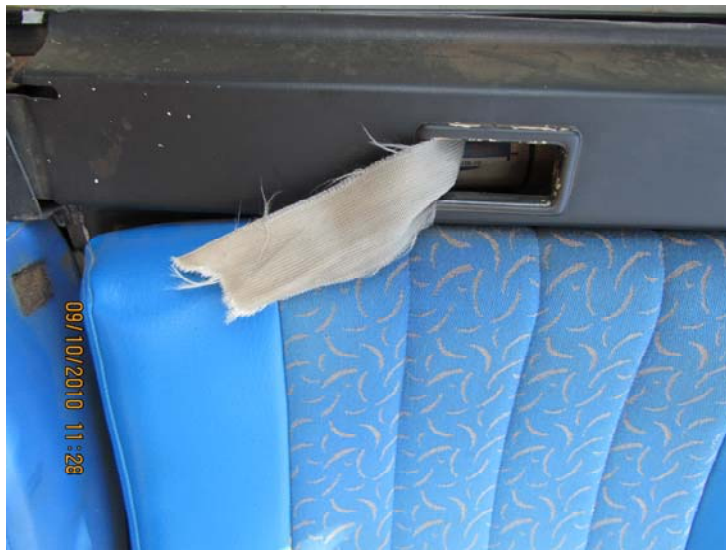
The passenger that was seated on the right-hand side sustained minor injuries; however, the pilot was seriously injured in the accident as he sustained three broken vertebra. His shoulder harness failed during the impact sequence and was found to be in a dilapidated state, most probably aggravated by prolonged exposure to the sun. The shoulder harness on the right-hand side was found to be in the same condition, but did not fail. It is believed that if the pilot's shoulder harness had not failed, his injuries might have been much less severe.

Figure 2. A view of the failed shoulder harness at the left seat (pilot side).

- 3.1.7 The pilot's shoulder harness failed during the impact sequence, and was found to be in a dilapidated state (not fit for the purpose).
- 3.1.8 The pilot was seriously injured in the accident.

The MAN should highlight the fact that such devices should be in a good overall condition, and that the integrity of such inspection should not compromise the intent of such a device in any way. Should the harness not meet the minimum required standard(s), or should the integrity thereof be questionable, the unit (harness) should be replaced without further delay.

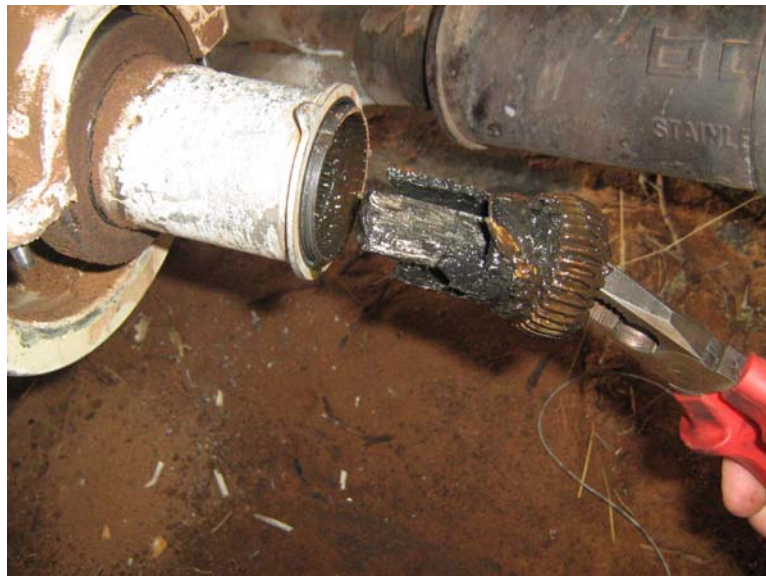
1.16.1 The wreckage was recovered to an aircraft maintenance organisation (AMO) where the main transmission components were removed. It was found that the lower shaft part number 269A5559-3, serial number S1206 had failed. The shaft was subjected to metallurgical analysis in order to determine the failure mode. Along with the shaft the two lower pulley bearings (part number 269A5050-80) were also examined. *(The lower coupling driveshaft as well as the two bearings may be viewed in the diagram inserted on page 9 of this report).*

Figure 3. A view of the failed driveshaft being removed from the drive pulley assembly.

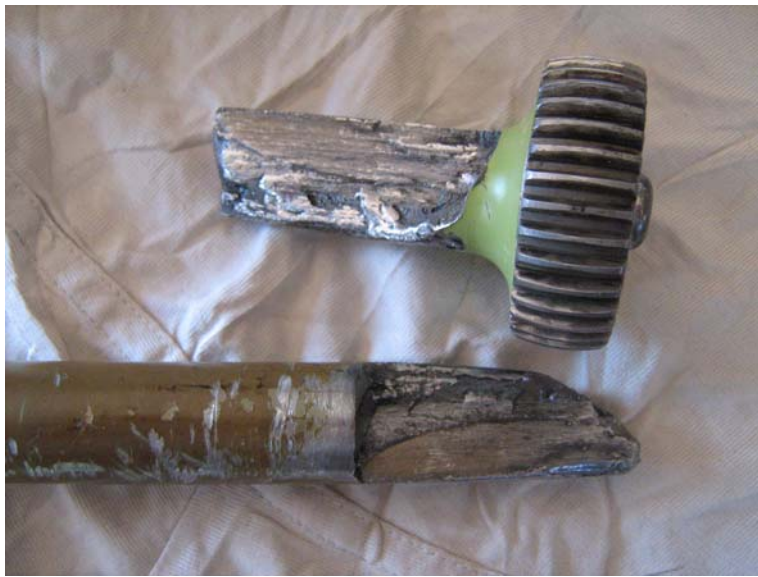
Figure 4. A view of the failed driveshaft after it was cleaned (grease removed).

2.2 The post-field investigation revealed that the lower coupling driveshaft had failed in fatigue during operation. The driveshaft, which has a service life of 6 000 hours, failed after being in service for 1 442.8 operational hours, according to available records. The investigator did consider the possibility that the failure could have been attributed to an engine over-speed condition that might have been induced by the deactivation of the clutch assembly in-flight, due to the clutch guide pulley bracket that was found to have failed.

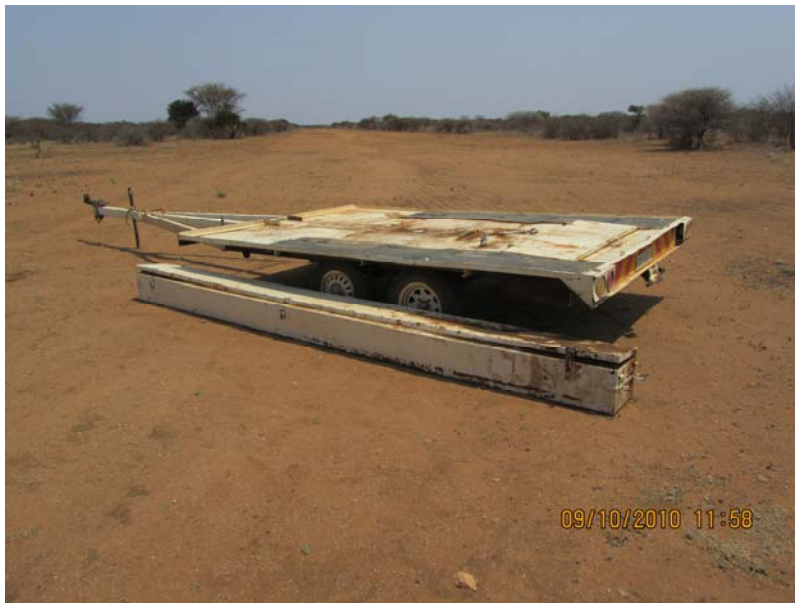
The photo below was taken on the game farm during the on-site investigation into the accident in question. A main rotor blade box is positioned next to the trailer, as the trailer does not have any supporting structure to accommodate the blade folding method, as discussed above.

A view of a helicopter trailer and next to it, a main rotor blade box.

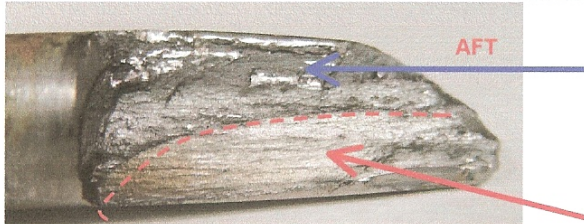
The on-site visual examination revealed the drive shaft (Diagram 1, red arrow) to be fractured at the pulley (AFT) end (Photo 2, red arrow) of the assembly. Lubrication remains was evident. The clutch pulley (Photo 1, blue arrow) was fractured with the clutch cable in wedged position (Photo's 15 and 16).

Photo 4: Drive shaft fracture, AFT end (digital)

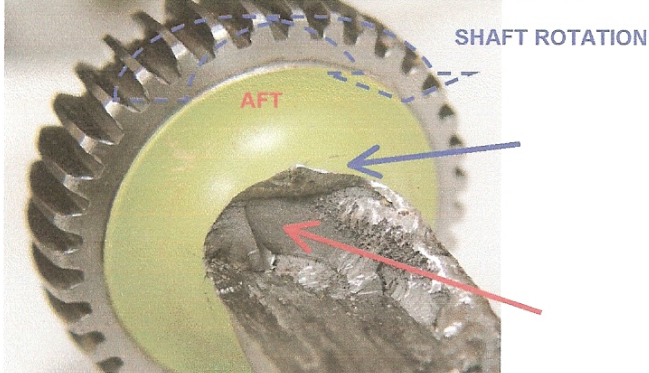
Photo 5: Drive shaft fracture, AFT end (digital)

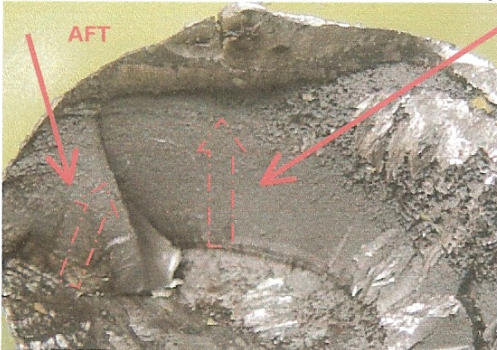
Photo 6: Fatigue fracture surface, AFT end (digital)

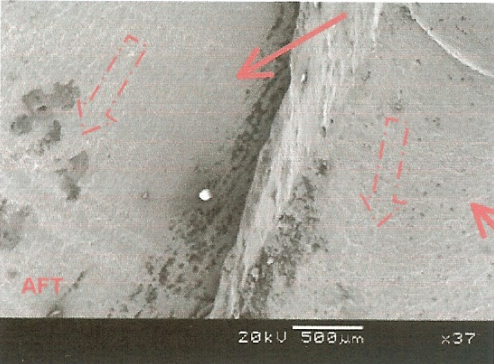
Photo 7: Fatigue beach marks on fracture surface, AFT end (x37, SEM)

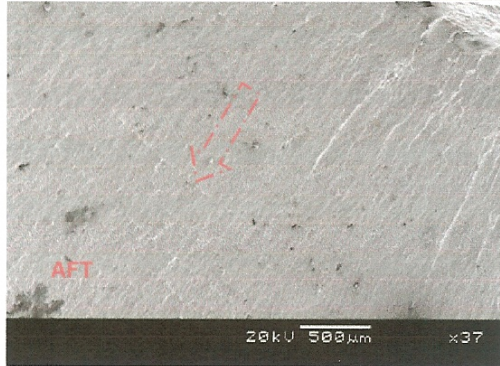
Photo 8: Fatigue beach marks on fracture surface, AFT end (x37, SEM)

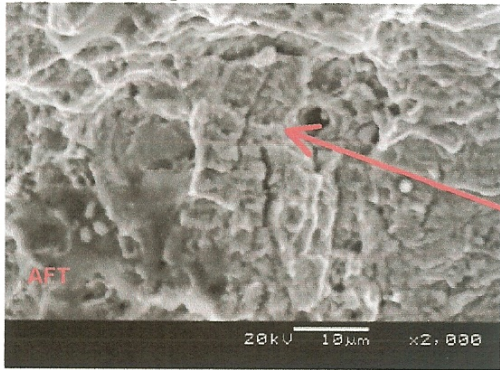
Photo 9: Fatigue striation marks on fracture surface, AFT end (x2000, SEM)

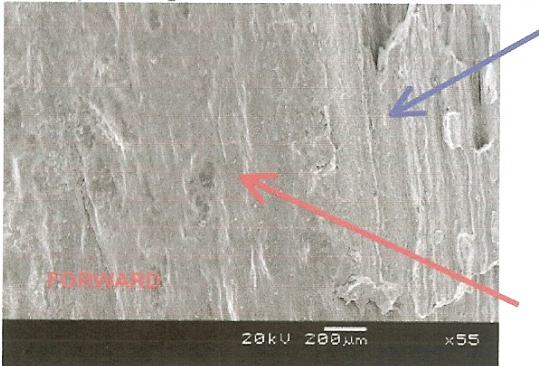
Photo 10: Lab opened fracture showing existing and 'new' surfaces (x55, SEM)

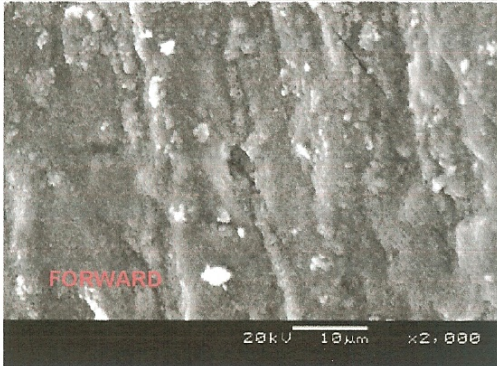
Photo 11: Lab opened fracture showing contaminated existing surface (x2000, SEM)

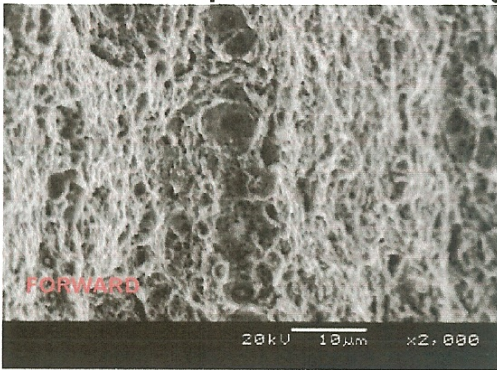
Photo 12: Lab opened fracture showing single tensile overload surface (x2000, SEM)

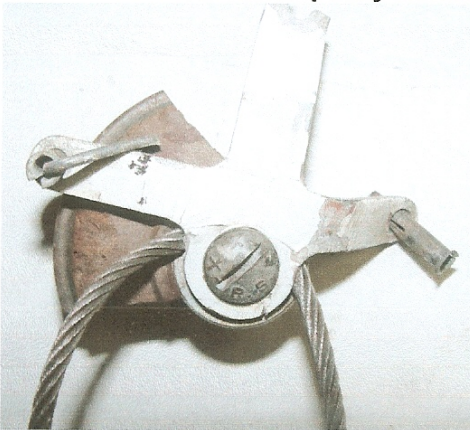
Photo 15: Fractured clutch pulley assemble (digital)

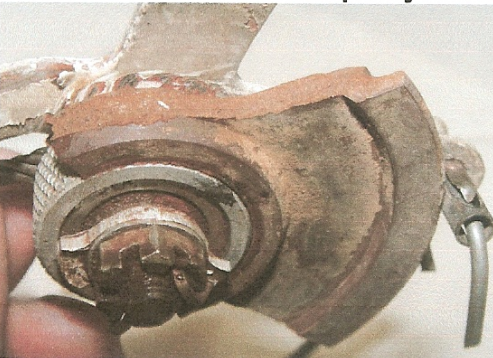
Photo 16: Fractured clutch pulley assemble (digital)

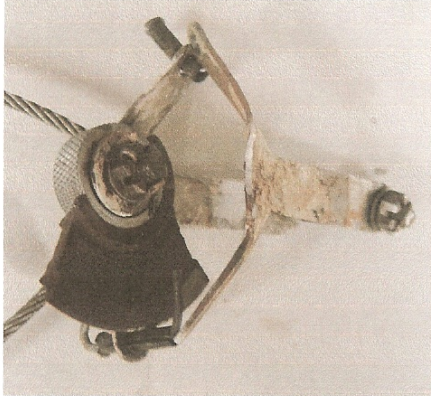
(ii) The clutch guide pulley bracket was found to have failed in overload mode, which was associated with impact damage. This eliminated the fact that an engine over-speed condition occurred during the flight in question, which could have contributed or propagated the failure that presented itself.

Photo 17: Fractured clutch pulley assembly (digital)
