SOUTH AFRICAN CIVIL AVIATION AUTHORITY

ACCIDENT REPORT – EXECUTIVE SUMMARY

Aircraft Registration	ZU-DCI	Date of Accident	18 October 2010	Time of Accident	0615Z
Type of Aircraft	Rotorway Executive 162		Type of Operation		Training
Pilot-in-Command Licence Type	Commercial Pilot	Age	38	Licence Valid	Yes
Pilot-in-Command Flying Experience	Total Flying Hours	1 280.6		Hours on Type	50.7
Last Point of Departure	Morning Star Aerodrome, Western Cape				
Next Point of Intended Landing	Morning Star Aerodrome, Western Cape				
Location of the Accident Site with Reference to Easily Defined Geographical points (GPS readings if possible)					
In a wheat field, approximately 3 nm east of Morning Star Aerodrome					
Meteorological Information	Wind 090° at 5 kts; temperature 18°C, visibility +10 km				
Number of People on Board	1 + 1	No. of People Injured	0	No. of People Killed	0
Synopsis	<p>An instructor and a student pilot took off from Morning Star Aerodrome on a training flight to Fisantekraal airfield (FAFK). At a height of approximately 1 500 ft above mean sea level (AMSL) during a climb, the instructor demonstrated to the student a simulated engine failure by rolling off the throttle.</p> <p

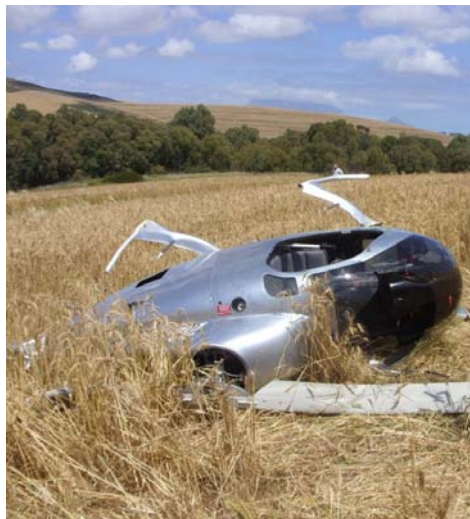
1.12.1 The pilot was performing an autorotation when the helicopter made contact with the ground and rolled over onto its right-hand side.

Figure 1: The helicopter on its right-hand side

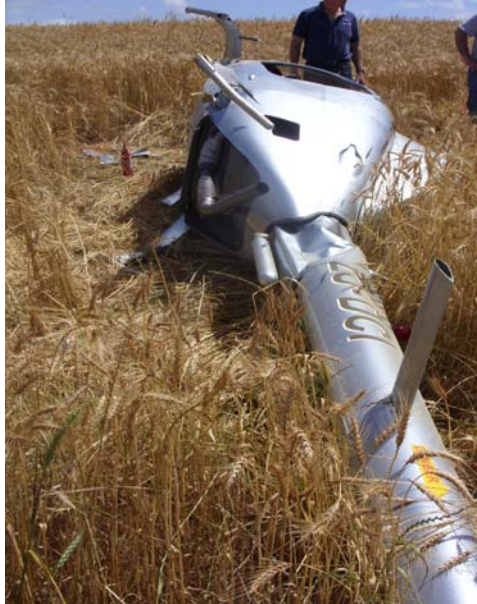
- 1.3.1 The helicopter sustained substantial damage to the main rotor blades, tail rotor, tail boom, skids and fuselage.

1.12.2 Impact with the ground occurred approximately 28 seconds after entering into the autorotation. This can be seen by the impact damage occurring on the front of the right-hand skid (i.e. no flare at touchdown) as well as the short forward distance the helicopter travelled after first impact (approx. 5 m), indicating a high decent angle.

Figure 2: Damage to and position of the helicopter
