## AIRCRAFT ACCIDENT REPORT AND EXECUTIVE SUMMARY

Reference:	CA18/2/3/8856	
<b>Aircraft Registration</b>	ZU-FHC	<b>Date of Accident</b>	23 October 2010		<b>Time of Accident</b>	0845Z
<b>Type of Aircraft</b>	Zenair C701 (kit-built aircraft)		<b>Type of Operation</b>	Private		
<b>Pilot-in-command Licence Type</b>		Commercial	<b>Age</b>	46	<b>Licence Valid</b>	Yes
<b>Pilot-in-command Flying Experience</b>		Total Flying Hours	425,1		Hours on Type	9,8
<b>Last point of departure</b>		Koedoesvlei private aerodrome, Western Cape				
<b>Next point of intended landing</b>		Koedoesvlei private aerodrome, Western Cape				
<b>Location of the accident site with reference to easily defined geographical points (GPS readings if possible)</b>						
Koedoesvlei area at GPS coordinates S32°.45.05' E18°20.48.00' at an elevation of 520 ft AMSL						
<b>Meteorological Information</b>		Clear skies; Visibility 10 km				
<b>Number of people on board</b>	1 + 0	<b>No. of people injured</b>	0	<b>No. of people killed</b>	0

## AIRCRAFT ACCIDENT REPORT

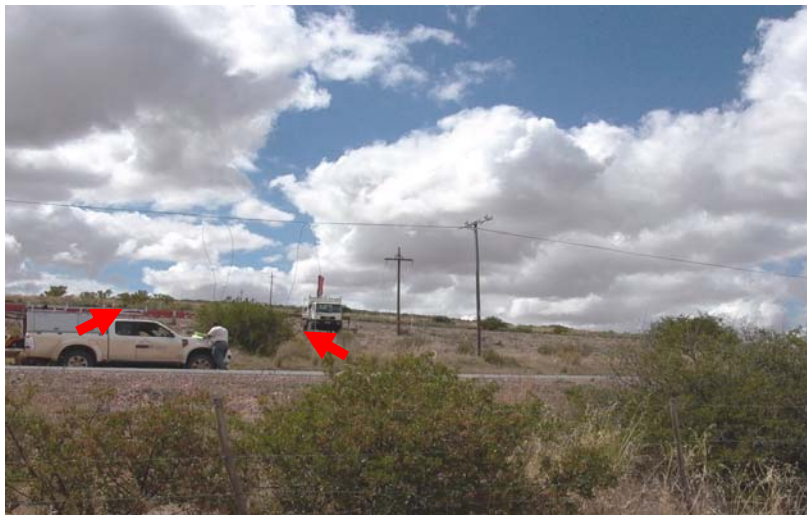
- 1.1.2 The pilot stated that takeoff was uneventful, and he performed several touch-and-goes. Then, during final approach from the south, the aircraft collided with power lines approximately 50 feet high, and struck the ground was a result. The aircraft was destroyed but the pilot was not injured. He unbuckled himself, climbed out unassisted and immediately telephoned the aircraft maintenance organisation (AMO). Engineers were dispatched to recover the aeroplane.

**Figure 1.** The damaged power lines alongside the road.

- 3.2.1 The pilot's failure to clear a known obstacle (power lines).

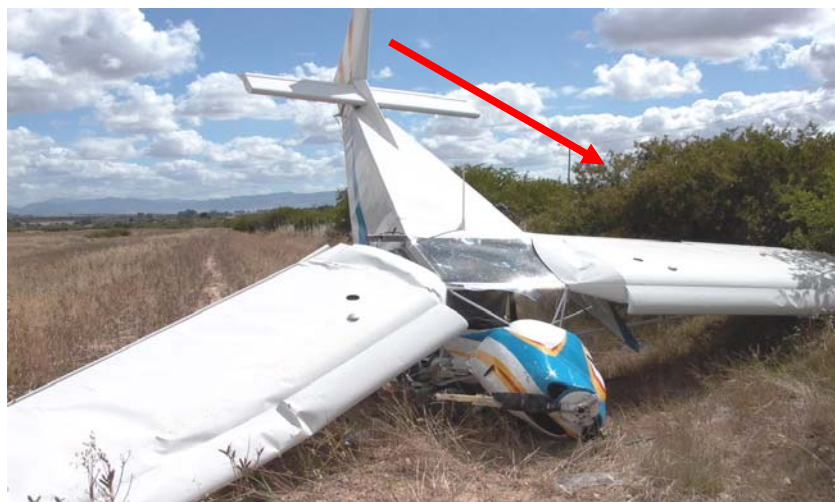
- The undercarriage was destroyed
- Both wings were substantially damaged
- The three-bladed wooden propeller was destroyed
- The engine mountings were substantially damaged
- The aircraft windscreen was destroyed

**Figure 2.** The aircraft after the accident – front view.

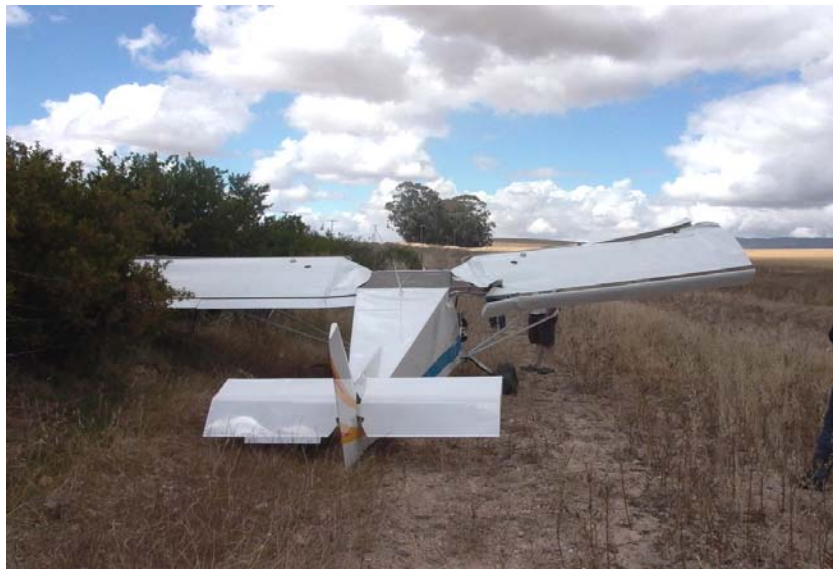
1.12.1 The on-site investigation revealed that the aircraft had hit the ground in a nose-down attitude after collision with the power lines. The windscreen, undercarriage and wooden propeller were destroyed. The wings, engine mountings and firewall were substantially damaged.

**Figure 3.** The aircraft after the accident – rear view.
