**AIRCRAFT ACCIDENT REPORT AND EXECUTIVE SUMMARY**

Reference:	CA18/2/3/8858	
<b>Aircraft Registration</b>	<b>ZS-KIN ZU-BXA</b>	<b>Date of Accident</b>	26 October 2010		<b>Time of Accident</b>	1530Z
<b>Type of Aircraft</b>	Piper PA-28-180 Jabiru SK		<b>Type of Operation</b>	Training		
<b>Pilot-in-command Licence Type</b>		Student Pilot Commercial Pilot	<b>Age</b>	25 50	<b>Licence Valid</b>	Yes Yes
<b>Pilot-in-command Flying Experience</b>		Total Flying Hours	34,4 1046,7	Hours on Type	34,4 417,9	
<b>Last point of departure</b>		Wonderboom Aerodrome (FAWB); Gauteng province Kitty Hawk Aerodrome (FAKT); Gauteng province				
<b>Next point of intended landing</b>		Wonderboom Aerodrome (FAWB); Gauteng Province Kitty Hawk Aerodrome (FAKT); Gauteng Province				
<b>Location of the accident site with reference to easily defined geographical points (GPS readings if possible)</b>						
On Runway 29 at Wonderboom Aerodrome, approximately 200 meters to the west of the intersection with Runway 06/24 at a GPS position; South 25°39'12" East 028°13'22'

## AIRCRAFT ACCIDENT REPORT

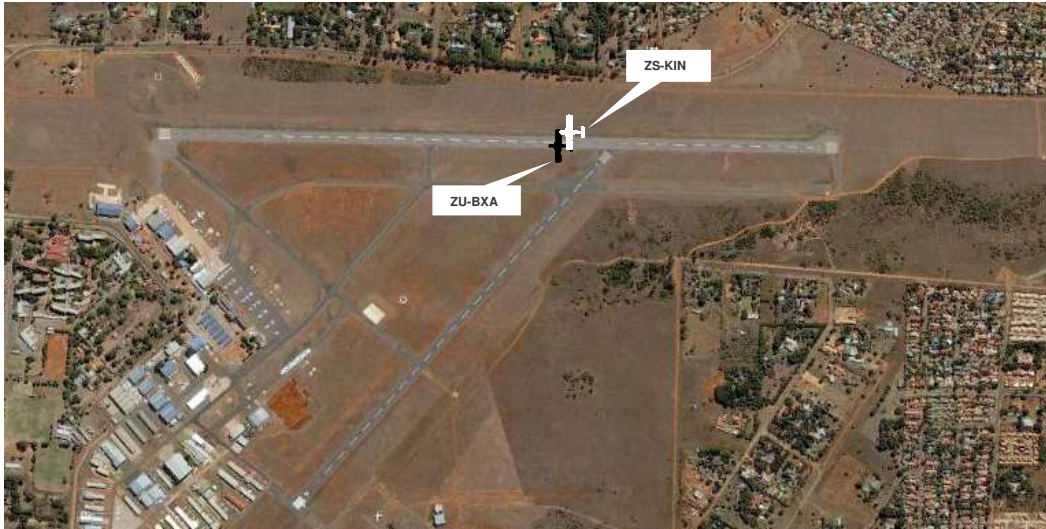
Shortly after the student pilot of ZS-KIN acknowledge the ATC command the aircraft ZU-BXA became airborne following the touch-and-go and struck the aircraft ZS-KIN from below at a height of approximately 30 feet above the runway surface. (See Fig 4)

Figure 4 Relative position of the collision between ZU-BXA and ZS-KIN<sup>3</sup>

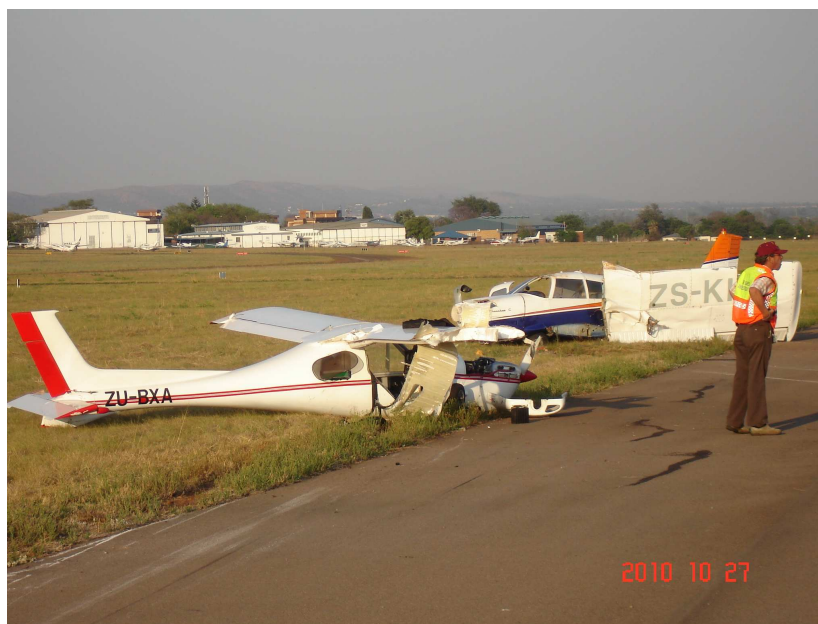
1.3.1 Both aircraft sustained substantial damaged during the midair collision and the subsequent collision with the ground (runway). (See Fig. 5)

Figure 5. A view of the two aircraft as they came to rest to the left of Runway 29.

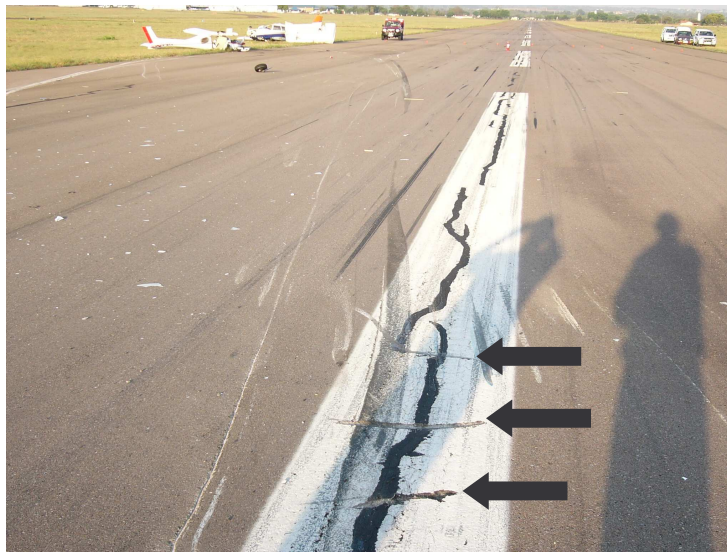
1.4.1 One runway light (light A15) was damaged by one of the aircraft during the sequence of the accident and minor damage was caused to the runway surface by the propeller of one of the aircraft. (See Fig. 6)

**Figure 6.** Propeller strike markings visible on the runway centre line.

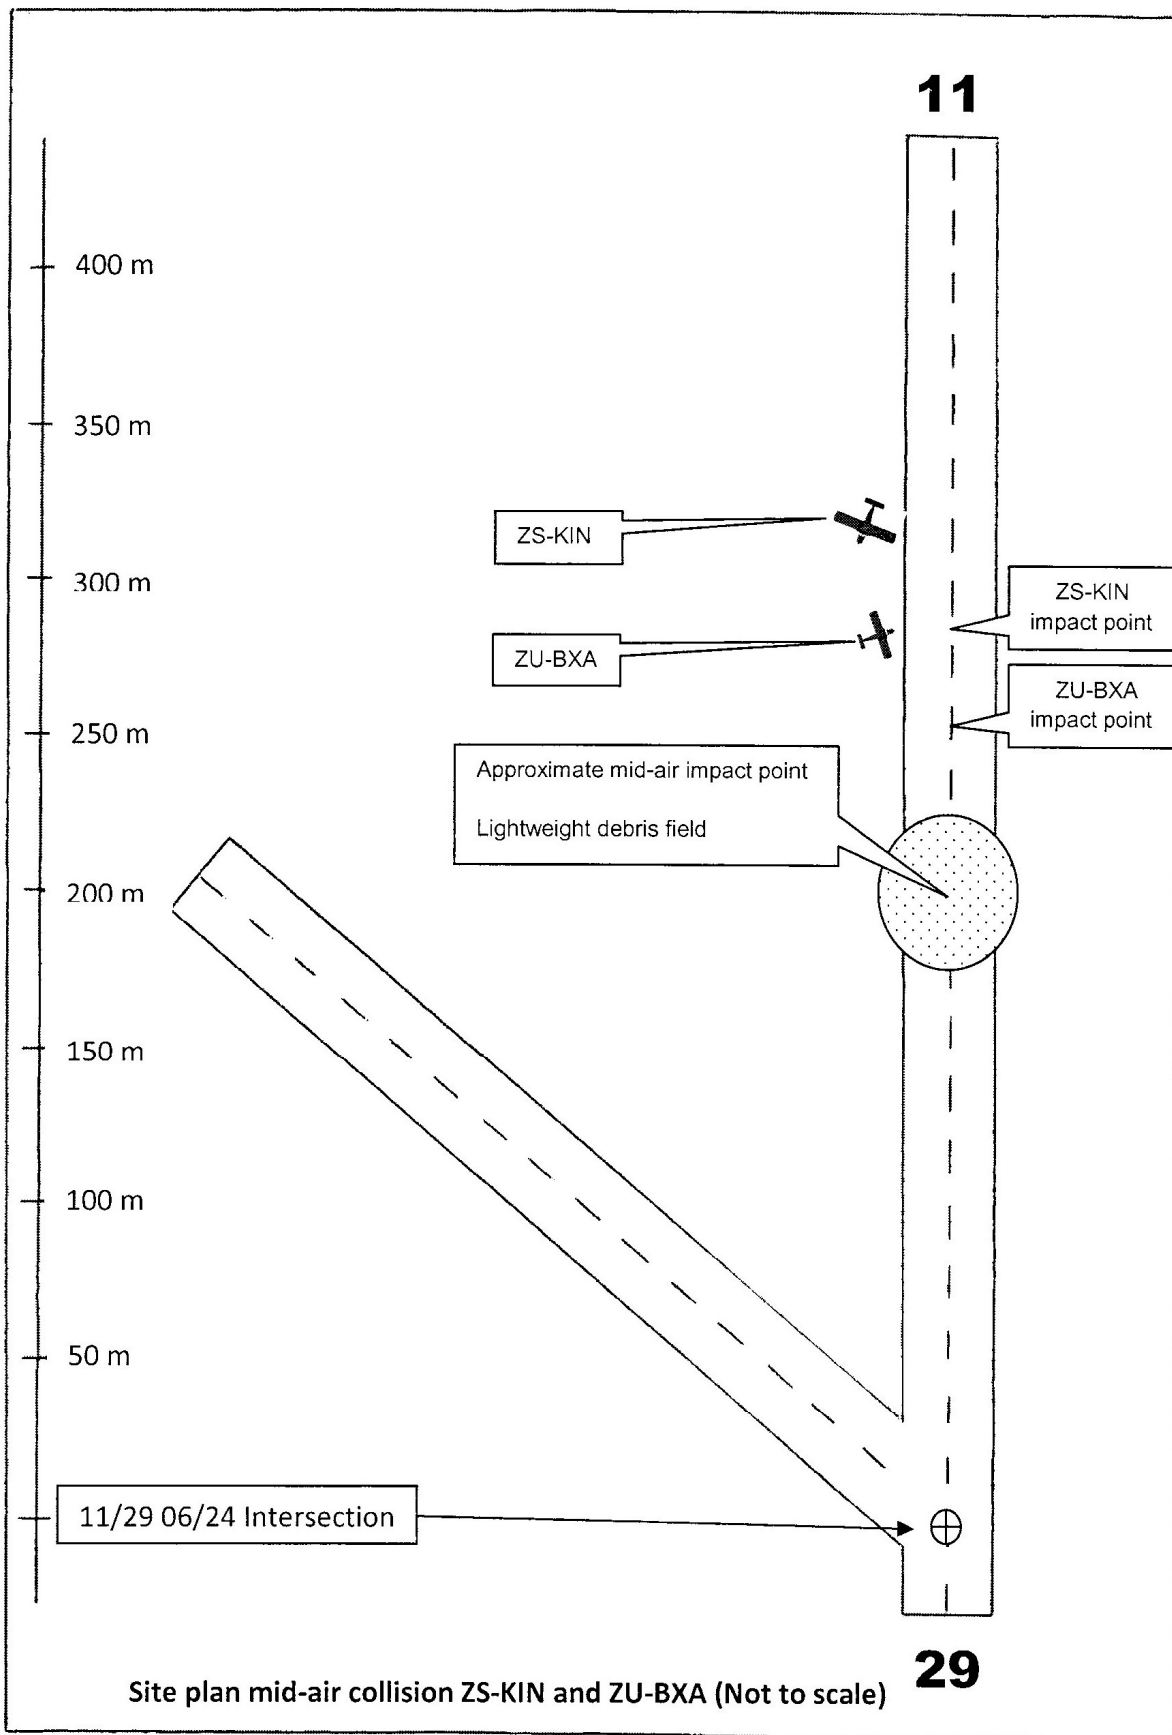
From this point onwards, alongside Runway 29, various heavier pieces of debris were found scattered along a trail of 115 meters. This includes items such as landing gear wheels and a fire extinguisher.

Figure 10. Accident site plan (not to scale).

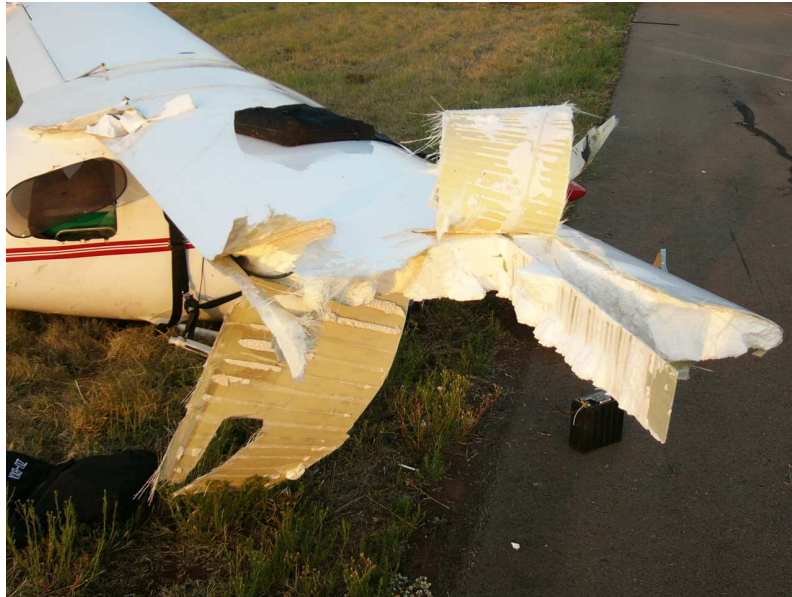
Available evidence indicate that the propeller of ZS-KIN made contact with the outer wing surface of ZU-BXA, which caused substantial damage to the lifting surface, including destroying the right aileron as can be seen in Figure 8. This resulted in a loss of control of the aircraft ZU-BXA, which was found to have impacted with the runway surface approximately 280 m pass the intersection of the two runways. (See Fig. 11)

Figure 11. Damage caused to the right and aileron of ZU-BXA.

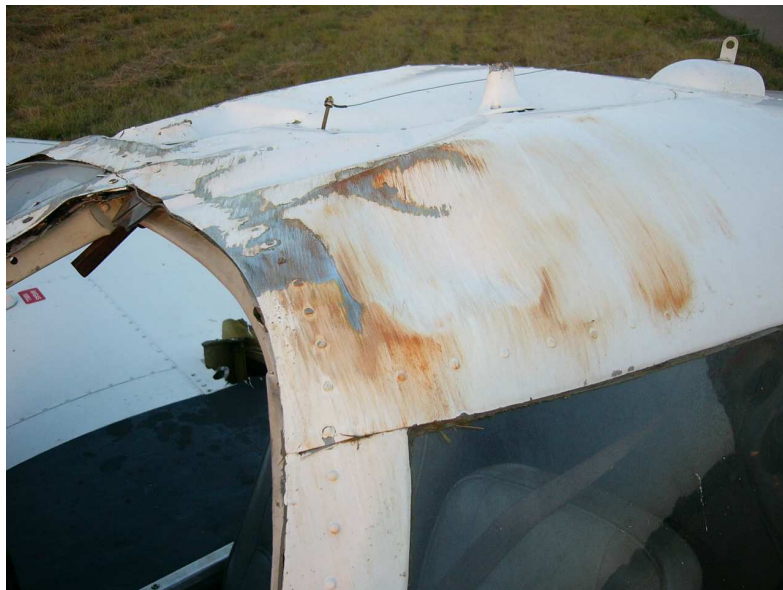
Abrasion marks on the canopy substantiate the instructor's account that was in the control tower that the aircraft ZS-KIN had rolled about its longitudinal axis as the pilot lost control of the aircraft. Diagonal abrasions and ground smear marks just to the left edge of the runway substantiate the observation. (See Fig. 12)

Figure 12. Abrasion and ground smear marks on the canopy of ZS-KIN.

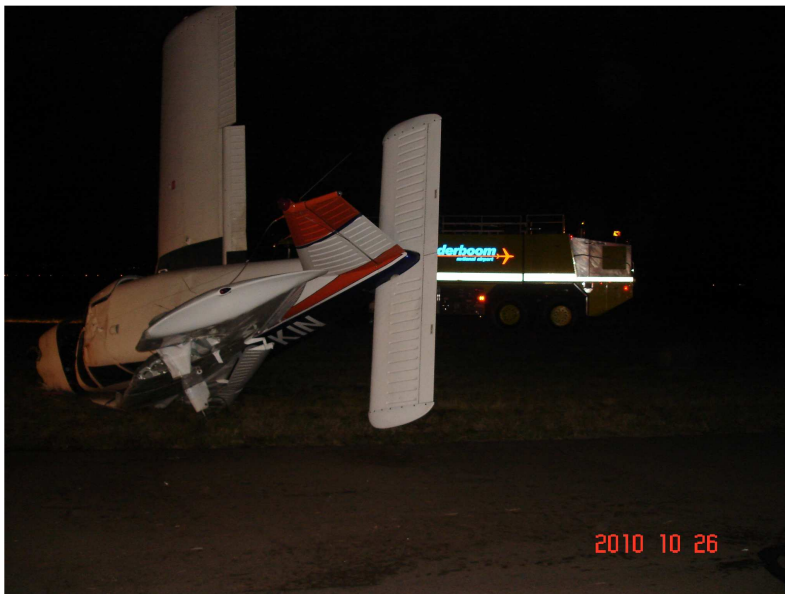
The rolling moment carried the aircraft ZS-KIN to a position where it came to rest in an uneven keel position facing into a south-easterly direction. (See Fig. 13)

**Figure 13.** Final position of ZS-KIN.

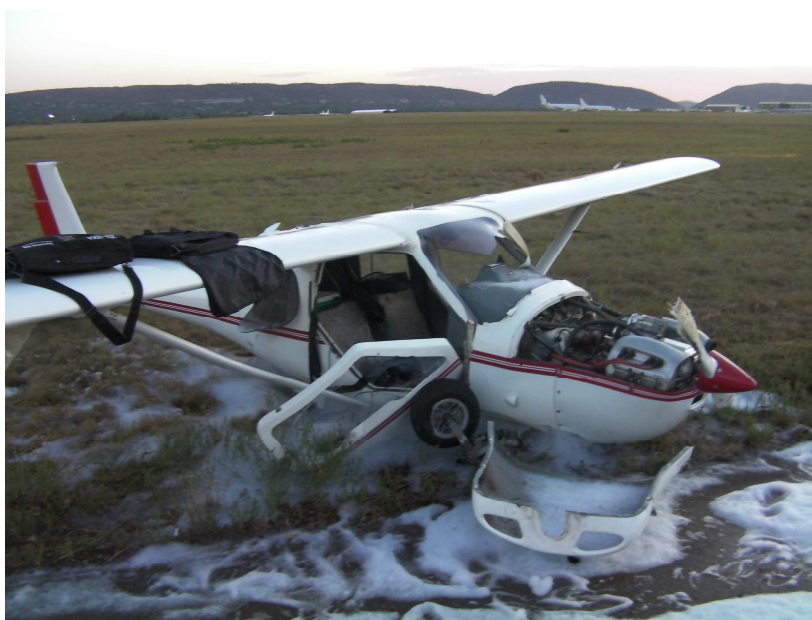
The aircraft ZU-BXA was impacted from behind by the aircraft ZS-KIN. The propeller of ZS-KIN made contact with the right wing aileron of ZU-BXA and control was lost. The aircraft ZU-BXA impacted the runway surface approximately 250 meters past the runway intersection and approximately 5 meters to the left of centre line where after the aircraft skidded forward and sideways coming to rest at a point to the left of the runway approximately 279 meters from the intersection. (See Fig 14)

**Figure 14.** Final position of ZU-BXA.
