AIRCRAFT ACCIDENT REPORT AND EXECUTIVE SUMMARY

Reference:	CA18/2/3/8861	
Aircraft Registration	ZS-RNN	Date of Accident	02 November 2010	Time of Accident	1430-1500Z	
Type of Aircraft	Robinson R22 Beta		Type of Operation	Private		
Pilot-in-command Licence Type		Commercial Helicopter	Age	38	Licence Valid	Yes
Pilot-in-command Flying Experience		Total Flying Hours	396.4		Hours on Type	Unknown
Last point of departure		Wonderboom Airport(FAWB) - Gauteng Province				
Next point of intended landing		Wonderboom Airport(FAWB) - Gauteng Province				
Location of the accident site with reference to easily defined geographical points (GPS readings if possible)						
House No. 78 Second Street, Rooiwal Approximately 5NM north of FAWB. GPS coordinates: S25° 33.526 E028° 14.862						
Meteorological Information		Surface wind: 300/03knots; Temperature: 29° C; Dew point: 09°C				
Number of people on board	1 + 1	No. of people injured	0	No. of people killed	2	
Synopsis		<p>The helicopter was flown from FAWB to the GFA with the intention to land back at FAWB when the accident occurred. According to eyewitnesses, they saw the helicopter flying very low in a southerly direction towards FAWB. The helicopter

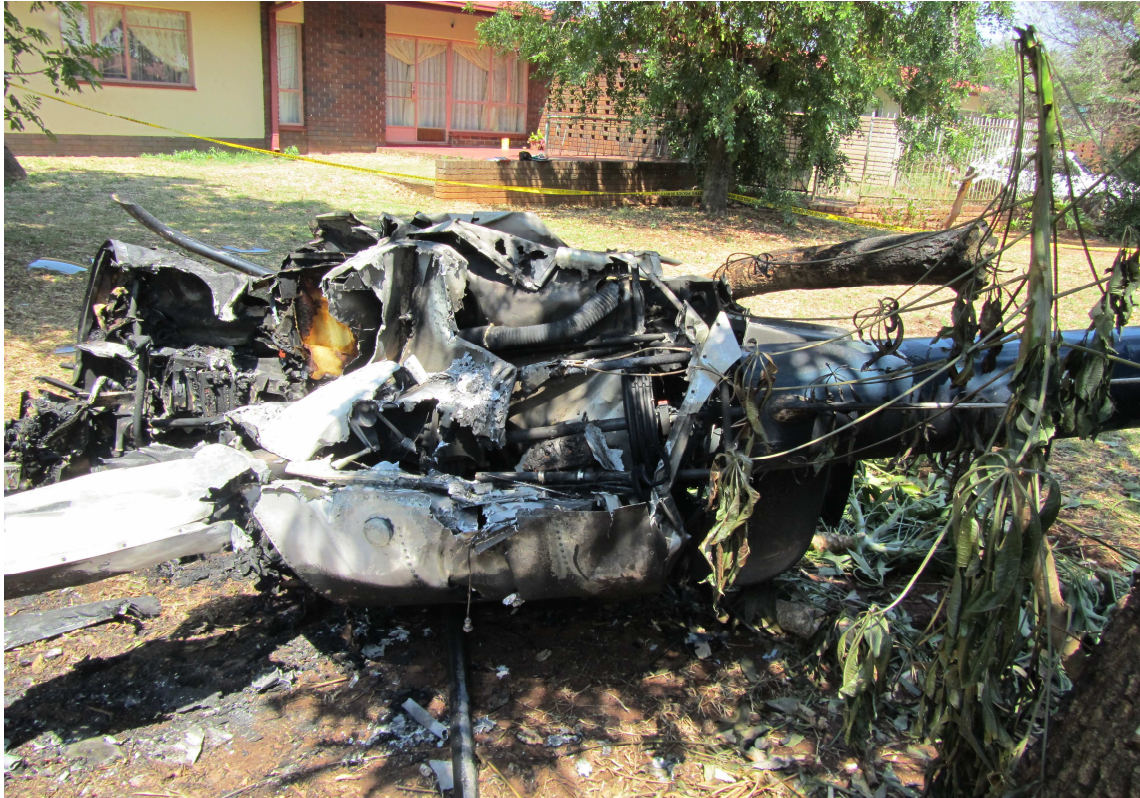
1.3.1 The helicopter was destroyed.

Photo1: Shows the helicopter wreckage.

fire. The debris from the wreckage was found scattered around a 5 m radius. The main rotor was still intact and not burnt. The tail boom and tail rotor was broken due to the helicopter impacting the asbestos hall. The engine and gearbox was partially burnt.

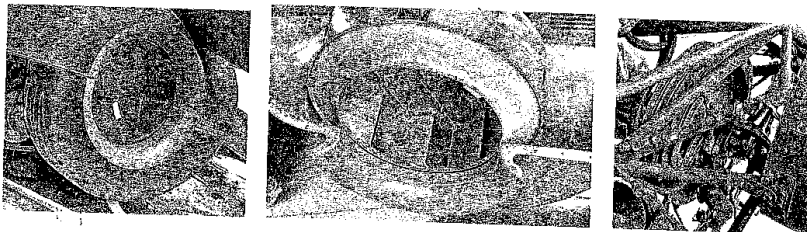
Figure 2: Indicating the observations before engine removal as discussed below

1. The fan and scroll assembly were pushed against one another and showed no indication that the fan was turning, as there were no scuff marks on the inside of both the scroll and the fan.
2. The Drive V-belts were no longer in their original position on the clutch assembly.
3. Front belt broken and rear belt twisted.

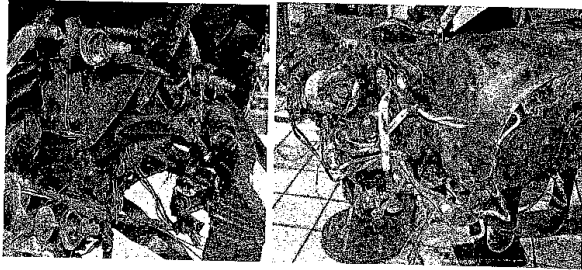
Figure 3: Indicating the engine compartment, after engine removal

Engine top mounting bolts were extremely bent and the engine compartment was severely burnt.

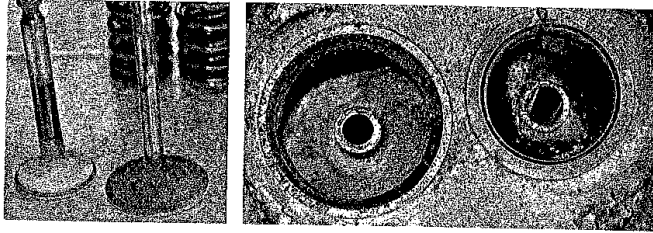
1. A general observation of the engine internally revealed it to be uncontaminated with no debris.
2. Spin-on oil filter and sump finger filter inspected and found to be uncontaminated with no metal particles.
3. All engine components have been inspected and found to be intact and not damaged.
4. Small amounts of dirt (sand) were found on some intake valves and exhaust valves.
5. All bottom spark plugs were fouled.

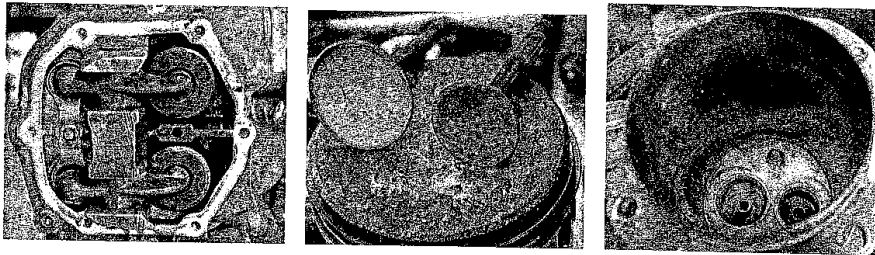
6. Cylinder bores visually inspected and no wear was found within the top two inches of the barrel.
7. Honing patterns were visible and no evidence of glazing.
8. Cylinder bores were dimensionally inspected and all cylinders were within serviceable limits.
9. Cylinder No. 2 had no compression during inspection on engine stand.
10. All intake and exhaust valves were moving freely.
11. No abnormal exhaust guide wear or carbon buildups were found.
12. No bent push rods were observed.
