## AIRCRAFT ACCIDENT REPORT AND EXECUTIVE SUMMARY

Reference:	CA18/2/3/8866	
<b>Aircraft Registration</b>	ZS-AWJ	<b>Date of Accident</b>	07 November 2010		<b>Time of Accident</b>	1200Z
<b>Type of Aircraft</b>	Piper PAJ3 Cub		<b>Type of Operation</b>		Private	
<b>Pilot-in-command Licence Type</b>		ATPL	<b>Age</b>	52	<b>Licence Valid</b>	Yes
<b>Pilot-in-command Flying Experience</b>		Total Flying Hours	14116.0		Hours on Type	211.0
<b>Last point of departure</b>		Rand Aerodrome (FAGM) Gauteng				
<b>Next point of intended landing</b>		Rand Aerodrome (FAGM) Gauteng				
<b>Location of accident site with reference to easily defined geographical points (GPS readings if possible)</b>						
Henley Aero Modellers Club near Meyerton, Gauteng at GPS Co-ordinates: S26°34' 42" E028°04' 23"						
<b>Meteorological Information</b>		Fine weather conditions, Surface wind 170°5-6kt. T emperature 25°C CAVOK				
<b>Number of people on board</b>		1+0	<b>No. of people injured</b>	1	<b>No. of people killed</b>	0

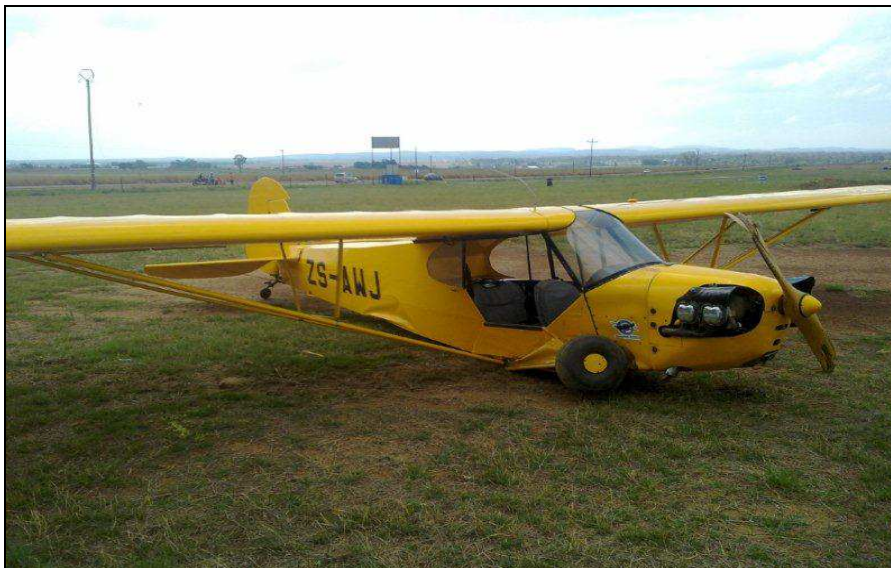
PICTURE 1: SHOWS DAMAGE TO LANDING GEAR, PROPELLER, UNDERSURFACE

1.3.1 The aircraft sustained substantial damage to the undercarriage, fuselage and propeller.

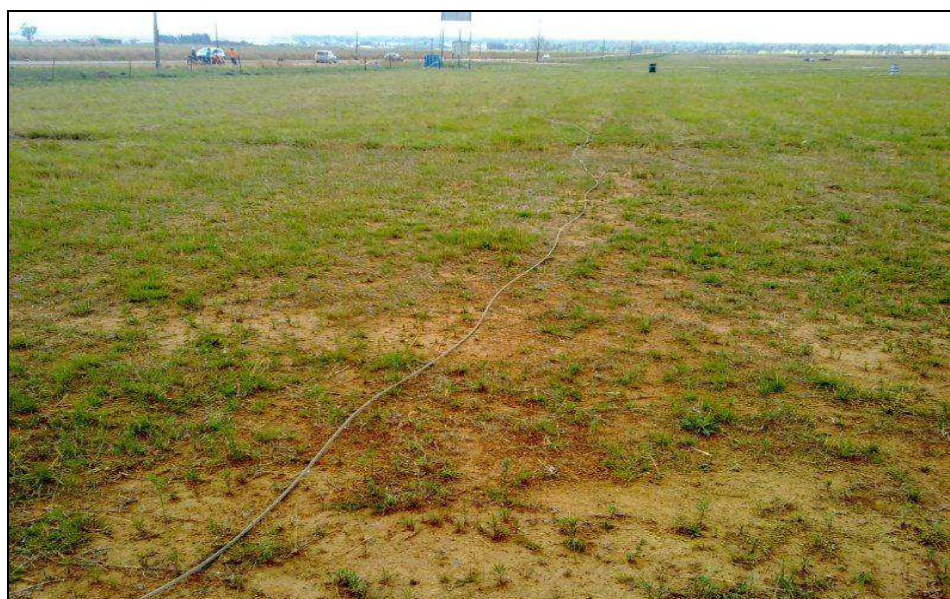
1.4.1 The upper power line snapped during the impact with the aircraft undercarriage

PICTURE 2: SHOWS UPPER TENSION CABLE SNAPPED ON IMPACT
