AIRCRAFT ACCIDENT REPORT AND EXECUTIVE SUMMARY

Reference:	CA18/2/3/8867	
Aircraft Registration	ZU-BID	Date of Accident	20 November 2010		Time of Accident	0600Z
Type of Aircraft	Windlass Trike		Type of Operation		Private	
Pilot-in-command Licence Type		Private	Age	44	Licence Valid	Yes
Pilot-in-command Flying Experience		Total Flying Hours	40.2		Hours on Type	40.2
Last point of departure		Harrismith Aerodrome (FAHR), Kwa-Zulu Natal Province				
Next point of intended landing		Lemon Duca Farm, Estcourt, Kwa-Zulu Natal Province				
Location of the accident site with reference to easily defined geographical points (GPS readings if possible)						
Next to R103 road, Estcourt. GPS Coordinates S28°57.143 E029°50.940						
Meteorological Information		Temperature: 20°C; Visibility: Good; Wind speed: 2 k nots; Cloud cover: None				
Number of people on board	1+1	No. of people injured	2	No. of people killed	0	
Synopsis						
<p>A pilot and passenger took off from Harrismith aerodrome on a private flight to his farm in Rosetta near Estcourt. En route to his farm, the pilot routed to another farm and began circling overhead the farm. The farmer who witnessed ZU-BID overhead, said that the pilot

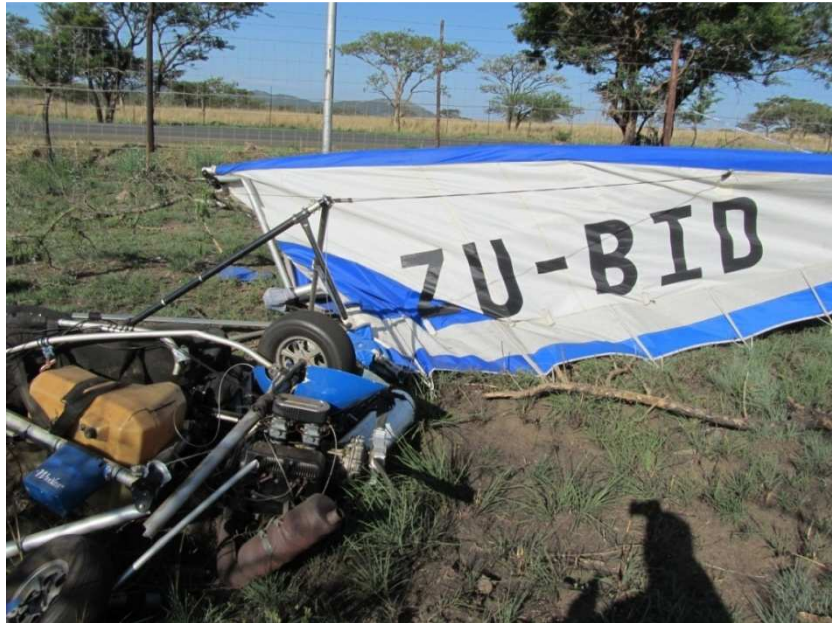
Picture 1: Showing the main wreckage

1.12.3 The aircraft suffered substantial damage to the wing and the fuselage.

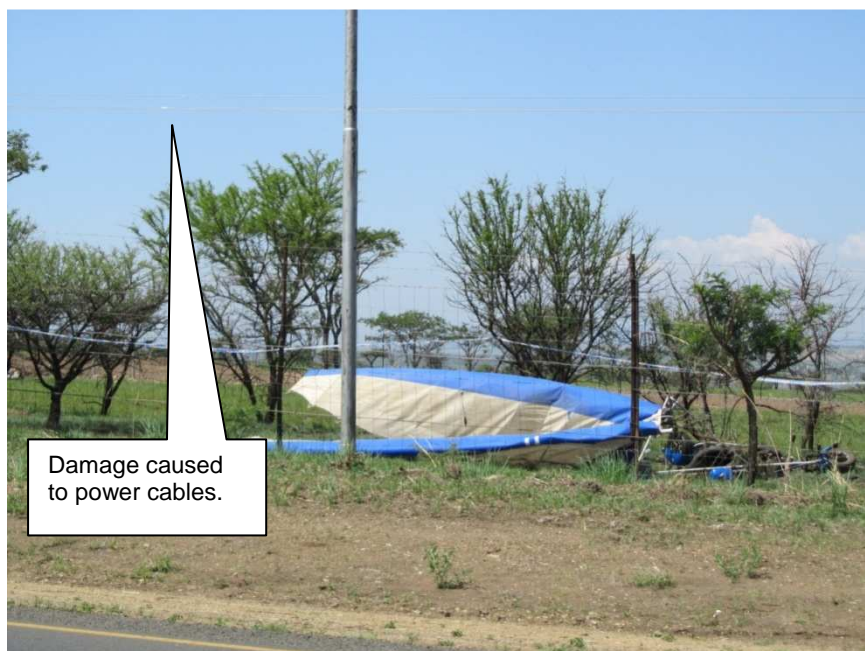
Picture 2: Showing the high tension wires damage in relation to accident site.

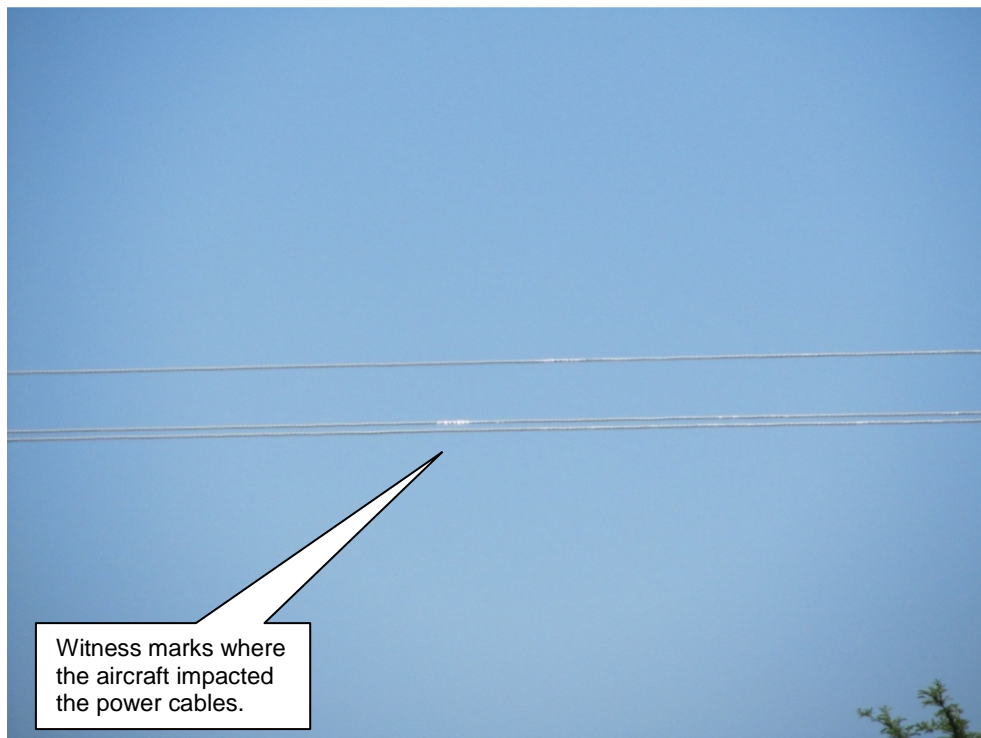
Picture 3: Showing the damage to high tension wires

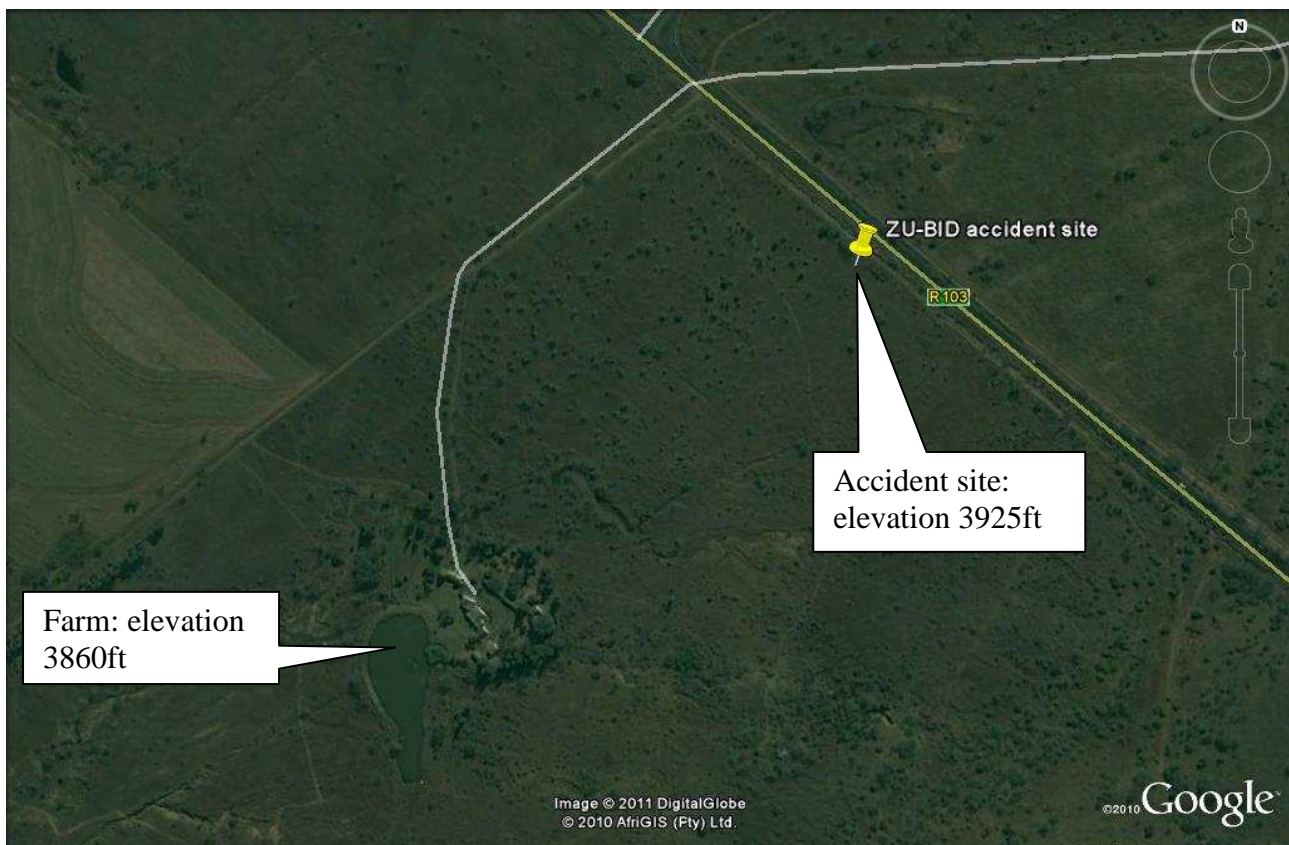
Picture 4: Showing the accident site in relation to the farm.

- The farmer reported that the aircraft was approximately 40 feet(12 meters)AGL above the farm as the aircraft circled.
- The distance from the farm house to the accident site is 1640 feet (500meters).
- The terrain from the farm house to the accident site raises by approximately 65 feet (20 meters)
- The height of the power lines is approximately 20 feet AGL (6 meters).

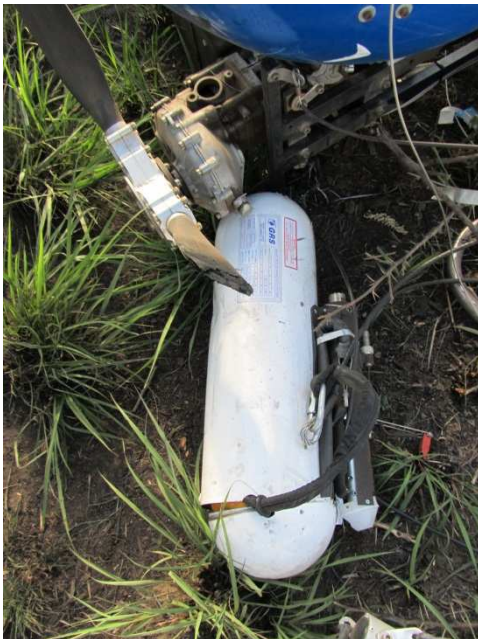
1.18.2 The aircraft was equipped with a ballistic parachute which was not deployed during the accident sequence. The ballistic parachute was removed from the aircraft by the Estcourt Fire Department.

Picture 5:Damaged parachute system

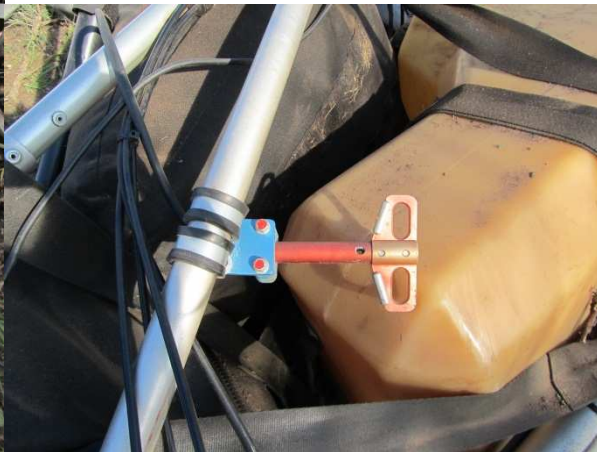
Picture 6:Parachute activation pin.

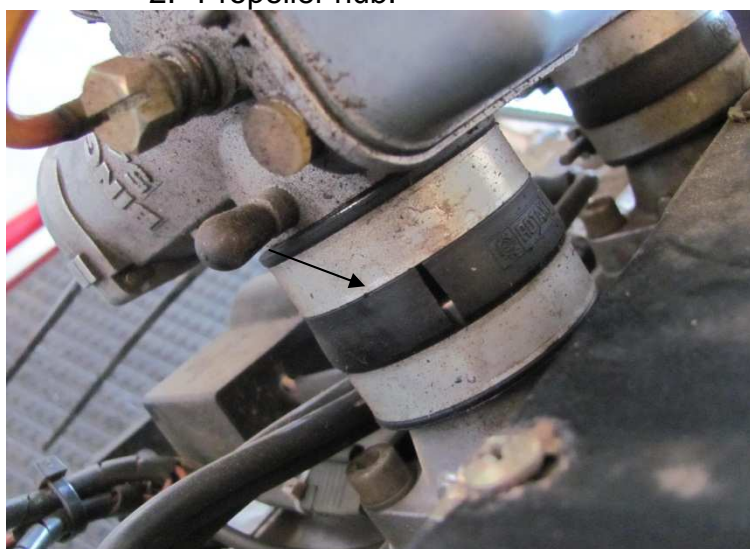
Carburetor intake socket Figure 1

A crack was detected on one off the carburetor intake sockets. With the engine inverted on the aircraft, the crack could have been miss looked during a pre-flight inspection and if the crack did appear during flight, a sudden power loss could have occurred. See figure 1.

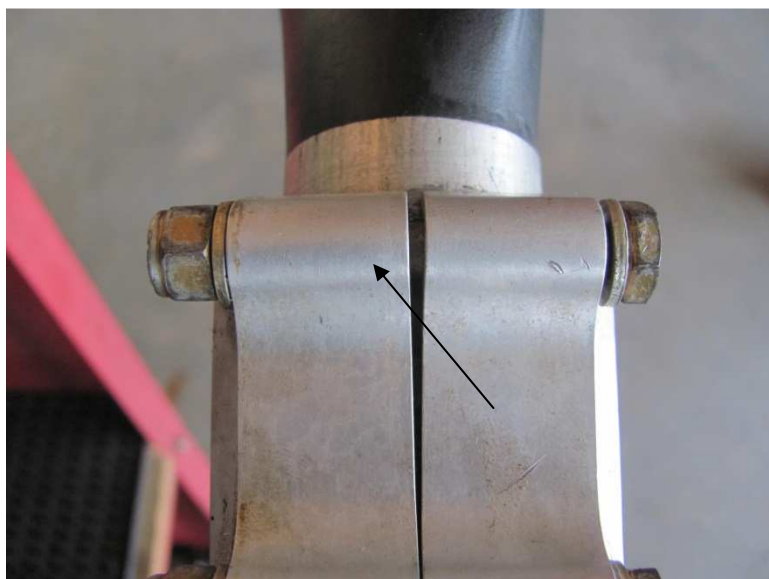
Propeller hub Figure 2

During the accident two of the three propeller blades was destroyed. The third blade was perfectly in tacked but, the hub aria witch accommodates the blade was badly distorted. It mite seem that the hub was in a previous accident and was reused. No distortion was detected on the rest of the hub specially in the mounting aria of the two damaged blades.

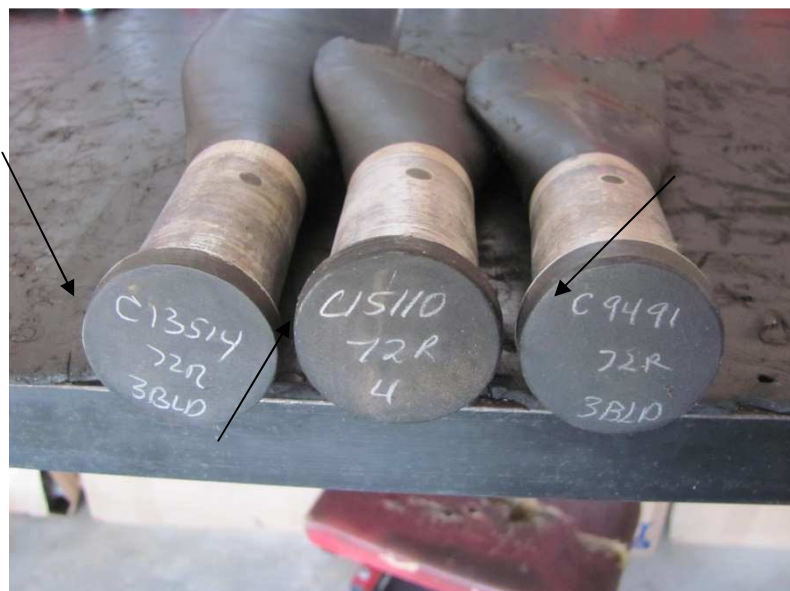
Blade Serial No.: Figure 3

With the dissemble of the propeller blades, it was noticed that the serial numbers were not a matching pear. See Figure 3. The factory will only supply blades with the same serial number. The serial number determents the weight, length and pitch of each blade. Unbalanced blades could have lead to severe engine vibration during flight. Cavitations due to a wrong pitch setting, will lead to loss of thrust and engine power during flight.

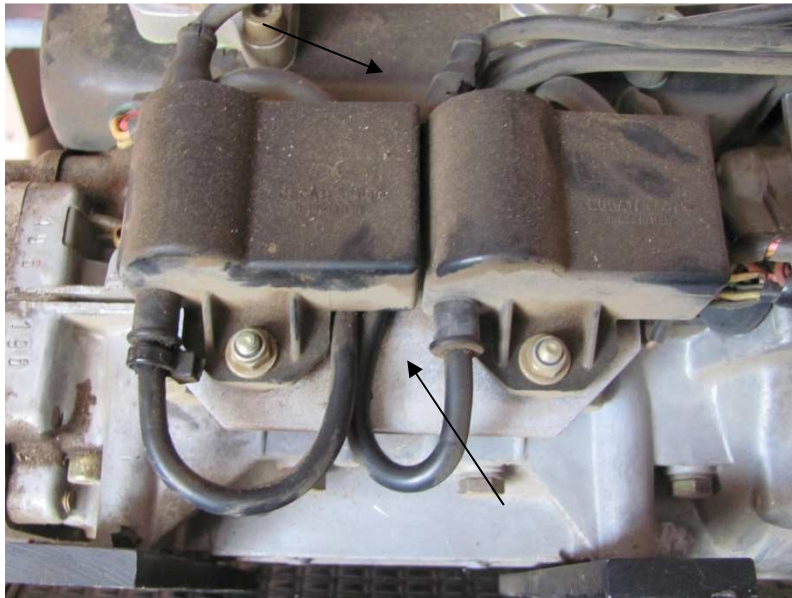
Ignition Coils Figure 4

All four protection caps on the ignition coils was totally degraded. The protection caps protects the sparkplug leads from moisture entering the coils that could lead to engine failure. See Figure 4.

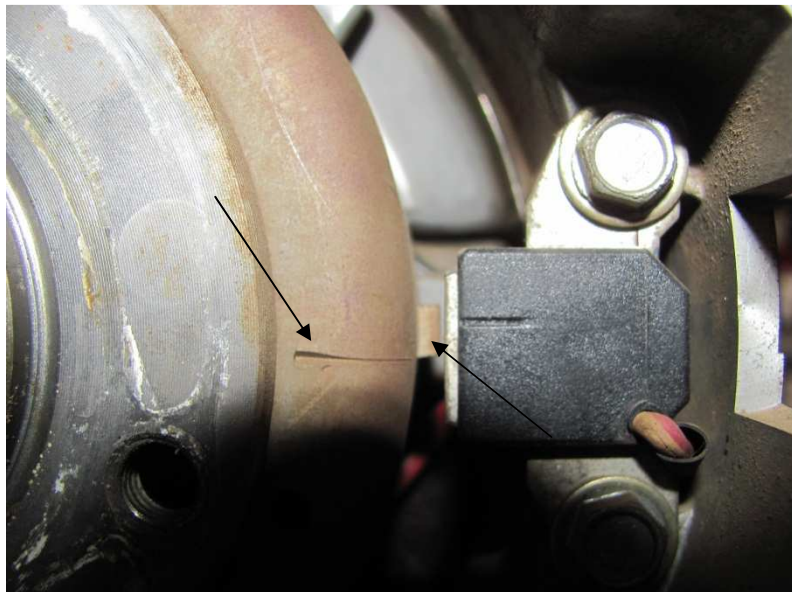
Timing Position Mark Figure 5

Before the engine was disassembled, the timing position was inspected as per the Rotax specification.

The timing position was out of line. See Figure 5.

Due to the wrong settings the engine could not perform to its full potential.

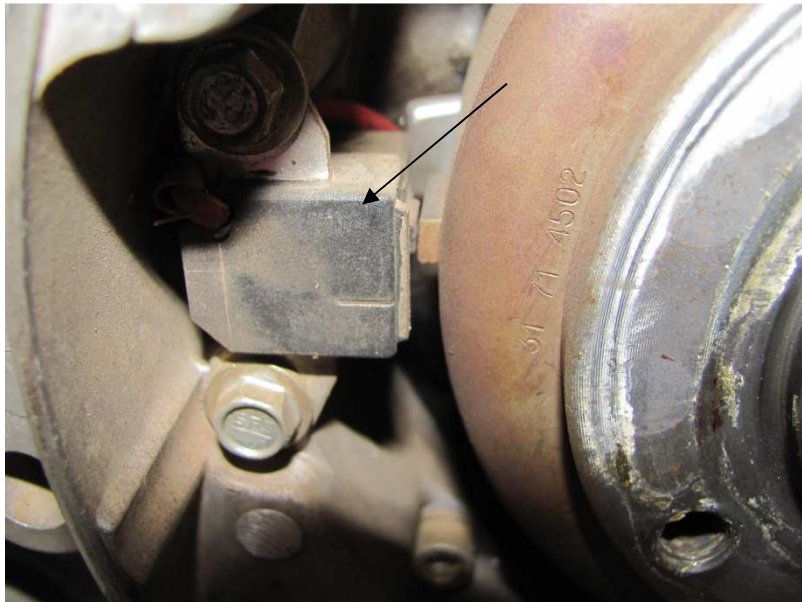
Trigger gap (Air gap) Figure 6

The trigger gap was set to the wrong setting (0.30 mm) (Min 0.4 mm Max 0.5 mm)
