AIRCRAFT ACCIDENT REPORT AND EXECUTIVE SUMMARY

Reference:	CA18/2/3/8874	
Aircraft Registration	ZS-LLA	Date of Accident	30 November 2010		Time of Accident	1330Z
Type of Aircraft	PA 46-310P (Piper Malibu)		Type of Operation		Private	
Pilot-in-command Licence Type		Commercial Pilot	Age	46	Licence Valid	Yes
Pilot-in-command Flying Experience		Total Flying Hours	1 153		Hours on Type	560
Last point of departure		Wonderboom aerodrome (FAWB), Gauteng				
Next point of intended landing		Wonderboom aerodrome (FAWB), Gauteng				
Location of the accident site with reference to easily defined geographical points (GPS readings if possible)						
Open area of veld on the extended centreline of runway 29 at Wonderboom aerodrome (GPS position S25°39'8" E28°12'16")						
Meteorological Information		Wind: westerly at 8 kt; Temperature: 26°C; Dew point: unknown; Visibility: > 10 km; Clouds: scattered at 8 000 ft.				
Number of people on board	1 + 0	No. of people injured	0	No. of people killed	0

AIRCRAFT ACCIDENT REPORT

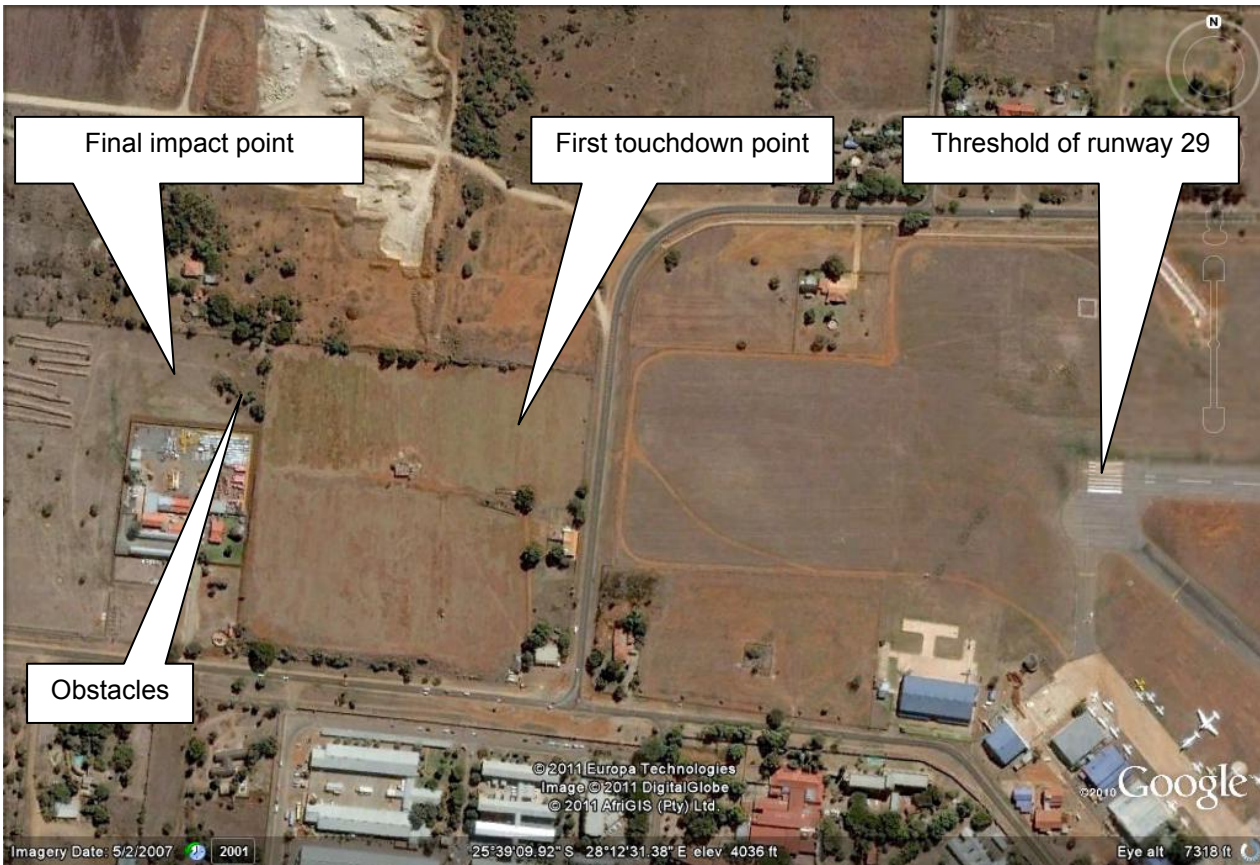
- 1.1.4 After touching down at speed, he realised that he was heading for trees, a concrete structure and telephone wires at the far edge of the open area. Unable to stop in time, he pulled up the nose of the aircraft and managed to clear the obstacles. He then struck the ground heavily. The nose wheel collapsed and the aircraft swung 90° before coming to a standstill.

Figure 1. Accident path after the engine failure.

1.12.1 The accident sequence occurred along the extended centre line of runway 29. The first contact point with the ground was 450m beyond the end of runway 29 and the final impact point was 740m beyond the end of the runway. The aircraft came to rest on its nose after the nose wheel collapsed.

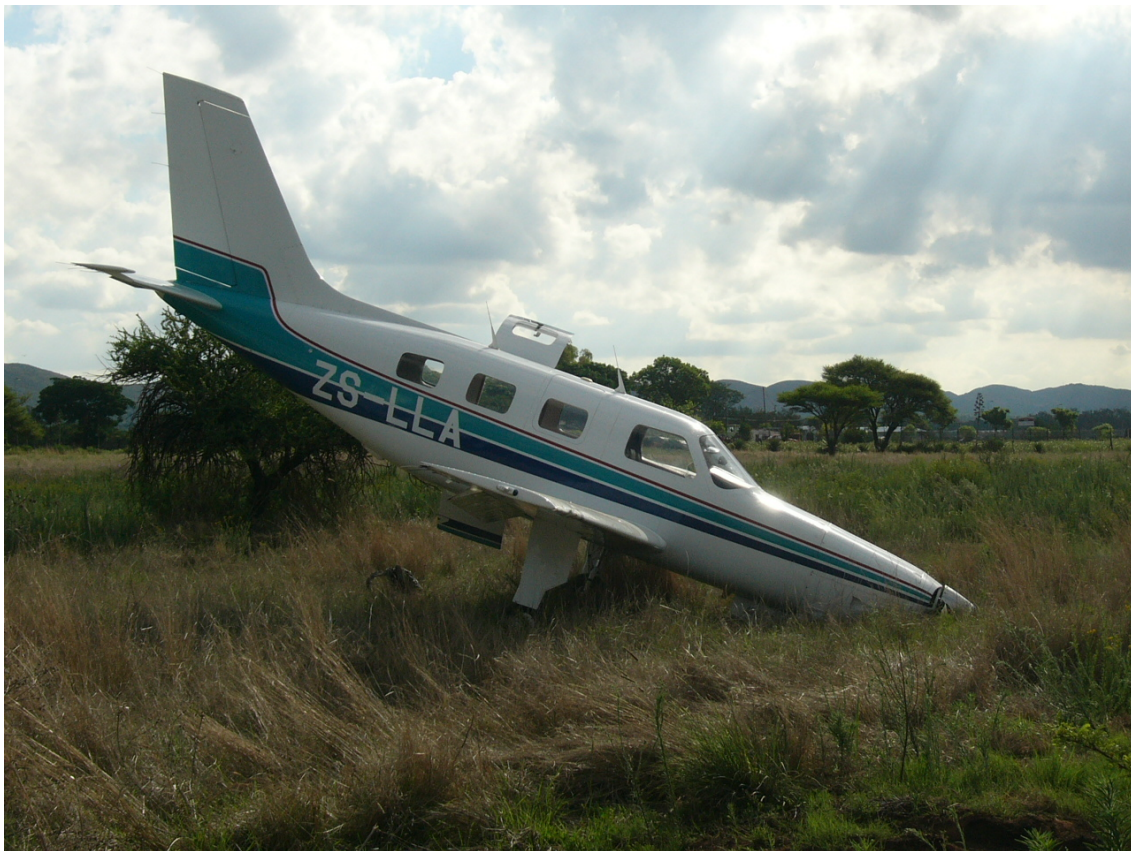
1.3.1 Substantial damage was caused to the propeller, nose wheel and wings.

Figure 2. The aircraft after the accident.

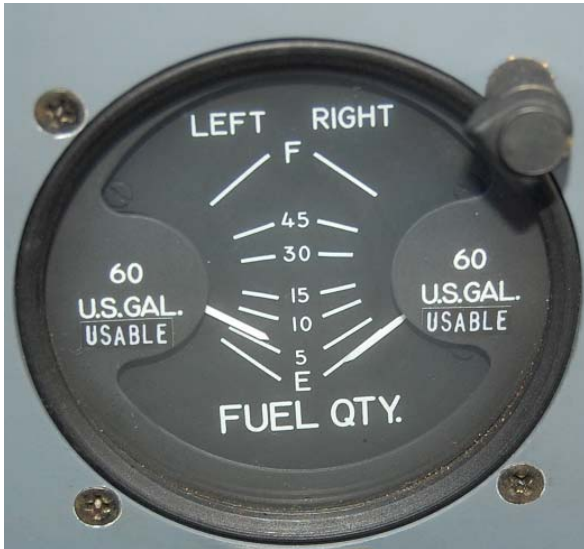
1.18.1 Directly after the accident, while the aircraft was in a nose-down attitude, the fuel gauge indicated that the left tank held six gallons and the right was empty.

Figure 3. Readings in a nose-down attitude.

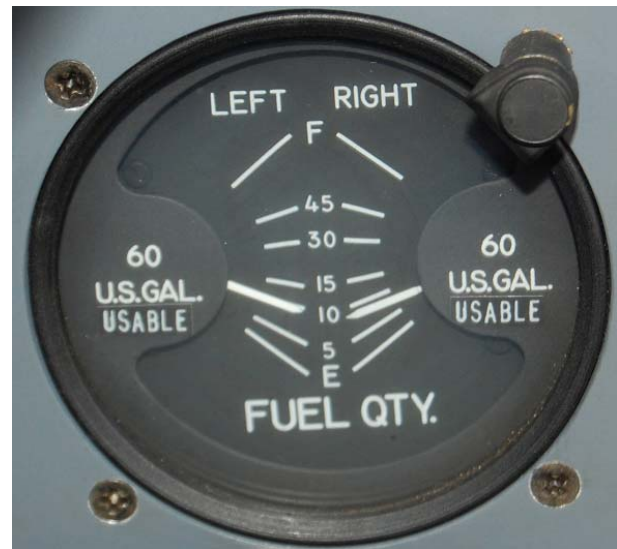
1.18.2 Once the aircraft was recovered and placed in a level attitude, the same gauge showed that the left tank held nine gallons and the right, eight.

Figure 4. Readings in a level attitude.

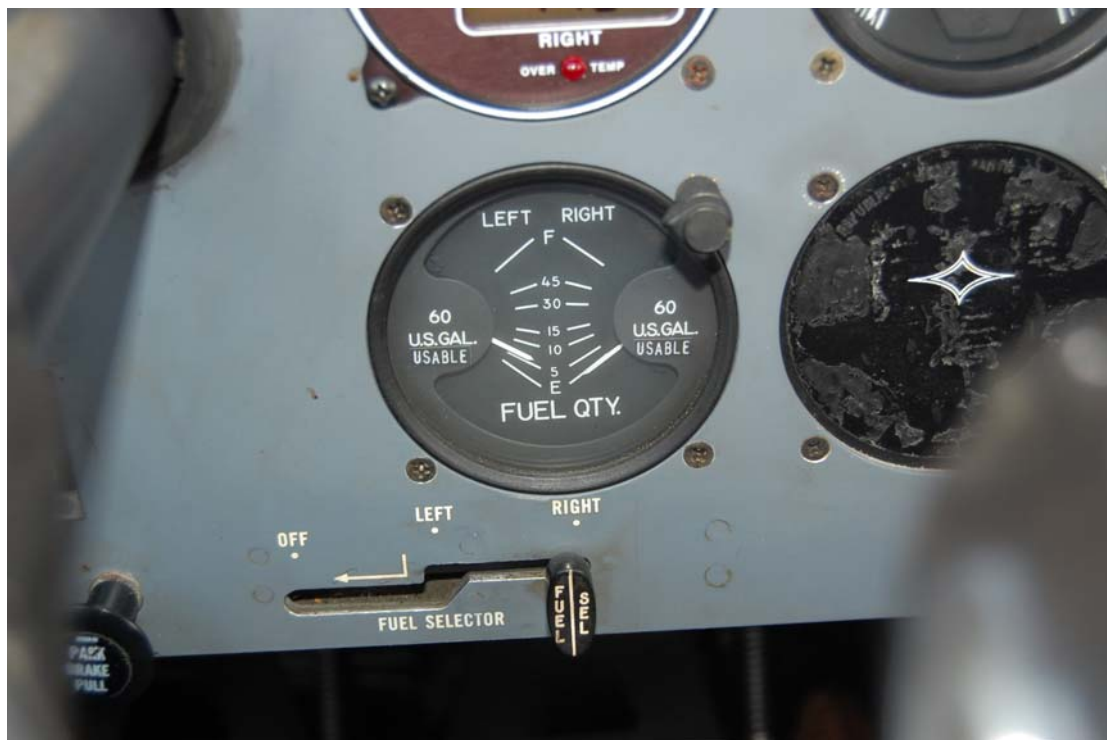
1.18.8 The pilot stated that he had taken off with the right-hand fuel tank selected, and when the engine failure occurred, had selected the left-hand tank. However, during the investigation immediately after the accident, the right-hand tank was found to be selected. The left-hand tank was selected for the engine test after the accident.

Figure 6. Position of the fuel tank selector immediately after the accident.

1.18.9 During the interview with the pilot on the day after the accident, the position of the fuel tank selector valve was discussed. The pilot then became unsure if the original selection had been the left or right tank. He said that he had been trying to rectify the engine problem and fly the aircraft simultaneously and could not recall his actions precisely.
