<b>AIRCRAFT ACCIDENT REPORT AND EXECUTIVE SUMMARY</b>
---

Reference:	CA18/2/3/8888	
<b>Aircraft Registration</b>	ZS-KIL	<b>Date of Accident</b>	27 January 2011		<b>Time of Accident</b>	0930Z
<b>Type of Aircraft</b>	Schweizer Grumman G-164B		<b>Type of Operation</b>	Agricultural		
<b>Pilot-in-command Licence Type</b>	ATPL	<b>Age</b>	25	<b>Licence Valid</b>	Yes	
<b>Pilot-in-command Flying Experience</b>	Total Flying Hours	1983.0		Hours on Type	Unknown	
<b>Last point of departure</b>	Farm Teana between Nigel and Balfour, Mpumalanga Province					
<b>Next point of intended landing</b>	Farm Teana between Nigel and Balfour, Mpumalanga Province					
<b>Location of the accident site with reference to easily defined geographical points (GPS readings if possible)</b>						
On farm Hartebeesfontein near Balfour:(GPS co-ordinates S26° 32.287, E028° 36.973) Elevation 5424ft AMSL						
<b>Meteorological Information</b>	Surface Wind: 050°/10kt 010V090; Visibility: 10km Temperature: 23°C

**Name of Owner/Operator** : Neonbel AGT (PTY) Ltd/ Protek Air  
**Manufacturer** : Schweizer Aircraft Corporation  
**Model** : Grumman G-164B  
**Nationality** : South African  
**Registration Marks** : ZS-KIL

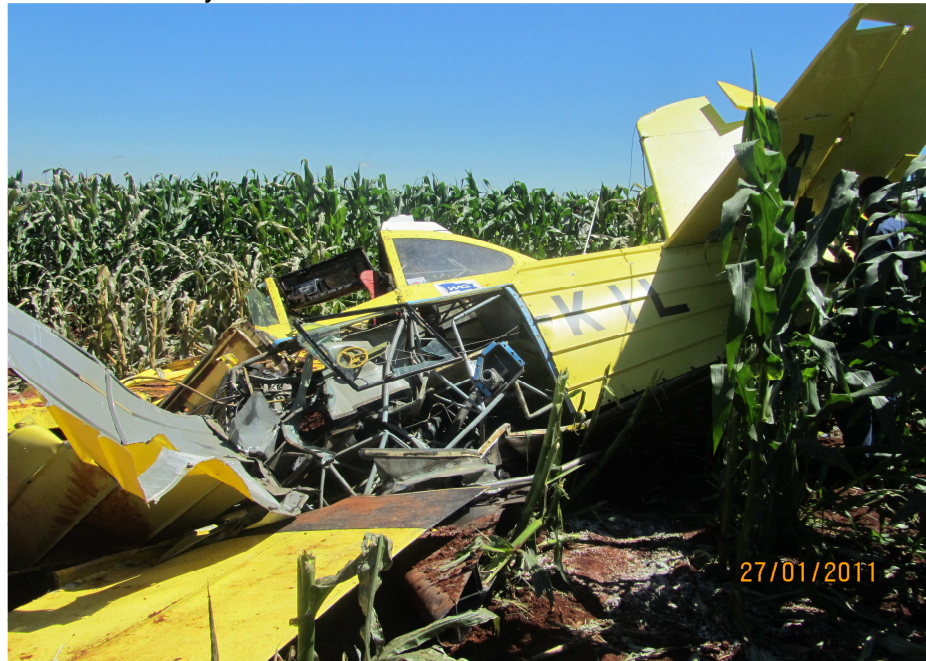
1.3.1 The aircraft was destroyed in the accident.

Photo 1: View of substantial damage caused to the aircraft fuselage, cockpit window frame and wings.

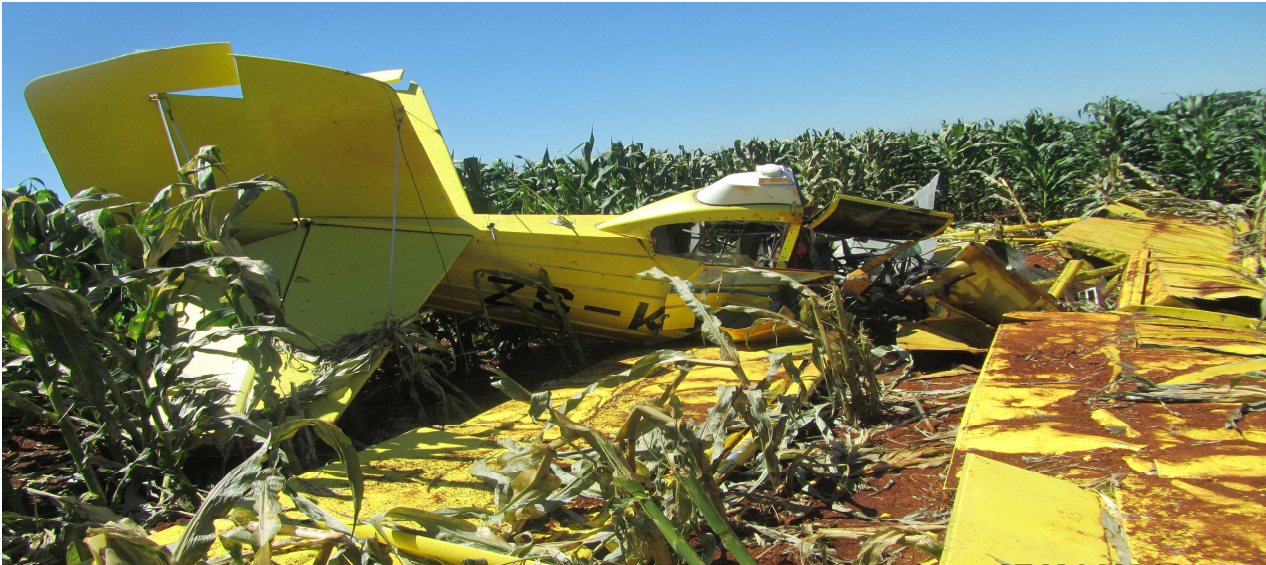
1.12.1 The aircraft was destroyed during the accident sequence. Due to the steep angle that the aircraft impacted the ground, the wreckage was not scattered.

Photo 3: showing the main wreckage including the wings.

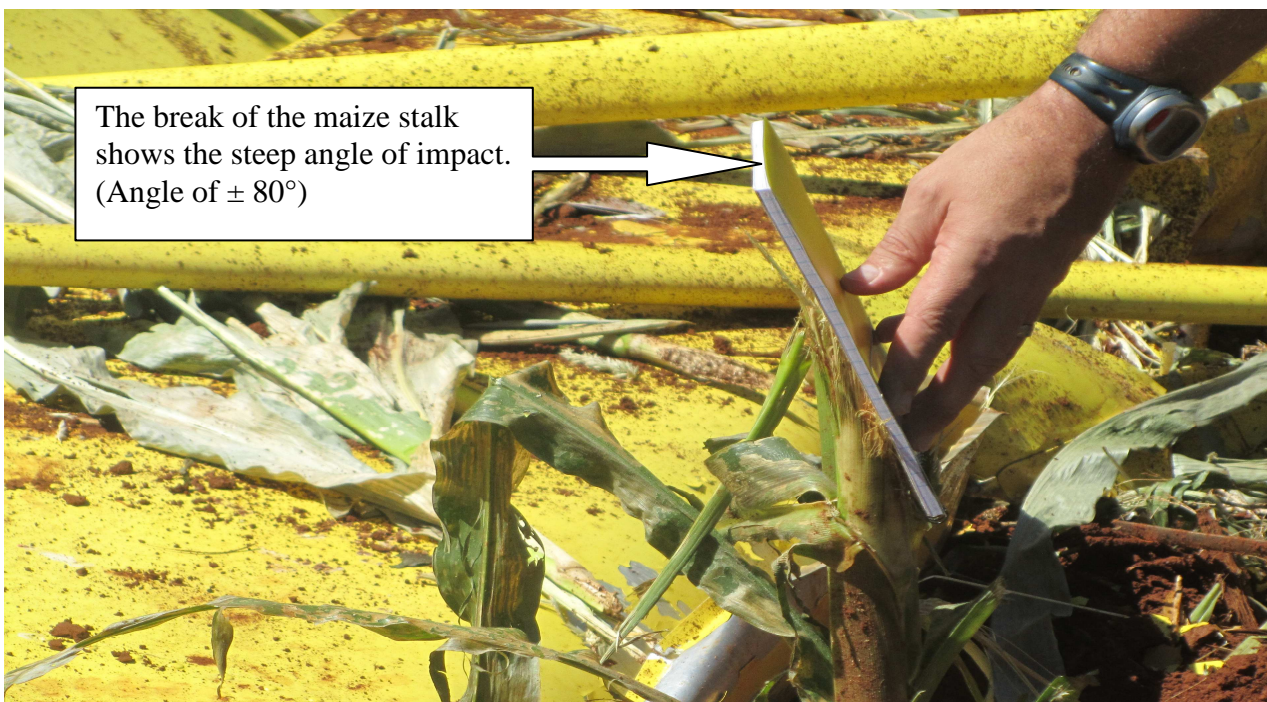
Photo 4: Showing the steep angle at impact.
