AIRCRAFT ACCIDENT REPORT AND EXECUTIVE SUMMARY

Reference:	CA18/3/2/8890	
Aircraft Registration	ZS-OPH	Date of Accident	1 February 2011		Time of Accident	1119Z
Type of Aircraft	GIPPSLAND GA-200C		Type of Operation	Crop Spraying		
Pilot-in-command Licence Type		Commercial	Age	26	Licence Valid	Yes
Pilot-in-command Flying Experience		Total Flying Hours	631,0		Hours on Type	50,8
Last point of departure		Bethlehem Aerodrome (FABM), Northern Cape				
Next point of intended landing		Ladybrand Aerodrome (FALB), Northern Cape				
Location of the accident site with reference to easily defined geographical points (GPS readings if possible)						
On a private farm at Ladybrand at GPS-Coordinates: (S29° 06.082, E027° 36.527)						
Meteorological Information		Wind direction: Calm; Visibility: clear; Temperature: 25°C; Cloud cover: 1/8; Cloud base: 3 000ft				
Number of people on board	1 + 0	No. of people injured	1	No. of people killed	0	
Synopsis						
<p>The pilot took off from Bethlehem aerodrome to perform crop spraying, with the intention of landing at Ladybrand aerodrome afterwards.</p> <p>On the second-last spray run, he pulled up and executed a left turn. During the turn, the engine lost

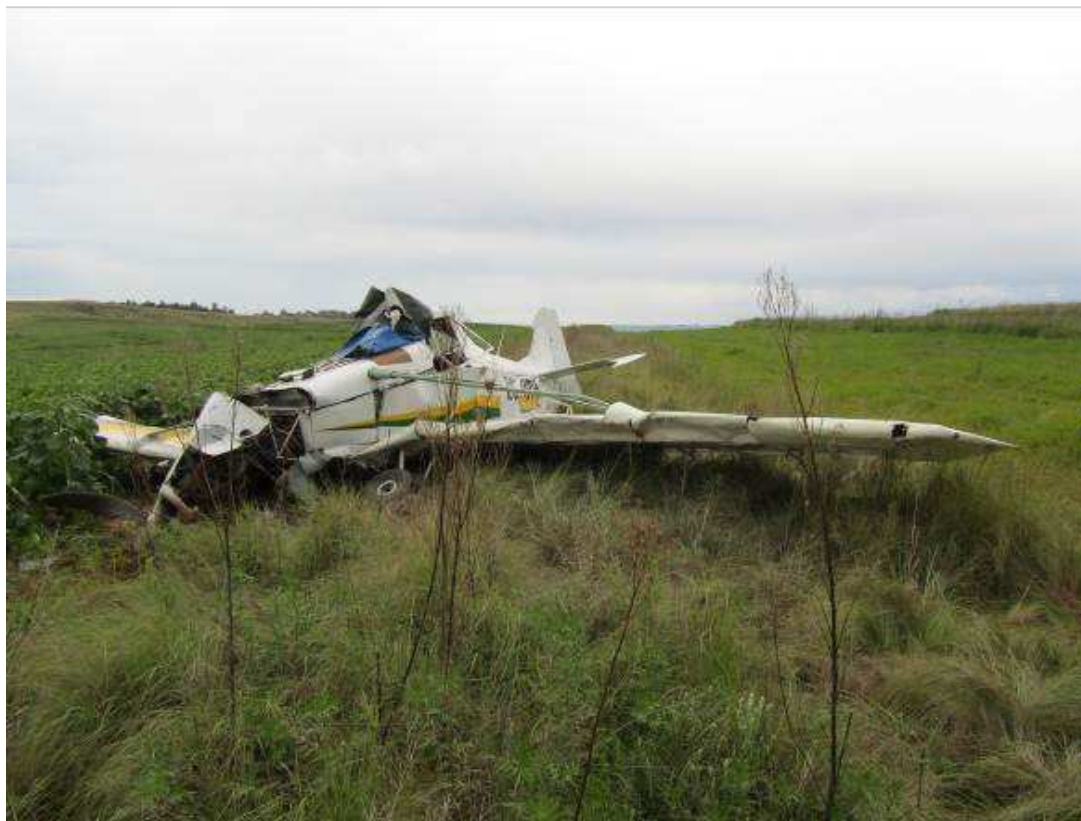
1.3.1 The aircraft was destroyed during the accident sequence.

Figure 1: The damage to ZS-OPH.

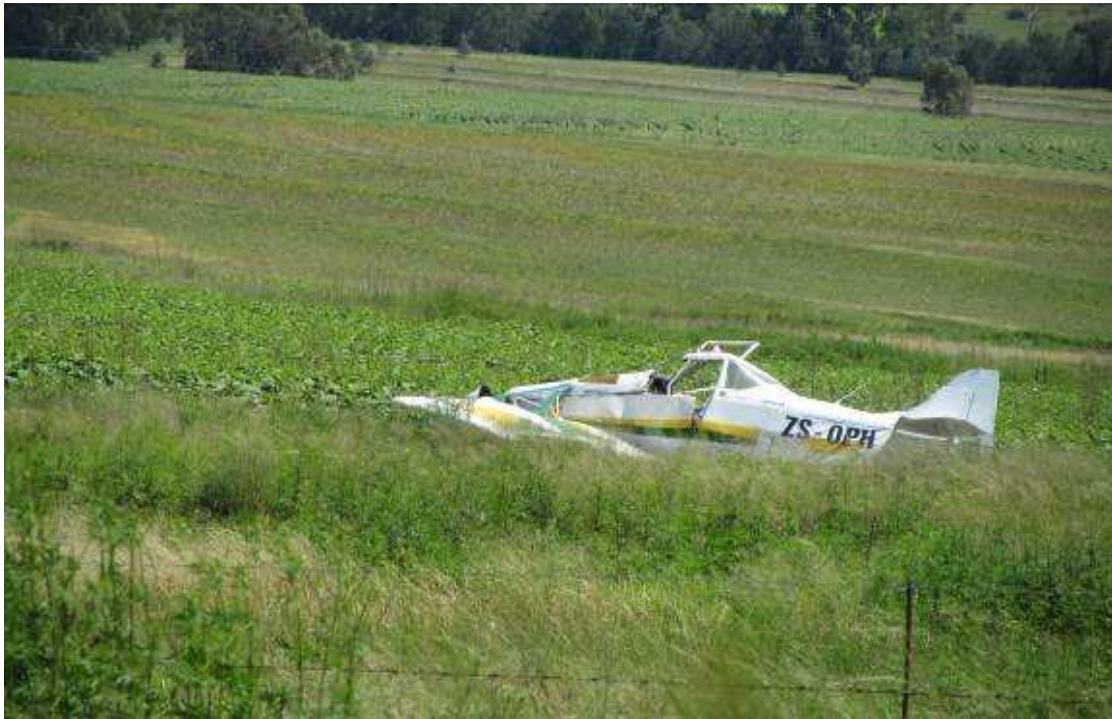
1.12.1 The site at which the accident occurred was a crop-cultivating field. The field has GPS co-ordinates readings (S29° 06.082, E027° 36.527) and a field elevation of 5288ft.

Figure 2: The aircraft after it came to rest in the field.

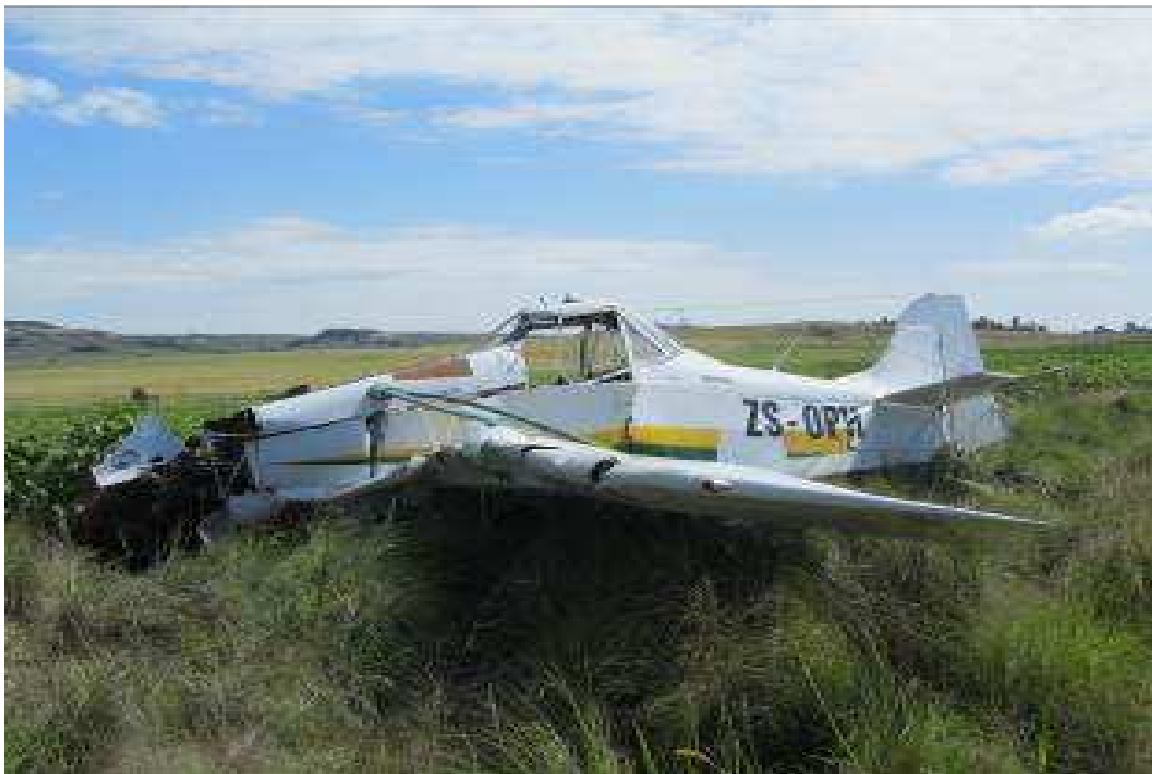
1.12.2 The aircraft struck the ground at a shallow angle and a low speed. The wreckage pattern indicated that the aircraft had stalled and spun in. The aircraft entered a flat spin to the left while the pilot was turning left after the loss of engine power.

Figure 3: The damage to the left side of the aircraft.

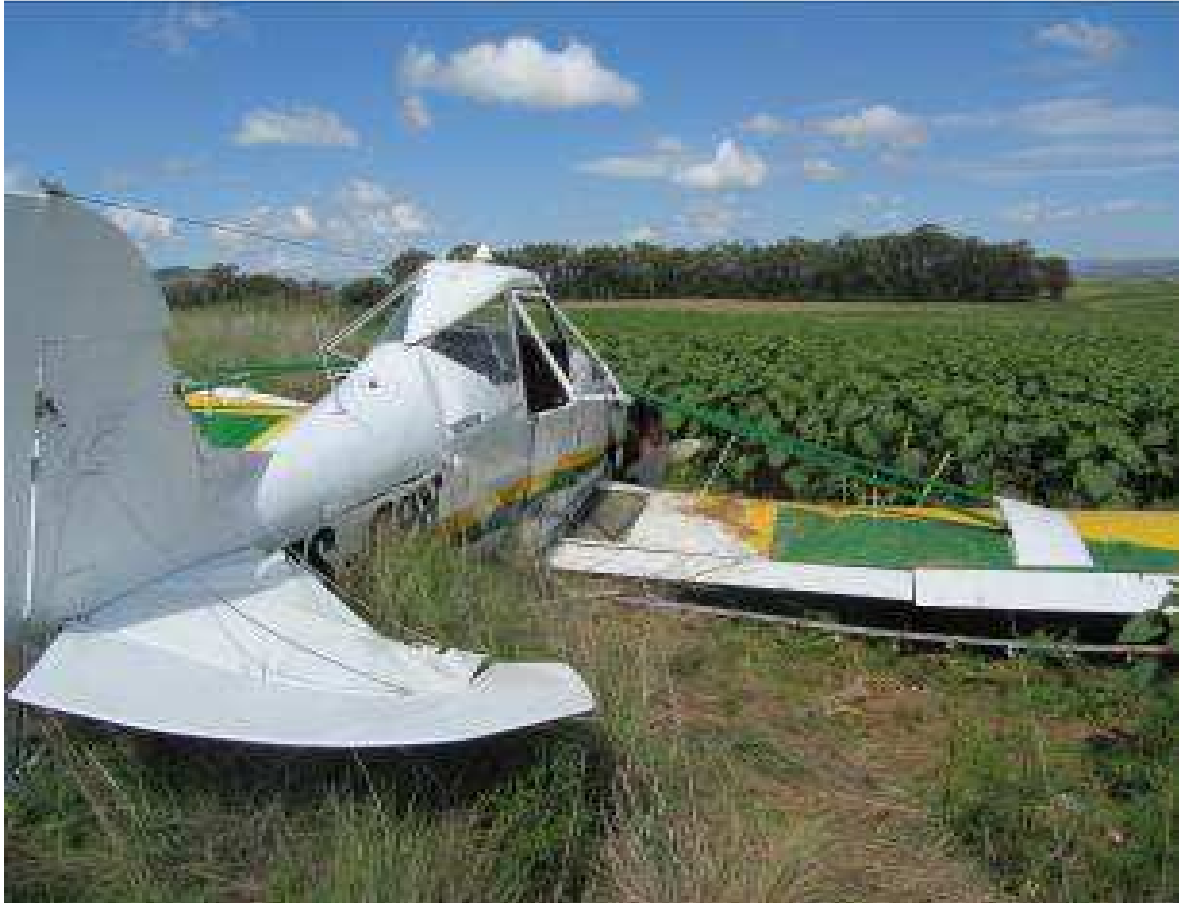
1.12.3 The impact damaged the nose, wings, cockpit, aft fuselage and undercarriage. The rudder, horizontal stabiliser and elevators were also damaged. The force of the impact caused the landing gear to inflict additional damage to the wings.

Figure 4: The right side of the aircraft after the accident.

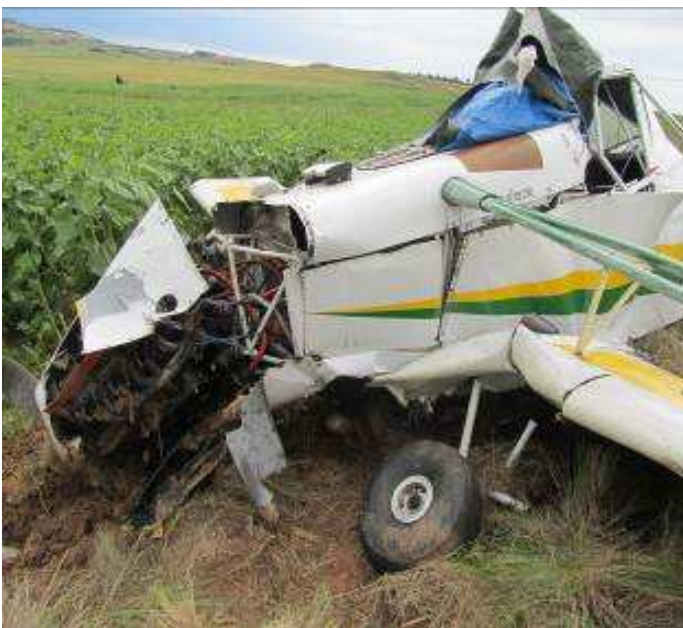
1.12.4 The aircraft was in a flat, left spin when it struck the ground. The impact pushed the engine to the right, and bent the propeller slightly. The damage to the propeller indicated that the engine had power and the propeller was turning on impact.

Figure 5: Damage to nose section.

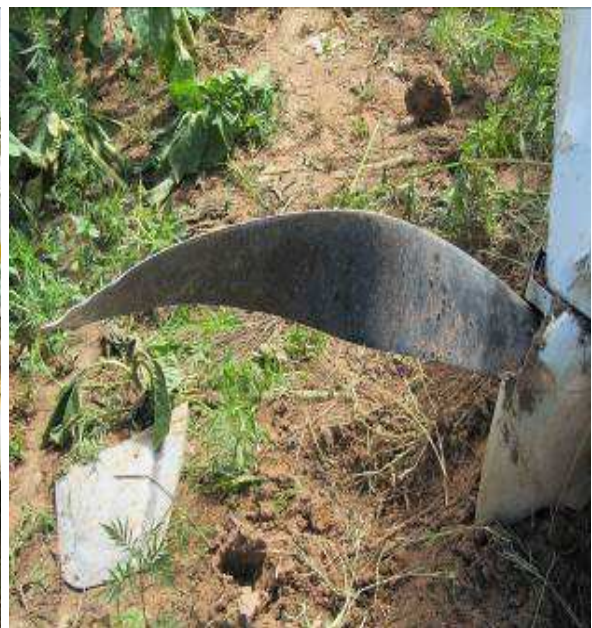
Figure 6: One of the propeller blades after the accident.

- 3.1.11 All control surfaces were accounted for, and all damage to the aircraft was attributable to the severe impact forces.
- 3.1.12 Propeller blade damage and twist was consistent with the engine producing power on impact.

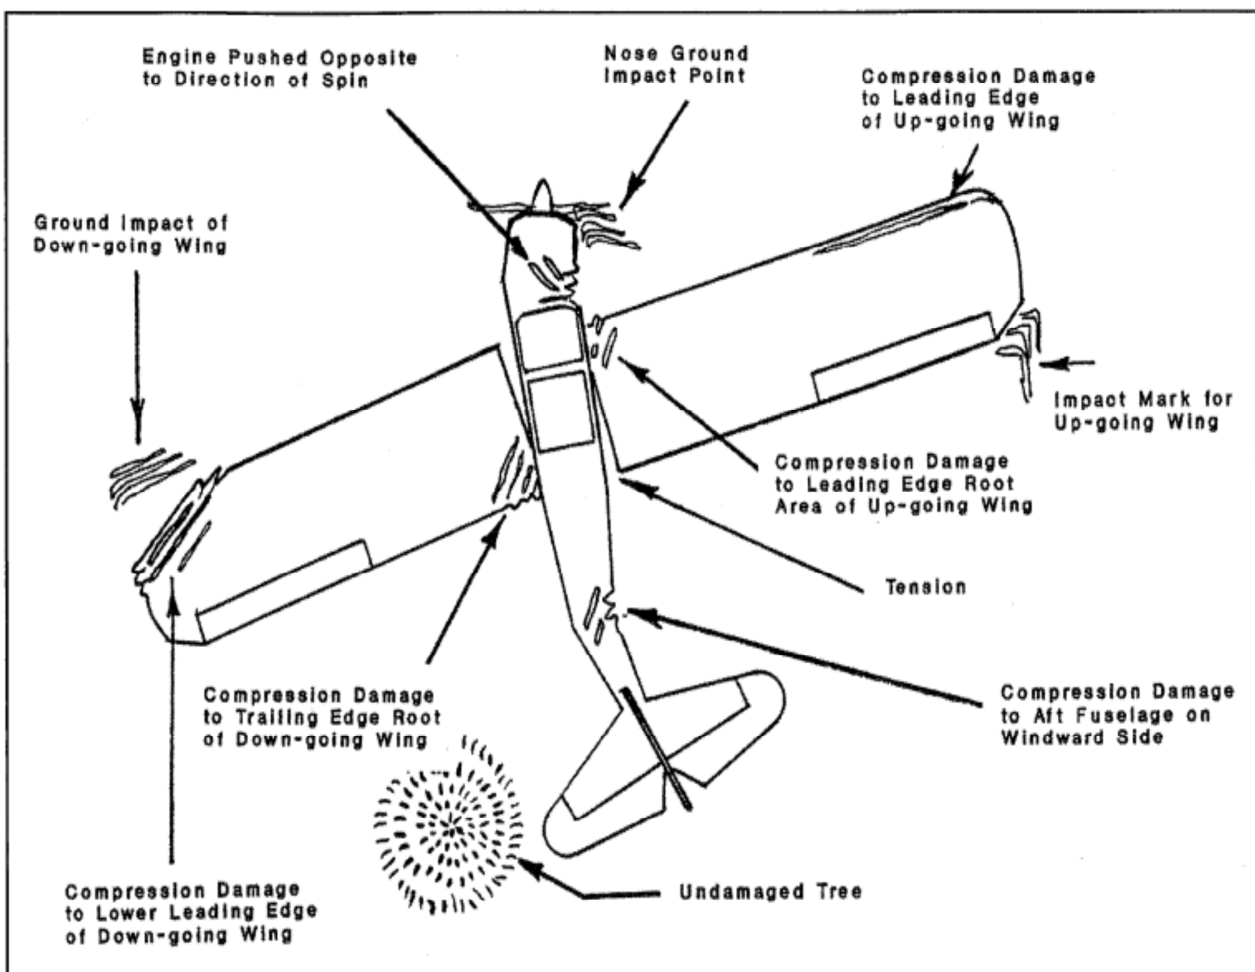
1.18.6 The wreckage pattern is indicative of an aircraft after having stalled and spun into the ground.

The damage that the aircraft sustained exhibited the wreckage pattern of a spinning aircraft as illustrated in *Aircraft Accident Investigation* (Second Edition) by Richard H. Wood and Robert W. Sweginnis.

- Engine pushed to the right (as viewed from the rear).
- Compression damage to the trailing edge root of the left (down going) wing
- Compression damage to the aft fuselage on the right windward side
- Tension to the trailing edge root of the right up-going wing
- Compression to the leading edge root of the right (up-going) wing
- Impact damage to trailing edge wingtip of the right (up-going) wing
- Compression damage to the leading edge of the right (up-going) wing
- Damage to the aft cockpit caused by the tensile stress.

Figure 8: Wreckage pattern of a stall/spin accident.
