<b>AIRCRAFT ACCIDENT REPORT AND EXECUTIVE SUMMARY</b>
-------------------------------------------------------

Reference:	CA18/3/2/0830	
<b>Aircraft Registration</b>	ZU-DHF	<b>Date of Accident</b>	19 February 2011		<b>Time of Accident</b>	1610Z
<b>Type of Aircraft</b>	Tecnam P92-S Echo		<b>Type of Operation</b>		Private	
<b>Pilot-in-command Licence Type</b>		Airline Transport	<b>Age</b>	46	<b>Licence Valid</b>	Yes
<b>Pilot-in-command Flying Experience</b>		Total Flying Hours	4590.0		Hours on Type	158.0
<b>Last point of departure</b>		Kitty Hawk Estate Airfield				
<b>Next point of intended landing</b>		Kitty Hawk Estate Airfield				
<b>Location of the accident site with reference to easily defined geographical points (GPS readings if possible)</b>						
On Runway at Kitty Hawk Estate.						
<b>Meteorological Information</b>		Temperature: 25°C, Wind direction: Southerly, Wind speed:±10 kts, Visibility: good, Dew Point: Unknown, Cloud Cover/Base: CAVOK.				
<b>Number of people on board</b>	2 + 0	<b>No. of people injured</b>	0	<b>No. of people killed</b>	0

## AIRCRAFT ACCIDENT REPORT

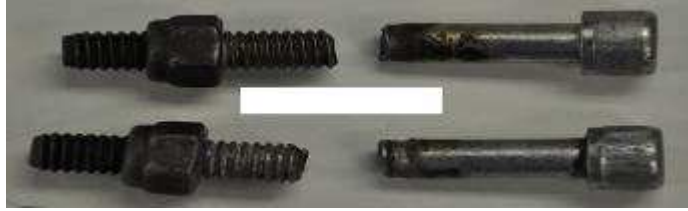
1.12.2 The aircraft was examined by the pilots to determine the cause of the landing gear failure. The evidence shows that two bolts on the left side of the main gear had failed. The broken bolts were installed to a bracket plate that secured the left side gear strut/arm to the airframe. The pieces of broken bolts were found approximately 200 metres away from the threshold of Runway 19.

Figure 1, shows two left side landing gear bolts that had failed.

Figure 2, shows damage caused to the fuselage.

1.12.3 The aircraft sustained damage to the left side of the fuselage on the belly, left side main gear and nose landing gear.

1.16.1 The broken bolts were not submitted for metallurgical examination. However, the bolts were shown to a metallurgical specialist who visually inspected them. The metallurgical specialist's observation was that the bolts had failed as a result of being overstressed in operation. The metallurgical specialist recommended that it would be a waste of money to have the bolts examined in this regard. The bolts needed to be inspected periodically in order to check their condition and avoid this type of failure.

- 3.1.7 The debris of the broken bolts were found on the runway. The identified parts had separated from the aircraft during one of the landings.
- 3.1.8 After a visual inspection was conducted on the broken bolts, it was determined that the bolts had failed due to strain or overstress during a firm (hard) landing.
