AIRCRAFT ACCIDENT REPORT AND EXECUTIVE SUMMARY

Reference:	CA18/2/3/8894	
Aircraft Registration	ZS-GAA	Date of Accident	8 February 2011		Time of Accident	1433Z
Type of Aircraft	Pilatus PC-12/47 (Aeroplane)		Type of Operation		Private (Part 91)	
Pilot-in-command Licence Type		Commercial Pilot	Age	32	Licence Valid	Yes
Pilot-in-command Flying Experience		Total Flying Hours	2 662.3		Hours on Type	582.2
Last point of departure		Queenstown Aerodrome (FAQT), (Eastern Cape Province)				
Next point of intended landing		Plettenberg Bay Aerodrome (FAPG), (Western Cape Province)				
Location of the accident site with reference to easily defined geographical points (GPS readings if possible)						
Crashed into the sea near Plettenberg Bay (GPS position; South 34°06'.954 East 023°23'.522)						
Meteorological Information		Surface wind; light/variable, Temperature; 20°C, Overcast, light drizzle/mist.				
Number of people on board	2 + 7	No. of people injured	0	No. of people killed	9

AIRCRAFT ACCIDENT REPORT

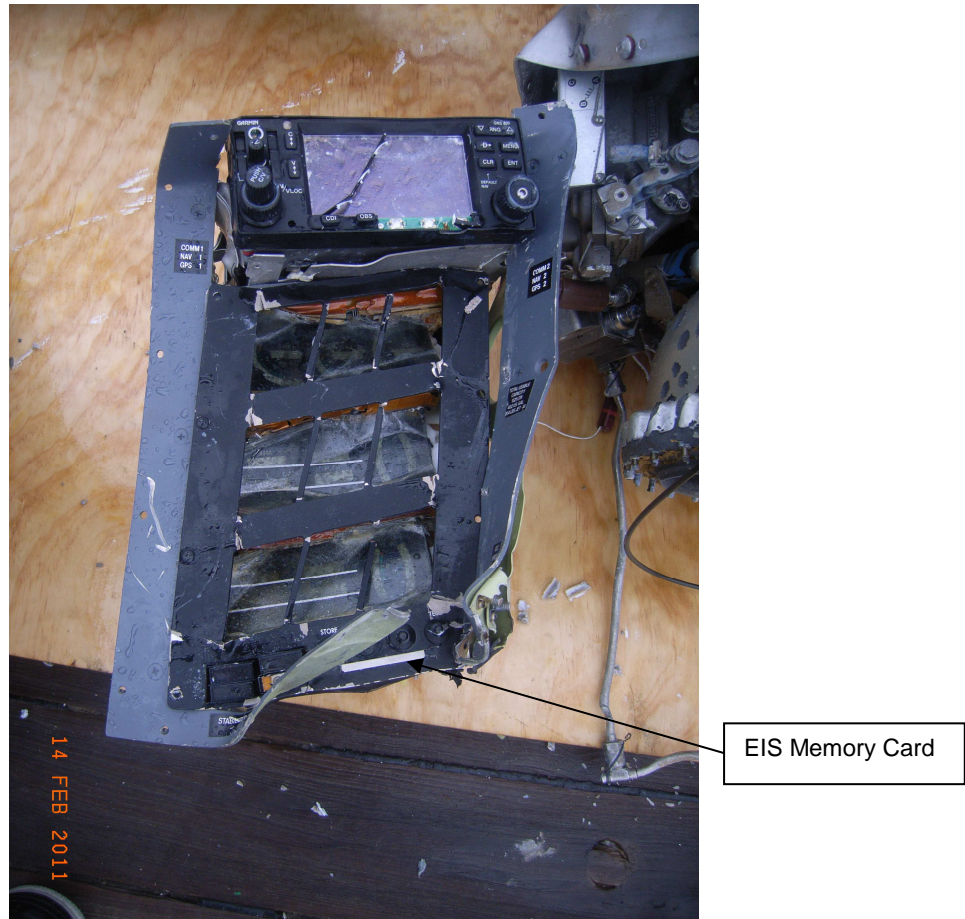
Figure 1. EIS Display

1.11.2 The aircraft was equipped with an Engine Indication System (EIS), which contained a non volatile memory (NVM) in the form of a memory card. The memory card was normally used to download Engine Condition & Trend Monitoring (ECTM), which records engine trend data, but also engine exceedance data, if applicable. The EIS display was recovered from the sea after several days and after recovery was immediately rinsed in fresh water.

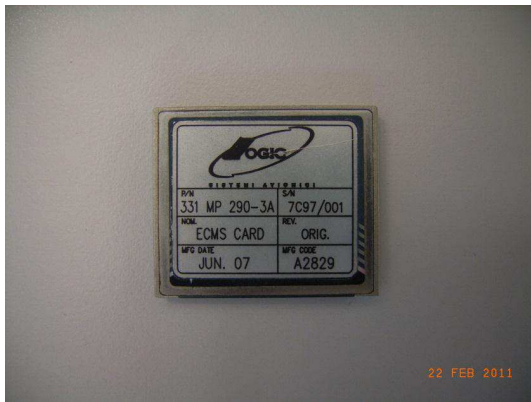
Figure 2. EIS Memory Card

“The EIS memory card most likely sustained internal damage to such an extent that normal data download using the normal tooling was not possible. The reason for this damage was most likely the penetration of salt water into the card itself”.

The actual vendor/manufacturer of the memory card was contacted following the download attempt of the memory card referred above. They indicated that the memory card was not designed nor manufactured as a waterproof unit and by being exposed to the sea water for several days, the flash chip inside most probably deteriorated/broke, with the result that the downloading/retrieval of data was not possible.

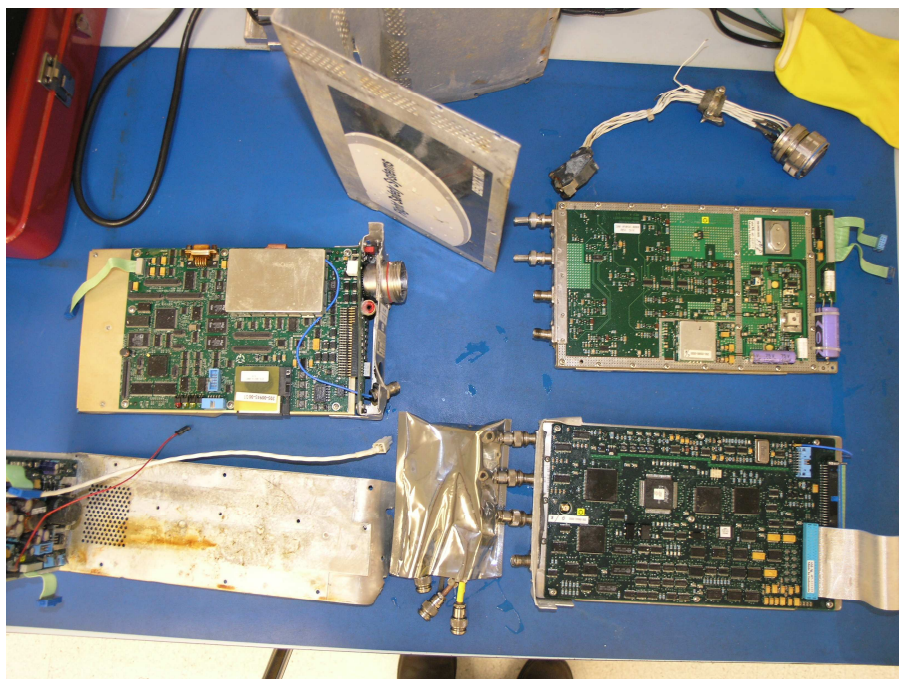
A view of the unit after it was dismantled and cleaned at the Honeywell laboratory.

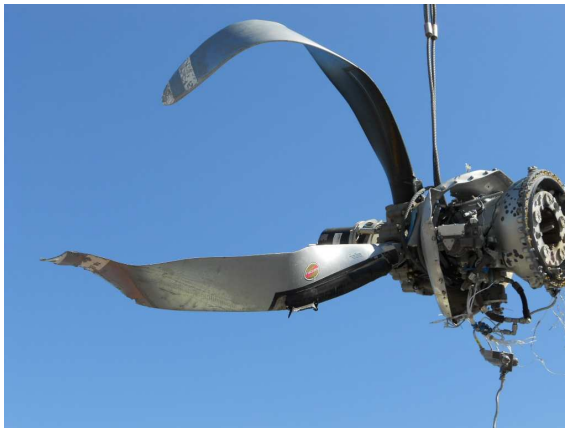
The propeller, with two of the four blades still attached to the hub assembly and the reduction gearbox of the engine were recovered, and so was the engine.

Figure 4. A view of the propeller.

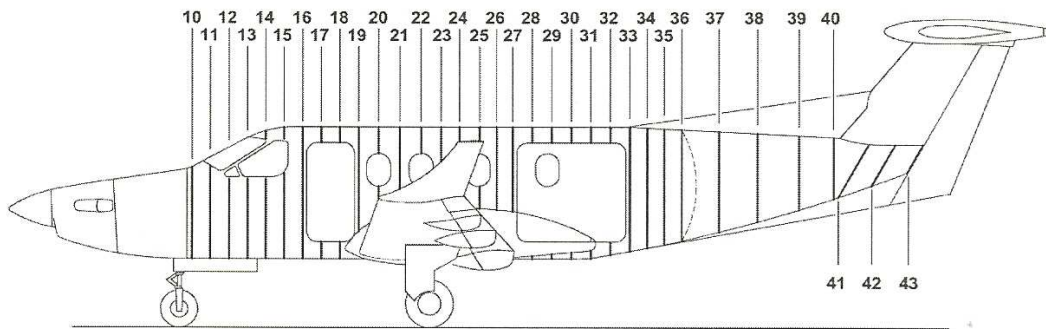
Several parts of the fuselage section were recovered, however, except for a few parts, the entire section from frame 10 (firewall) to approximately frame 27 (in front of the cargo door) is still missing (see figure 6 for reference to the frame numbers). This include the right wing, from which only the weather radar dome/cover and the

Figure 6. Fuselage Structure Identification

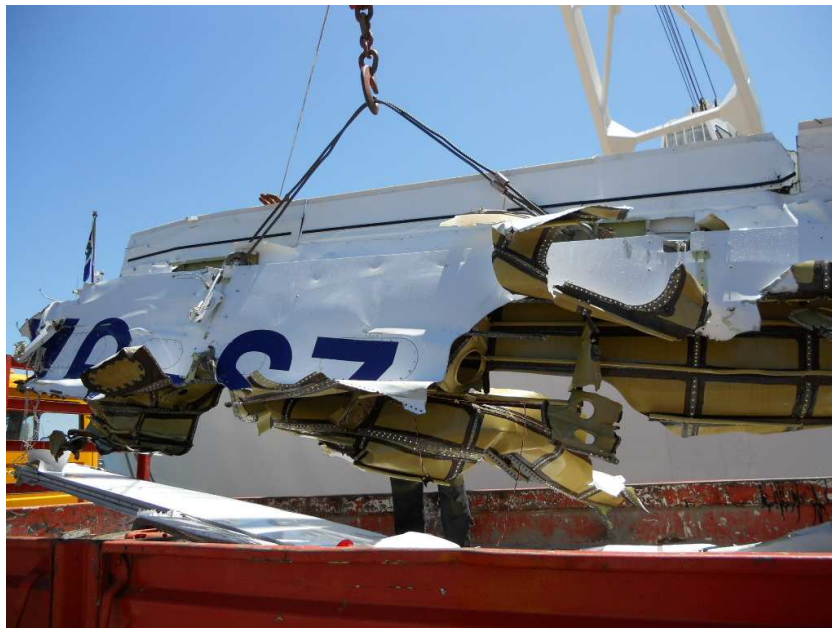
A section of the left wing was recovered (see figure 7). The inner part of the wing up to rib 5 is missing (refer to Figure 8). The outer part of the wing is fractured in the area of rib 16. Except for the wing tip none of the pieces of this section was found. The inner leading edge is missing and the tank area had burst open. The rear spar of the wing was fractured at the landing gear attachment. Both wing fuselage/wing attachments are missing. No pieces of the left main landing gear were found.

Figure 7: A view of the left wing that was recovered with a section of the flap attached.

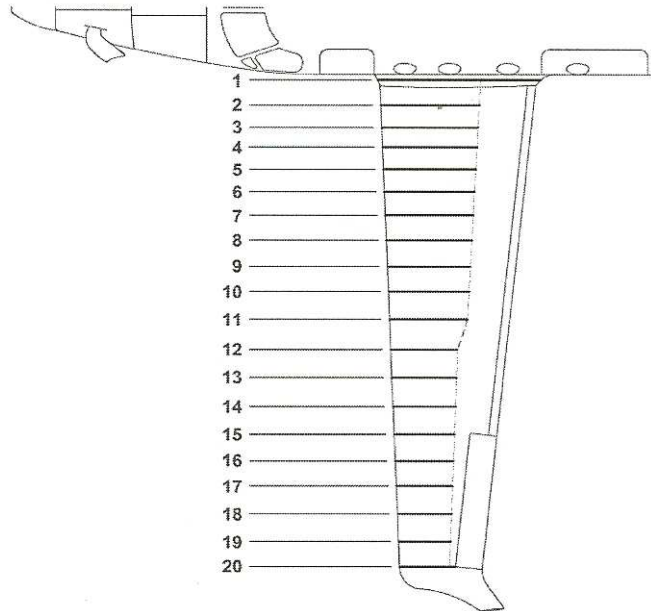
Figure 8. Left wing sections.

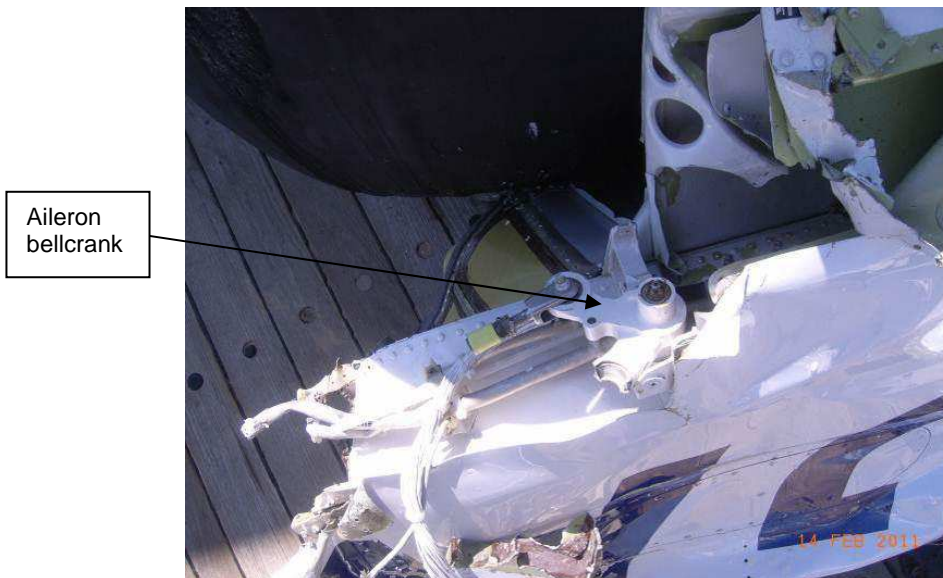
Except for one bellcrank (see Figure 9) (left-hand outer), no other parts of the aileron system, including the surfaces itself were found. The aileron trim actuator, (located on the left side) was not recovered either, therefore aileron control continuity could not be established.

Figure 9. The left-hand outer aileron bellcrank.

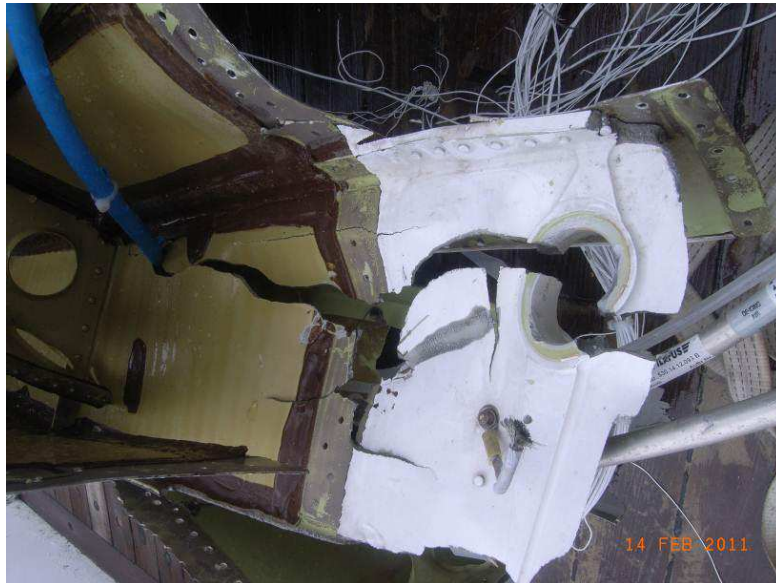
time of impact with 100% certainty. The left-hand side landing gear attachment point at the rear wing spar did not show any signs of torsion (see Figure 10).

Figure 10: Left-hand landing gear attachment point at the wing main spar.

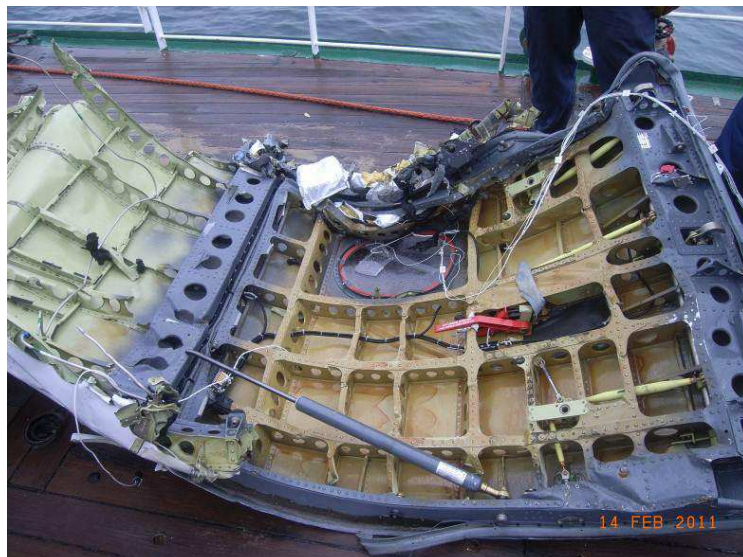
The cargo door area and associated structure were recovered from the sea. The cargo door was found still attached to the hinge on the top fuselage. The 3 hooks were free to rotate, as the locking mechanism reflected damage to the individual units. One shoot bolt was found out and jammed, which was an indication that the door was closed and locked at the time of impact.

Figure 11. Cargo door with shoot bolt.

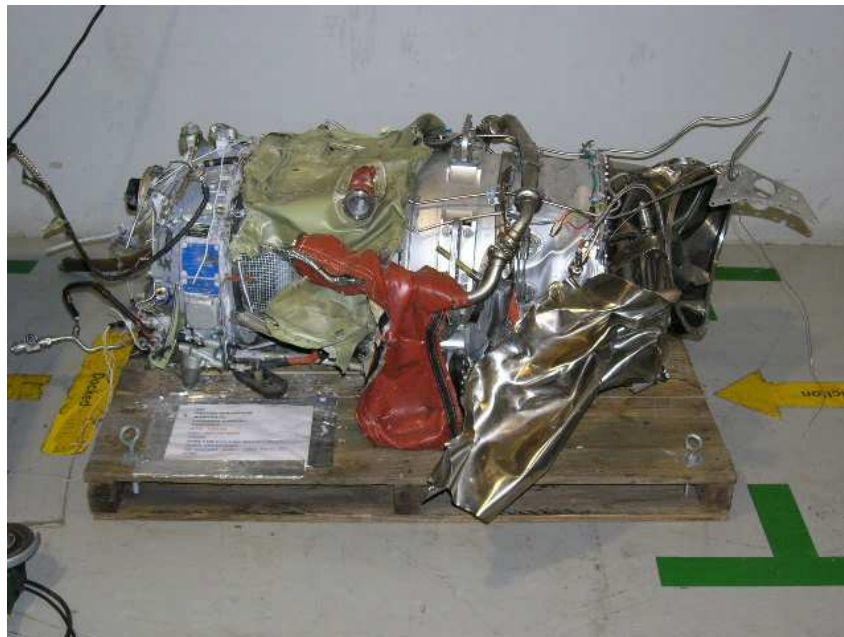
“A brief summary of observations, engine displayed deformation to the compressor 1st stage blades and contact signatures to the compressor axial stages, compressor impeller and shroud, compressor turbine, 1st stage power turbine vane ring and shroud, 1st stage power turbine, 2nd stage power turbine vane ring shroud, 2nd stage power turbine, and torsional fracture of the reduction gearbox propeller shaft coupling webs characteristic of the engine producing power at impact, likely in the middle to high power range. There were no indications of any pre-impact mechanical anomalies or dysfunction to any of the components observed.”

Photo No. 1
General view of the engine (right-hand side).

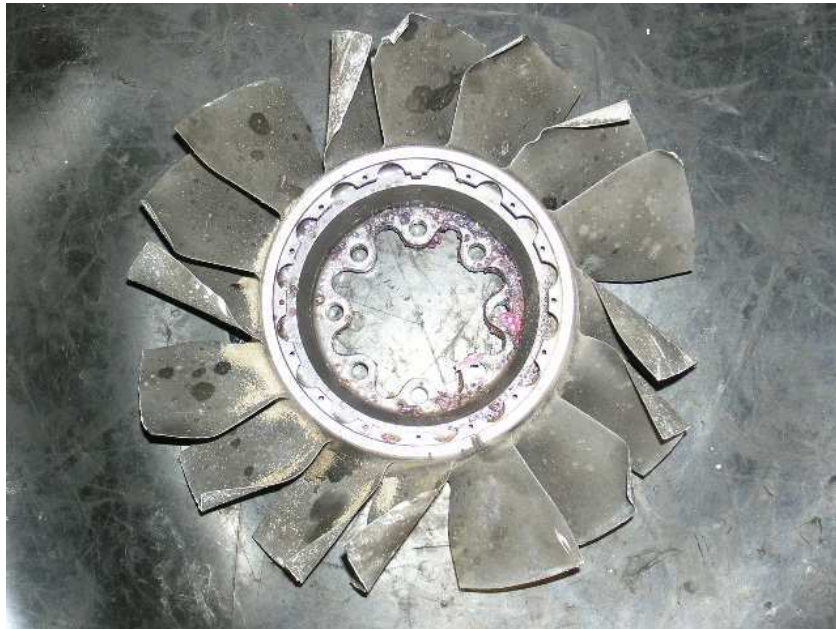
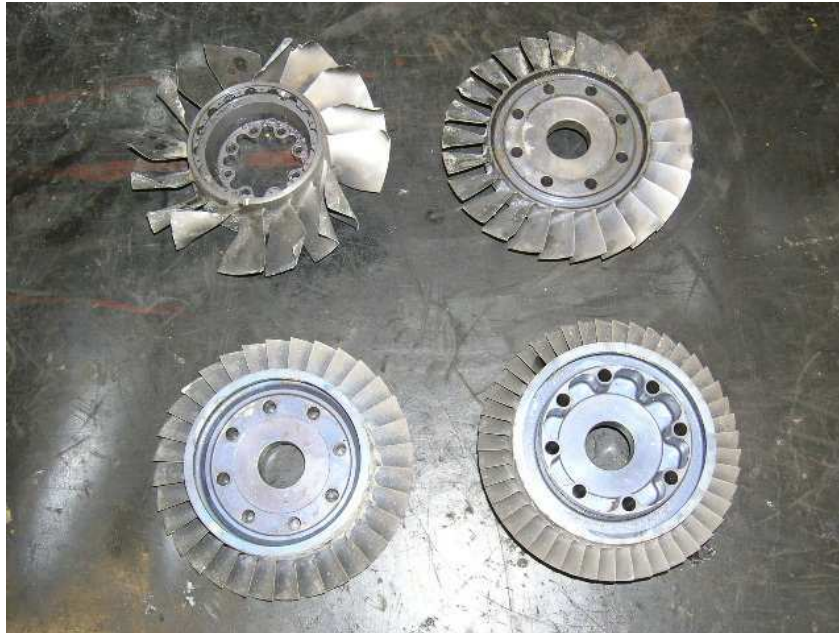
Compressor Discs and Blades: The 1st stage blade airfoils were deformed randomly forward and away from the direction of rotation. The blade airfoil leading edges displayed nicks and deformation. The 2nd stage blade airfoils displayed slight nicks and deformation. The 3rd and 4th stages were intact. Please refer to photos No. 2 to 5.

Photo No. 2
Compressor 1st stage disc.

Photo No. 3
Compressor 1st, 2nd, 3rd, and 4th stage discs.

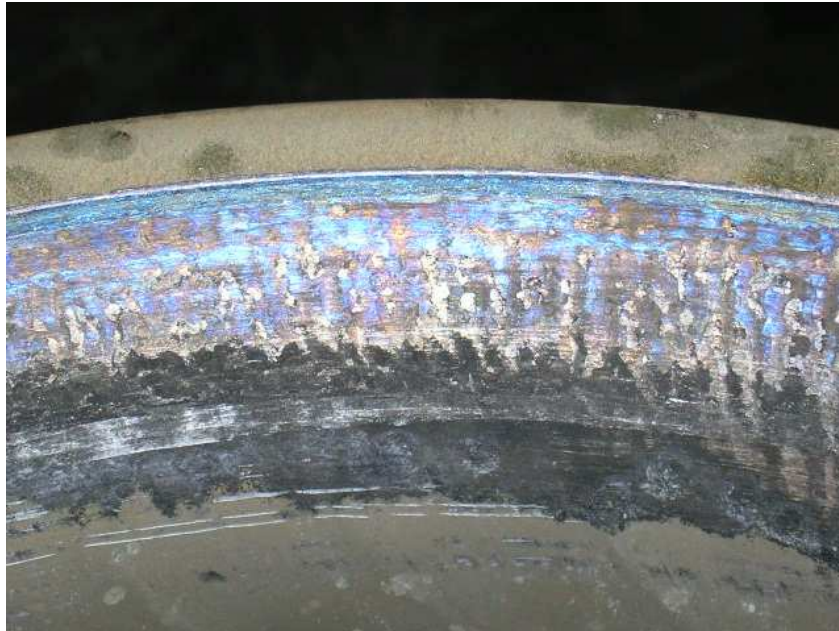
Centrifugal Impeller Shroud: The shroud face displayed circumferential rubbing, with frictional heat discoloration and material transfer, due to contact with the impeller. Refer to photo No. 5 on the next page.

Photo No. 5
Centrifugal impeller shroud, detail.

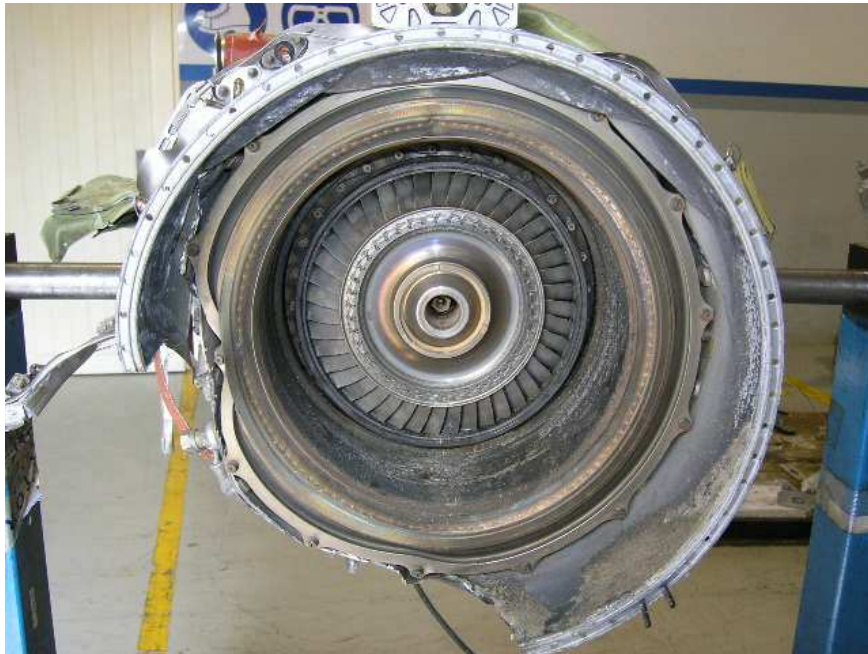
Combustion Chamber Liner: Displayed no indications of operational distress. The outer liner flame pattern indications appeared normal. Please refer to photo No. 6.

Photo No. 6
Combustion chamber liner and compressor turbine, in-situ.

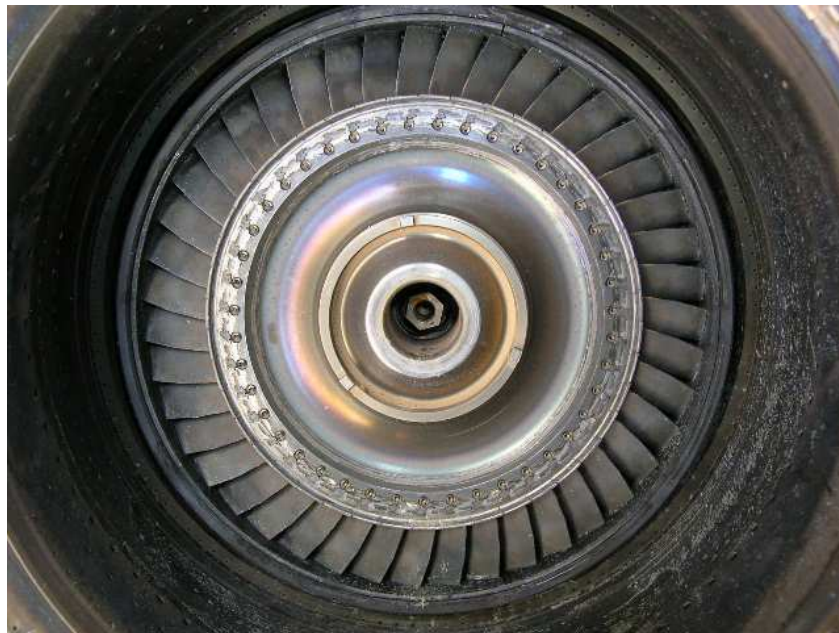
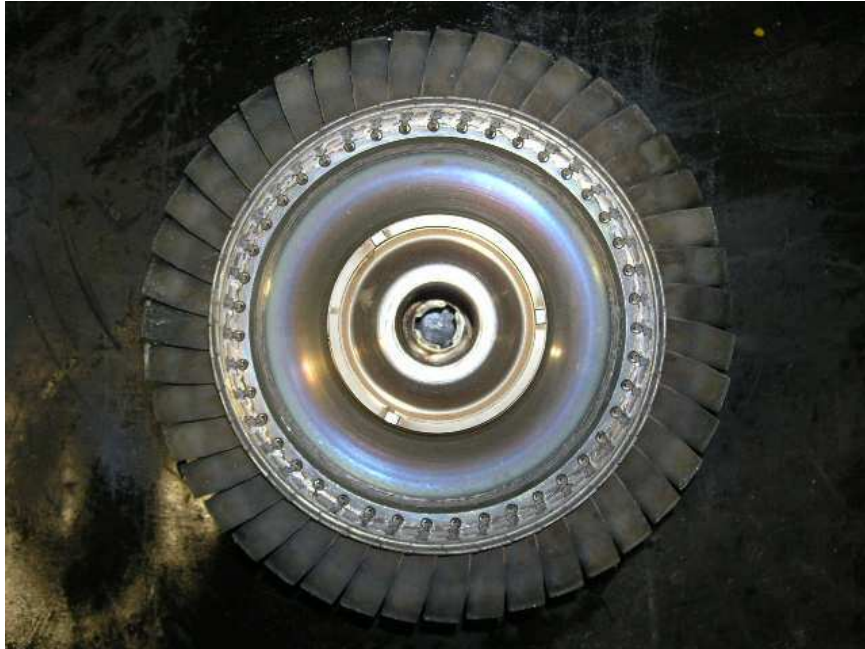
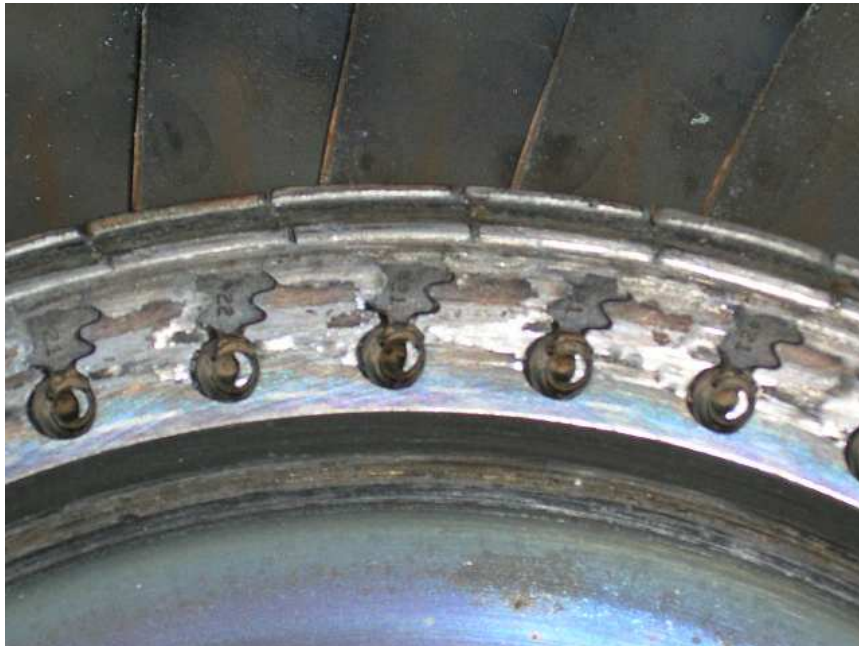
Compressor Turbine: The blade airfoils displayed no indications of distress. The upstream side blade platforms displayed circumferential rubbing due to contact with the compressor turbine vane ring inner drum. The downstream side blade platforms and disc outer rim were circumferentially machined due to contact with the 1st stage power turbine vane ring. The hub face was circumferentially rubbed due to contact with the inter-stage baffle. Please refer to photos No. 7 to 9.

Photo No. 7
Compressor turbine, in-situ.

Photo No. 8
Compressor turbine, downstream side.

Photo No. 9
Compressor turbine downstream side, detail.

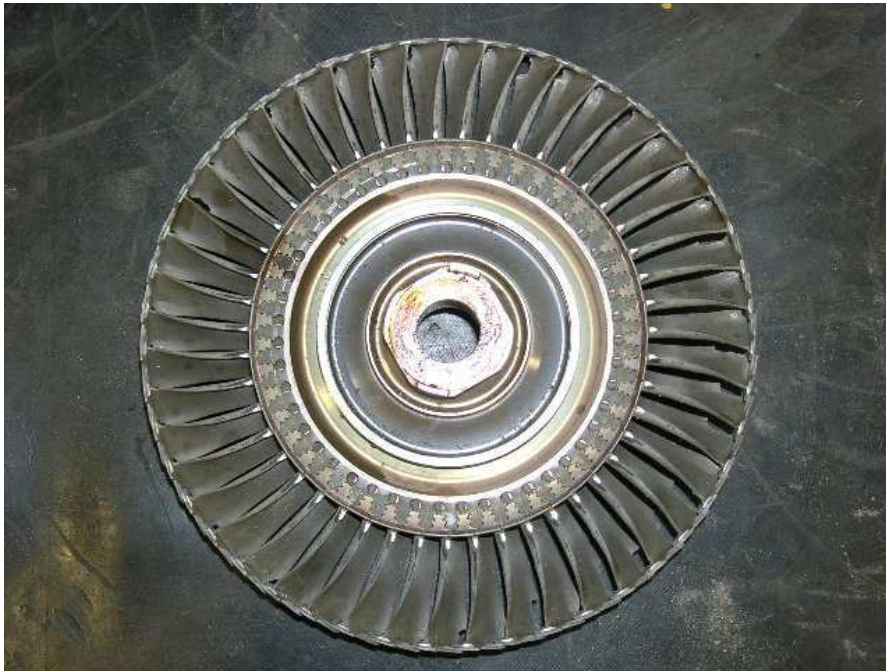
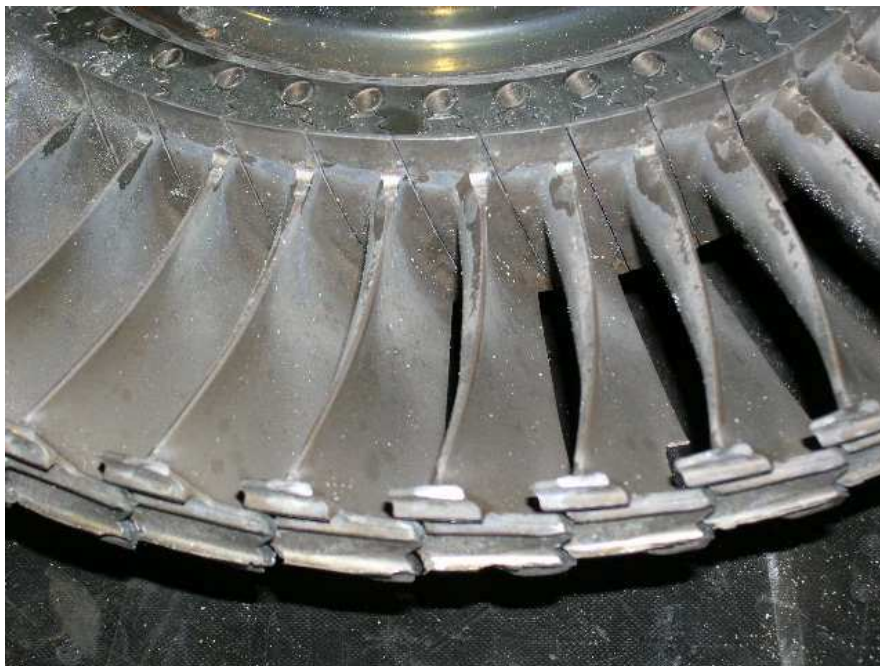
1st Stage Power Turbine: The upstream side blade roots and the blade tip shrouds displayed circumferential rubbing and machining due to contact with the 1st stage power turbine vane ring. The downstream disc outer rim and blade outer spans were circumferentially rubbed, and the outer spans deformed and fractured, due to contact with the 2nd stage power turbine vane ring. The blade tips were circumferentially rubbed due to contact with the shroud. Please refer to photos No. 10 and 11.

Photo No. 10
1st stage power turbine, upstream side.

Photo No. 11
1st stage power turbine upstream side, detail.

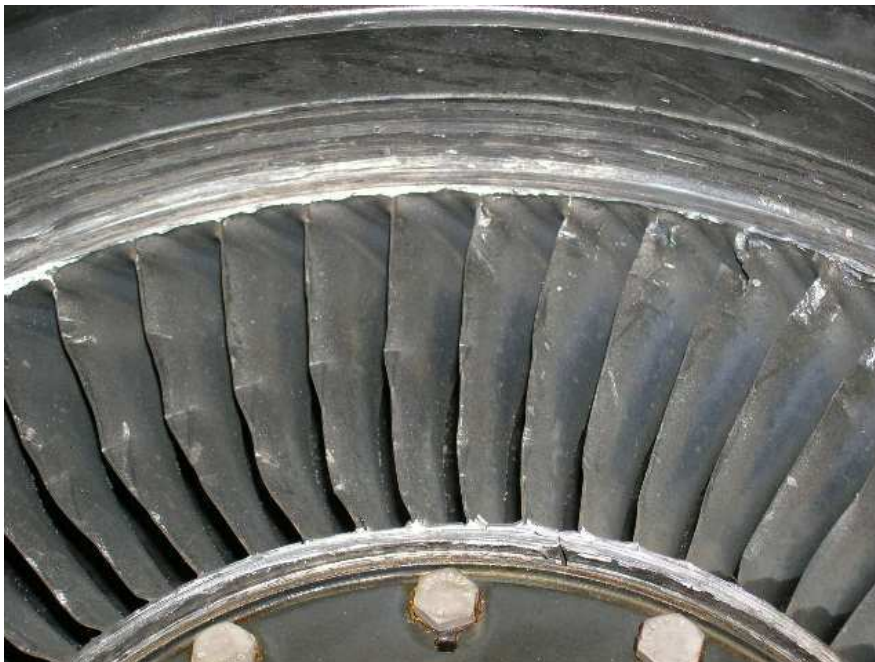
Photo No. 14

2nd Stage Power Turbine Shroud: Displayed heavy circumferential rubbing due to contact with the 2nd stage power turbine blade tips. Please refer to photo No. 14.

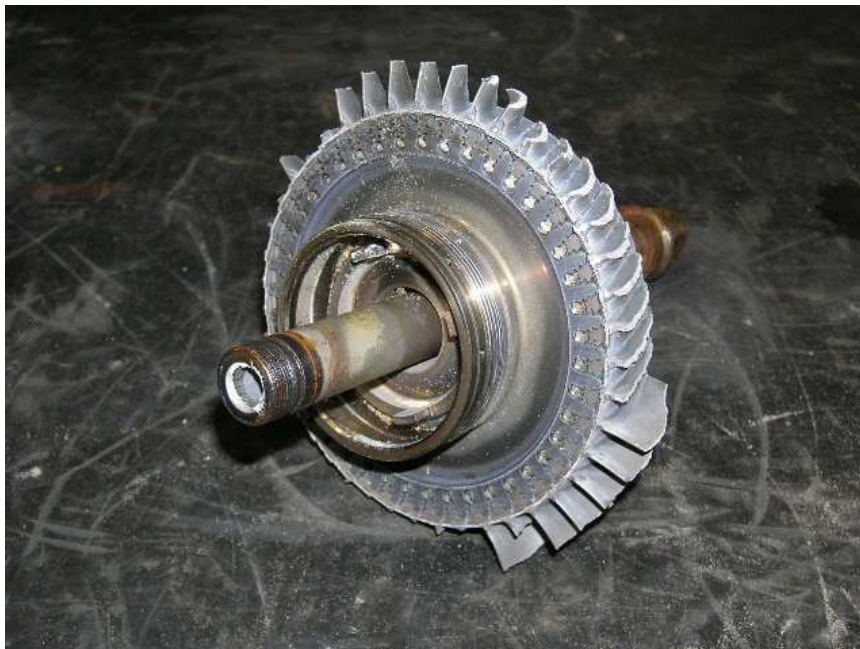
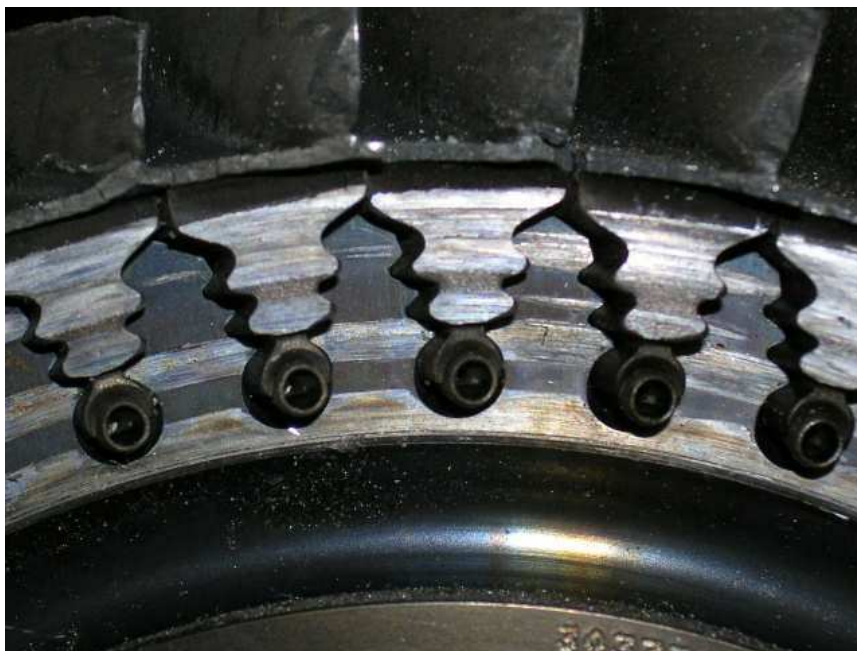
2nd Stage Power Turbine: The blade airfoils were circumferentially fractured at heights varying from the root to approximately 1/4 span due to contact with the duct, shroud, and 2nd stage power turbine vane ring. Fractured blade material remained in the exhaust duct. The recovered blade tips displayed circumferential rubbing. The upstream side blade platforms displayed circumferential machining due to contact with the vane ring. The downstream side blade platforms and disc face displayed circumferential rubbing due to contact with the power turbine shaft housing and exhaust duct inner shroud. Under unaided visual and macroscopic inspection all of the blade fractures displayed coarse dendritic features and displayed no indications of fatigue or other progressive fracture mechanism. Please refer to photos No. 15 and 16.

Photo No. 15
2nd stage power turbine and power turbine shaft, upstream side.

Photo No. 16
2nd stage power turbine downstream side, detail

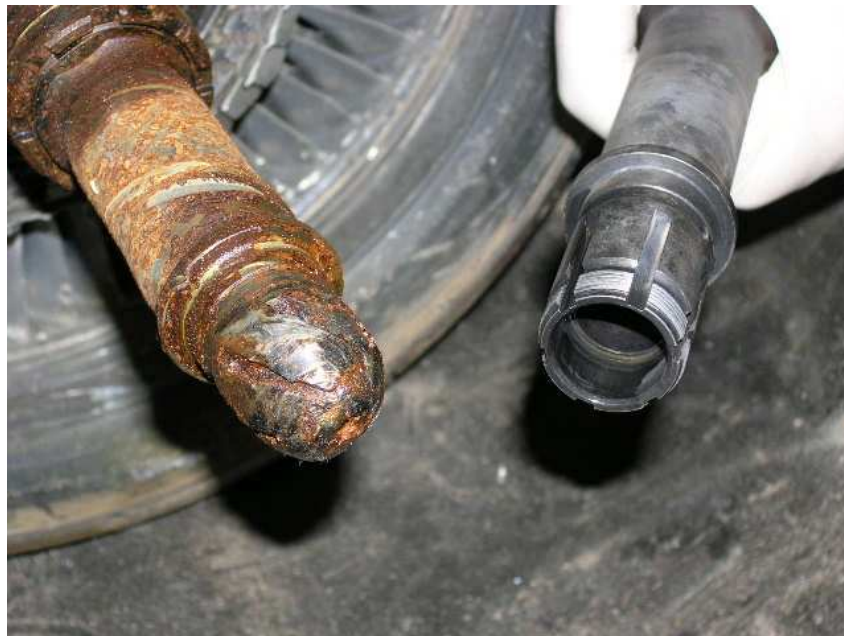
Power Turbine Shaft and Shaft Housing: The power turbine shaft was fractured from the reduction gearbox coupling. The shaft face displayed severe circumferential rubbing and deformation. The power turbine shaft housing was not recovered. The exhaust duct inner shroud displayed circumferential scoring due to contact with the 2nd stage power turbine. Please refer to photo No. 18.

Photo No. 18
Power turbine shaft forward section compared to exemplar shaft.

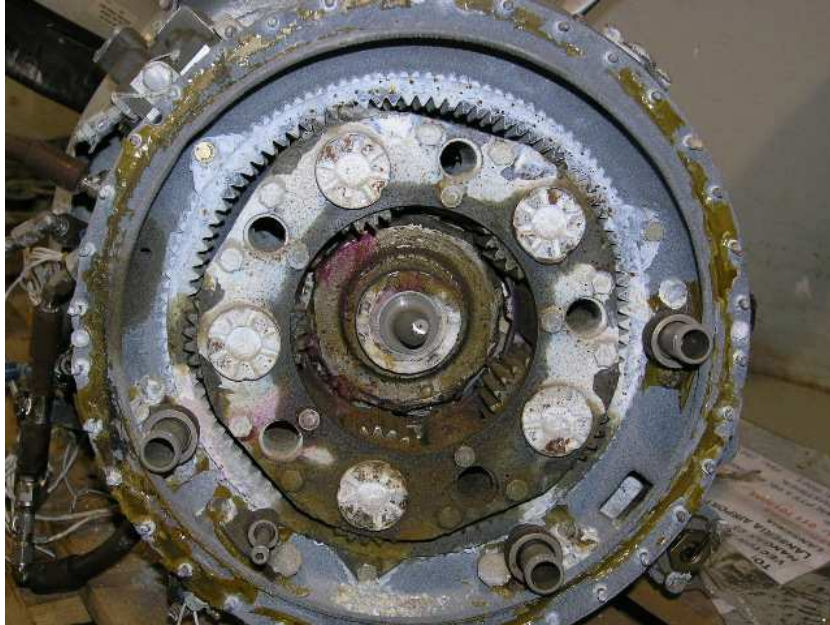
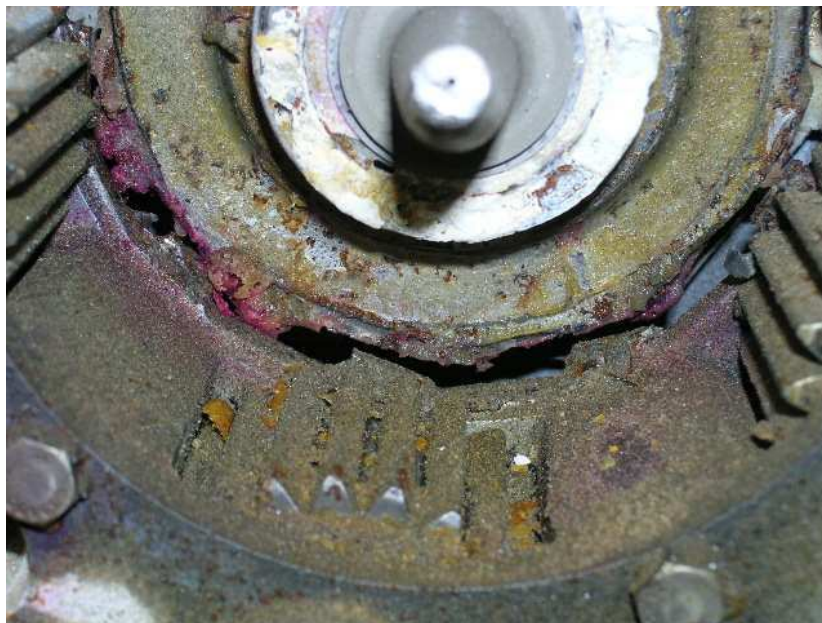
The 2nd stage gearing was observed in-situ in the reduction gearbox forward housing. The gearing displayed severe corrosion damage as a result of sea water. The 2nd stage planet gear carrier to propeller shaft spline mounting webs was fractured in torsion. The fractured webs displayed counter-clockwise torsional deformation. The reduction gearbox rear housing and 1st stage gearing were not recovered. Please refer to photos No. 19 and 20.

Photo No. 19
Reduction gearbox 2nd stage gearing.

Photo No. 20
2nd stage planet gear carrier propeller shaft coupling

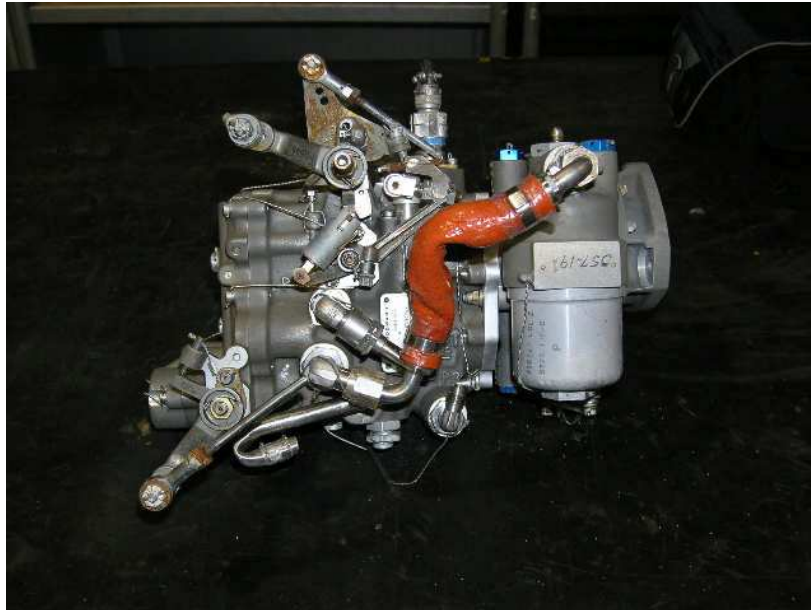
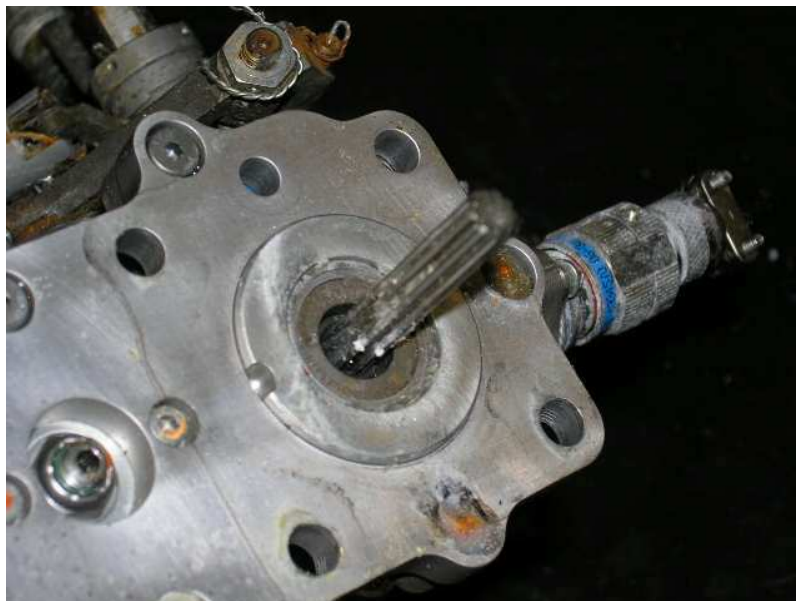
Salt water immersion damage precluded evaluation of the controls and accessories. The fuel control unit was separated from the high pressure fuel pump for inspection of the governor drive shaft. The shaft was intact and could be rotated by hand. Please refer to photos No. 21 and 22.

Photo No. 21
Fuel control unit and high pressure pump, right hand view

Photo No. 22
Fuel control unit governor drive shaft.

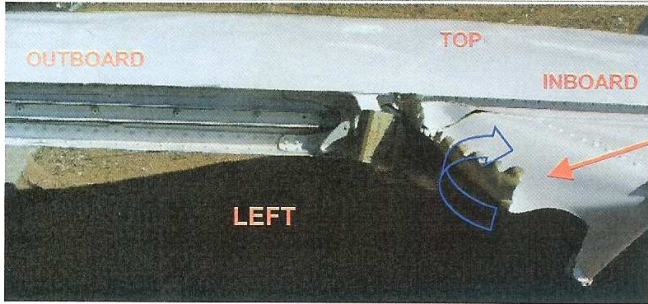
Photo 3: Left hand elevator section point of failure (digital)

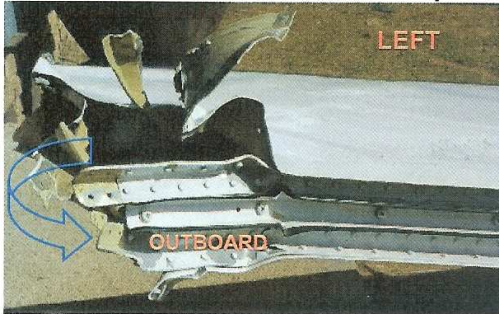
Photo 4: Left hand elevator failed outboard hinge (digital)

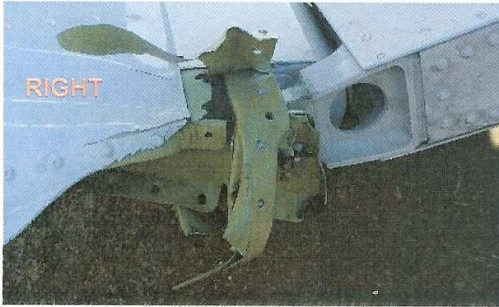
Photo 5: Right hand elevator damaged outboard hinge (digital)

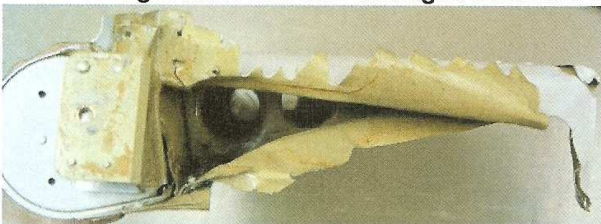
Photo 6: Left hand elevator fracture surfaces (digital)
