AIRCRAFT ACCIDENT REPORT AND EXECUTIVE SUMMARY

AIRCRAFT ACCIDENT REPORT

Name of Owner : Van den Berg Lugbespuiting cc
Name of Operator : Rautenbach Aerial Spraying
Manufacturer : Air Tractor
Model : AT-401
Nationality : South African
Registration Marks : ZS-NLP
Place : Kataza private airstrip - KZN
Date : 14 February 2011
Time : 0440Z

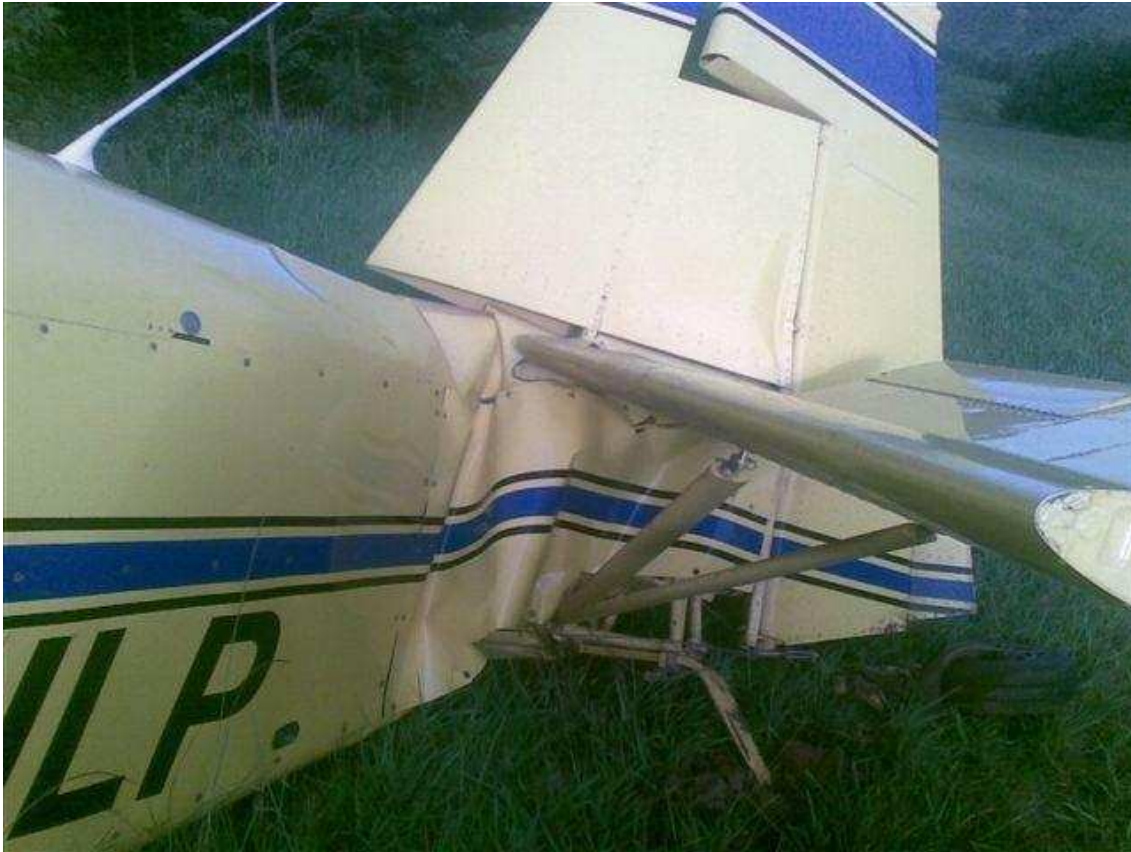
1.3.1 The aircraft sustained substantial damage to the tail section.

Figure 1 indicate damage to the aircraft

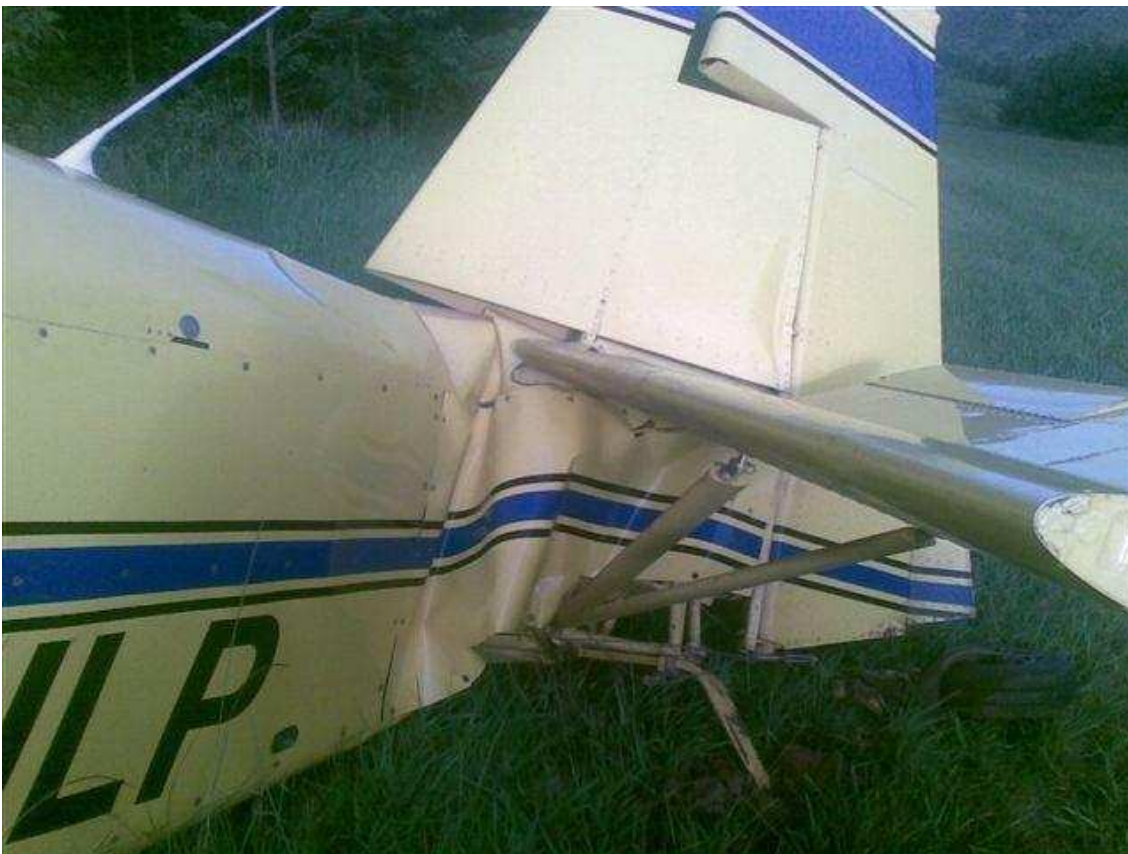
1.12.1 The aircraft bounced on a wet runway, the engine failed while the pilot attempted to recover, and as a result the aircraft crashed.

Figure 2 Wreckage of the aircraft

3.2.1 The pilot induced an engine failure by applying a rapid movement on the throttle. He lost control on landing.

3.2.2 Contributing factor: Wet runway.
