**NATIONAL
TRANSPORTATION
SAFETY
COMMITTEE**

Aircraft Accident Investigation Report

PK-LFI

Boeing 737-900ER

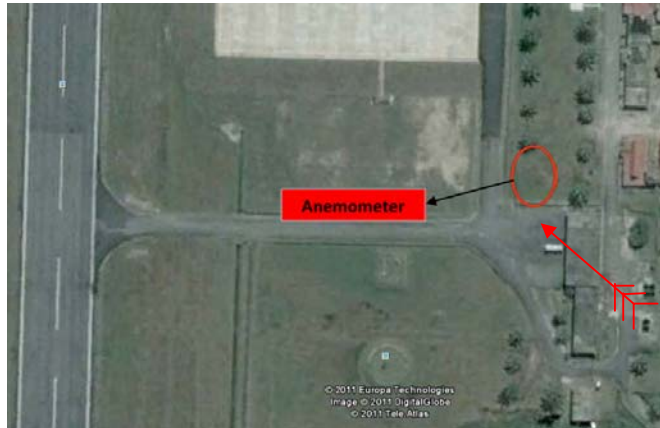
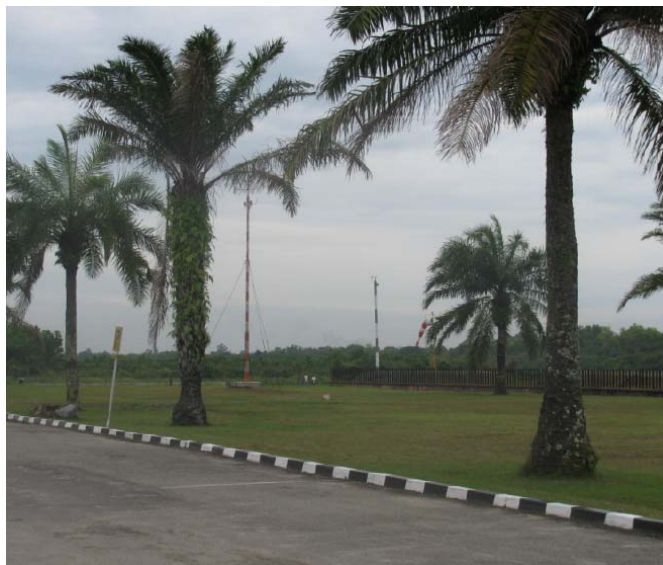
During the aircraft on final approach, the tower controller issued wind information based on the indication at wind indicator in tower. The wind indicator in tower source was from the anemometer which was surrounded by vegetation and building which may cause inaccuracy in the reading.

Figure 1: Location of anemometer and the wind direction at the time of landing

Figure 2: location of anemometer for tower wind indicator

The discrepancy of the surface wind data might arise from the fact that the location of the anemometer was surrounded by vegetation and building which might generates turbulence that might cause reading inaccuracy. Based on this condition it can be concluded that the wind speed report from the Tower controller might be incorrect.

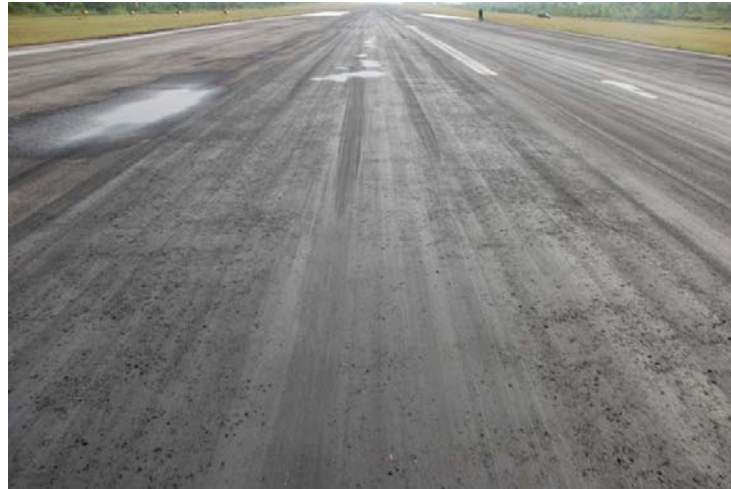
Figure 3: Rubber deposit on the touchdown zone runway 18.

At the day of the serious incident, the rubber deposit was found on the runway especially between the thresholds up to touch down zone runway 18 (see figure 3).

Observation on the runway performed after the serious incident found rubber deposit on the runway especially between the thresholds up to touch down marker runway 18. The touchdown markers located at 1000 feet from the runway thresholds. The examination also found some water spots. The combination of the rubber deposit and water spots would significantly reduce both the runway friction and brake effectiveness.

1. The airport authority of Sultan Syarif Kasim II was revised the interval schedule for the rubber deposit cleaning. The previous cleaning schedule was 6 (six) months, the revised schedule became "*On Condition*", depends on the inspection result;
2. The airport authority of Sultan Syarif Kasim II was conducted some repair on runway surface to ensure the standing water will be eliminate;
3. The airport authority of Sultan Syarif Kasim II shall issue a notam² to inform that the runway skid resistance was 0.55 and was below the minimum requirements of 0.60. This condition may result in poor braking action when the runway is wet.

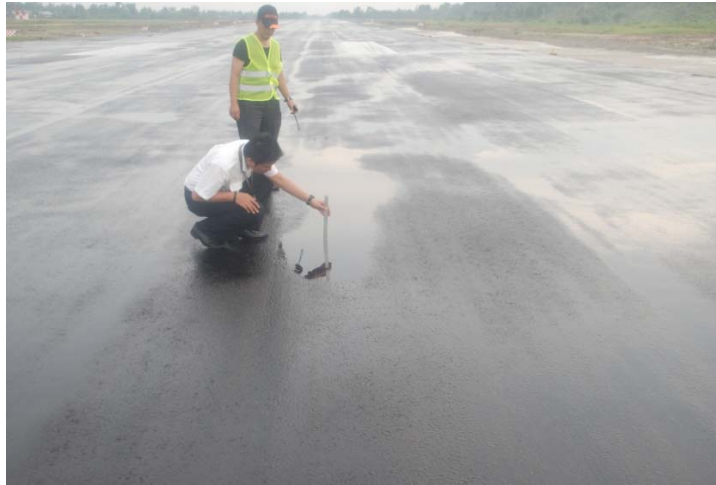
After the serious incident, the runway was examined for existing of standing water. It found several water spots on the runway up to 3 cm depth.

Figure 4: standing water examination performed 1 hour after rain.

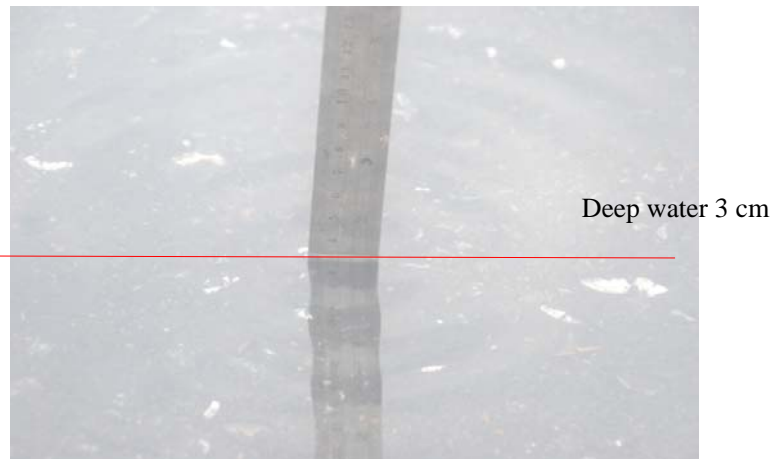
Figure 5: standing water up to 3 cm

- k) The runway examination found rubber deposit and water spots up to 3 cm depth on the runway along 1000 feet to the end of runway 36.
- l) The combination of the rubber deposit and water spots would significantly reduce both the runway friction and brake effectiveness.

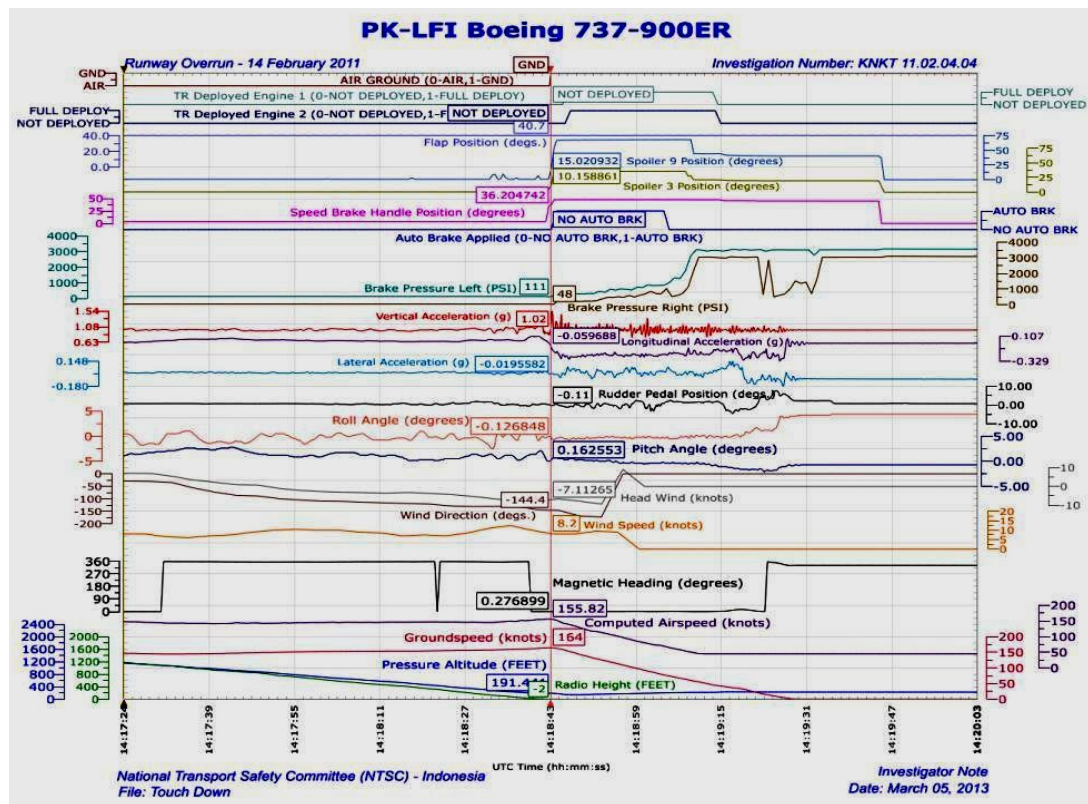
Figure 6: FDR data with special information during touch down

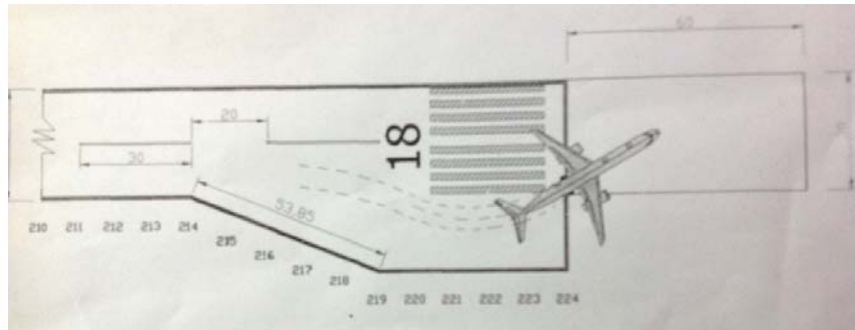
The investigation found several marks on the runway after the serious incident. The illustration below is based on the marks found on the runway.

Figure 8: Illustration on the last part of aircraft movement.

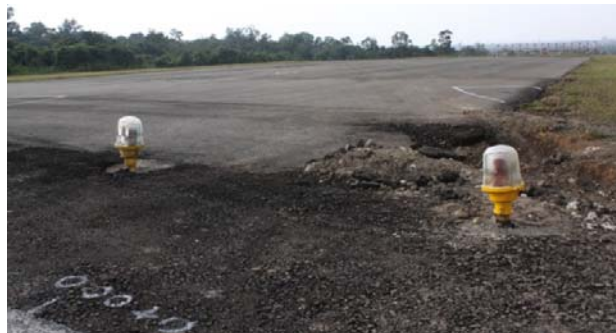
Figure 9: Final aircraft position after the aircraft has been removed
