AIRCRAFT ACCIDENT REPORT AND EXECUTIVE SUMMARY

Reference:	CA18/2/3/8896	
Aircraft Registration	ZS-HWR	Date of Accident	20 February 2011		Time of Accident	1425Z
Type of Aircraft	Enstrom 280 FX Helicopter		Type of Operation		Private	
Pilot-in-command Licence Type		Private Pilot	Age	55	Licence Valid	Yes
Pilot-in-command Flying Experience		Total Flying Hours	293,0		Hours on Type	104,1
Last point of departure		Kitty Hawk Aero Estate Airstrip (FAKT)				
Next point of intended landing		Kitty Hawk Aero Estate Airstrip (FAKT)				
Location of the accident site with reference to easily defined geographical points (GPS readings if possible)						
Open stretch of veld on southern side of Kitty Hawk Aero Estate Airstrip at GPS co-ordinates S25°24 45.2 E028°17 30.9.						
Meteorological Information		Temperature: 25°C; Visibility and clouds: CAVOK.				
Number of people on board	1 + 1	No. of people injured	0	No. of people killed	0	
Synopsis		<p>The pilot, accompanied by a passenger, was engaged on a private flight from Kitty Hawk Estate Airfield. During the flight, the engine spluttered and suddenly lost power. The pilot began executing an autorotation emergency landing on an open stretch of veld,

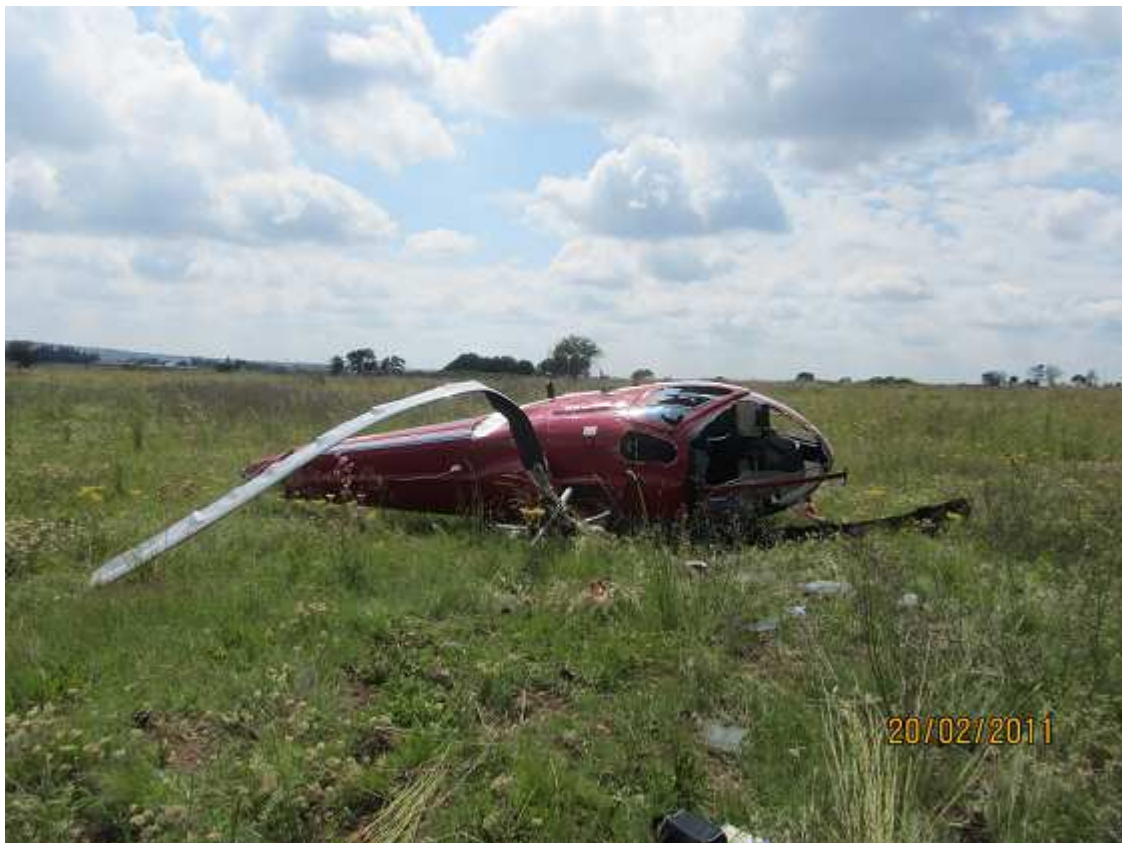
1.3.1 The helicopter was substantially damaged in the accident. The main rotor blades struck the tail boom during the landing sequence, severing the boom and tail rotor assembly. The fuselage also sustained damage after rolling onto its side, and the main rotor, skids and windscreen were destroyed.

Figure 1, The wreckage of the helicopter.

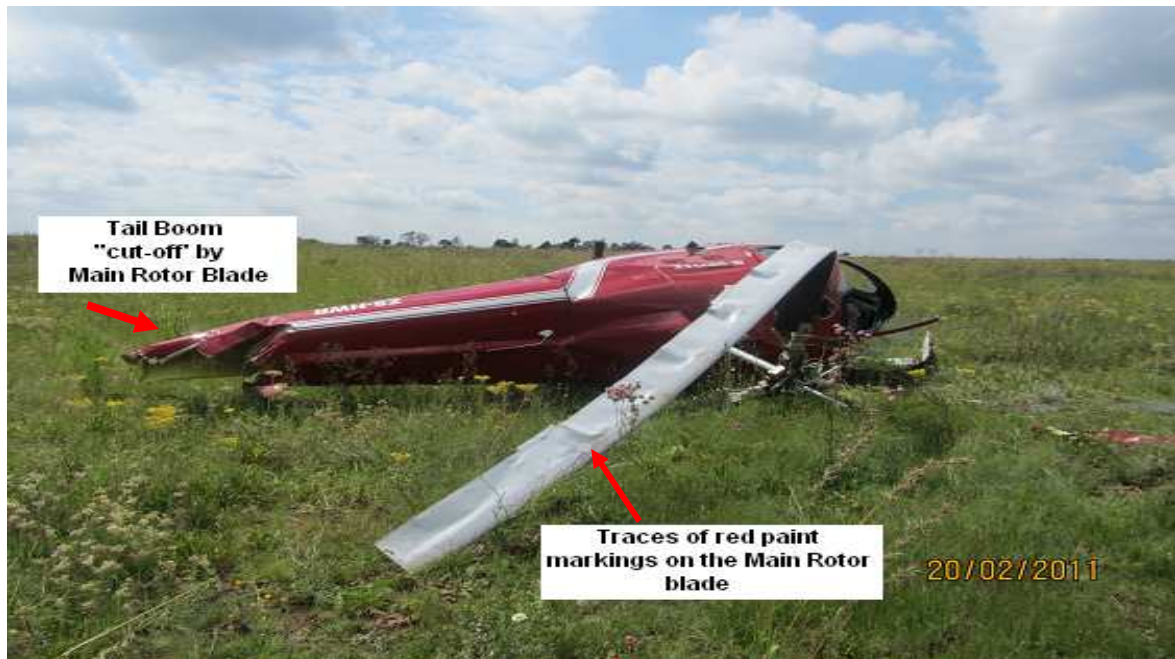
1.12.2 The helicopter sustained substantial damage in the accident. The evidence shows that the main rotor blades struck the tail boom during the landing sequence, severing the section of the boom containing the tail rotor assembly. The tail rotor drive shaft, control cables and electrical wires in the boom were damaged. The helicopter rolled over onto its right side about 50 m from the point of first impact.

Figure 3. The severed tail boom.

1.12.3 The helicopter ended up facing in the opposite (northerly) direction of the initial flight path. The tail rotor assembly had broken off from the rotor shaft and separated from the boom assembly as a result of the main rotor striking the boom. The tail rotor itself was found near the nose section. The left skid was approximately 20 m from the main wreckage. A piece of sheet metal structure from the tail boom was found about 30 m from the main wreckage.

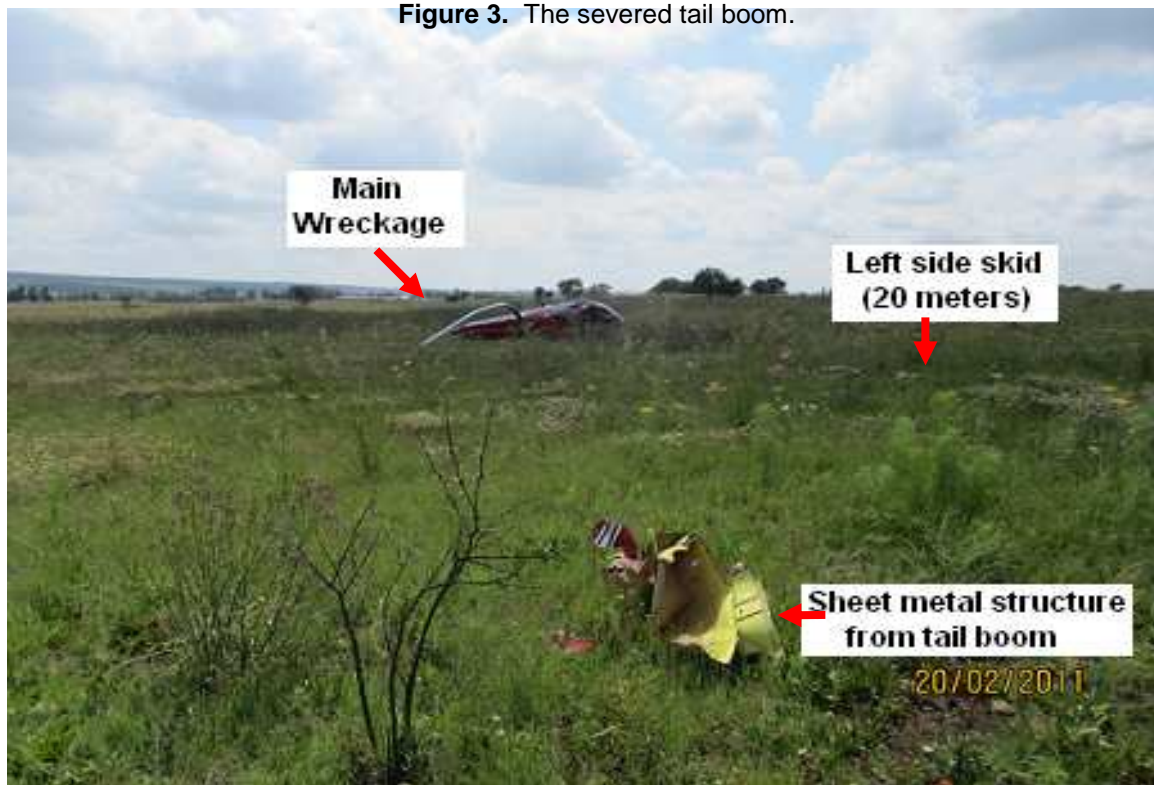
Figure 4. Debris from the wreckage.

1.12.4 It was concluded that after the left skid broke, the airframe initially struck the ground on its lower left side, then spun on the ground, toppling over onto its right side and ending up facing the opposite direction.
